STRUCTURAL DEFORMATION MONITORING ANALYSIS USING GEODETIC TECHNIQUES AFTER THE EARTHQUAKE AT BOLU PASS OF TRANS-EUROPEAN MOTORWAY

Esra TEKDAL EMNİYETİ, Rahmi Nurhan CELİK and Tefvik AYAN

*Istanbul Technical University, Civil Engineering Faculty, Division of Geodesy, 34469 Maslak
Istanbul, Turkey*

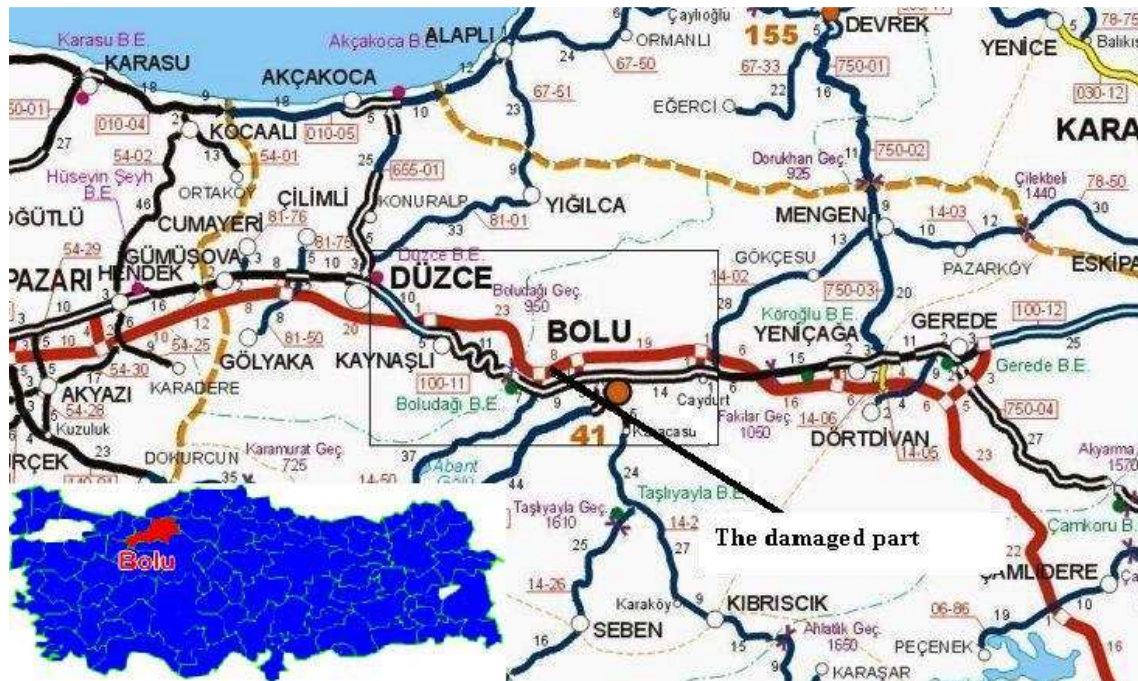
Figure 2 - Location and the damaged part of the Bolu Mountain Project

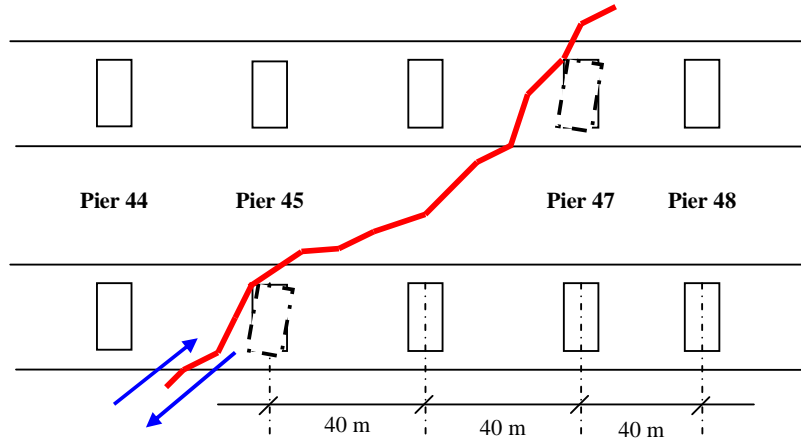
Figure 5 - Fault trace at viaduct (Celik et al. 2005)

As is mentioned above, there is no alternative to examine the viaduct previous position within a global system, since the viaducts have been seriously damaged by 3 individual cracks of the North Anatolian Fault. Therefore, the damages on the viaduct piers and stretch have been investigated in two parts. First part is, from Düzce to Bolu direction up to crossing crack and

the second part is from Bolu to Düzce up to crossing crack. The fault trace at viaduct is demonstrated detailed in Figure 5.

The viaduct region is divided into two parts near by pier 47. Therefore, analyses from two directions have been examined up to pier 48 from Düzce and up to pier 46 from Bolu. The overlapping region has been evaluated to see the effects of regional passing.

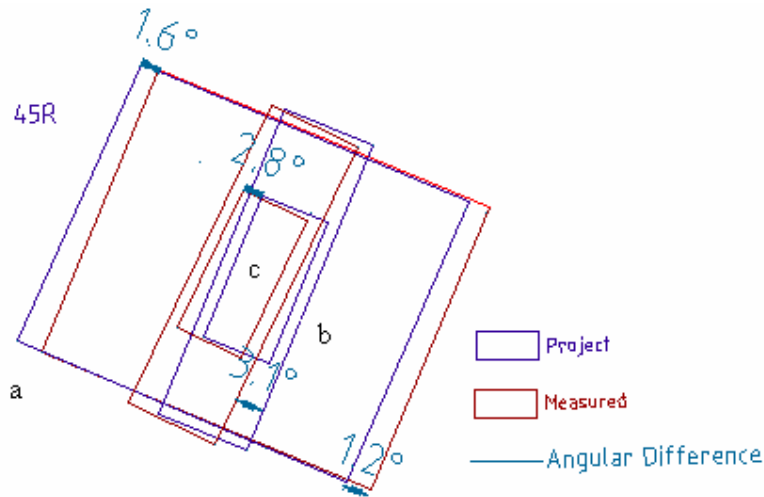
Figure 6 - The angular displacements in pier 45R (Tekdal, 2007)

The rotations in the viaduct are obtained by calculating the differences between the azimuths calculated according to a reference coordinate (Tekdal, 2007). In the figures below 'a' represents the ground block on the pier, 'b' represents the upper block and finally 'c' represents the column. As seen in Figure 6 there is an approximately 3° rotation in pier 45R.

In order to say there is torsion, the bottom and the upper part of the structures of the piers should perform different rotation angles at the same time. If we look at piers 45R in Figure 6 and 47L in Figure 8, lower and upper part has a different rotation value. So it can be said that the piers 45R and 47L has performed torsion (Tekdal, 2007).

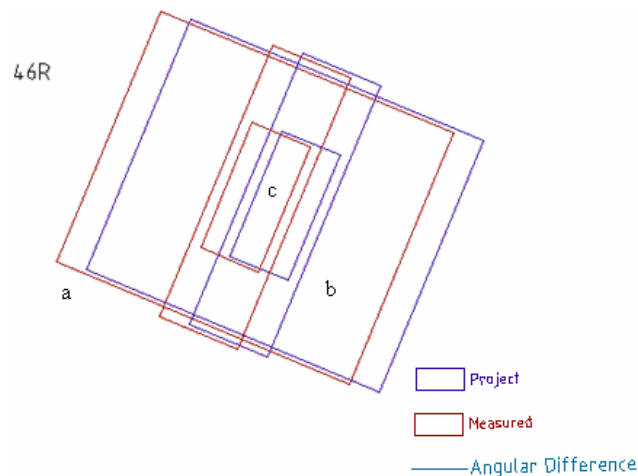
Figure 7 - The angular displacements in pier 46R

It is clearly seen in Figure 7 that the pier 46R did not performed a rotation, just moved parallel compared to the position before the earthquake.

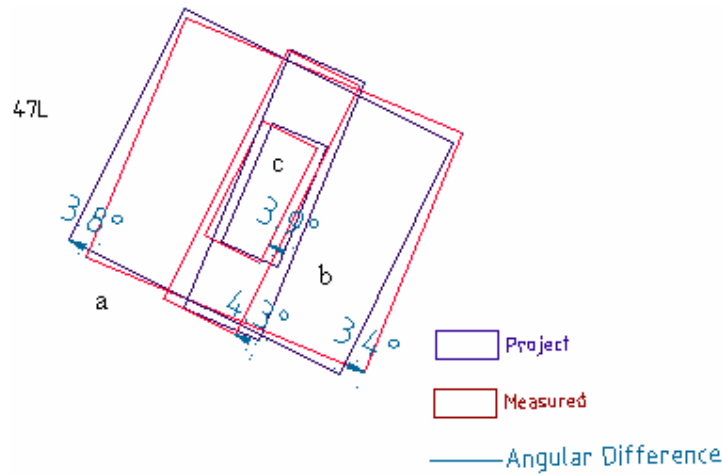
Figure 8 - The angular displacements in pier 47L

An approximate 4° of rotation achieved by pier 47L can be seen in Figure 8.
