## **CONTRIBUTION OF GEODETIC POSITIONING TO PREVENTING INCIDENTS IN FILL WORKS AND MITIGATION OF THEIR EFFECTS**

António VEIGA PINTO and Maria João HENRIQUES

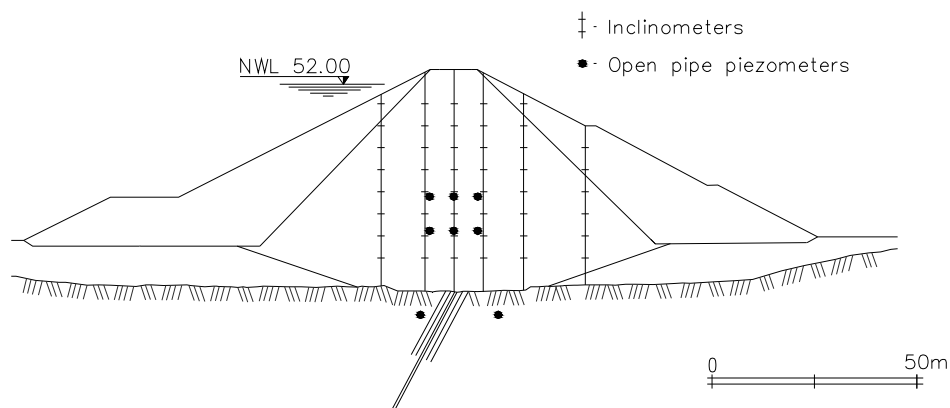
Figure 1 – Beliche Dam. Devices on the maximum cross-section

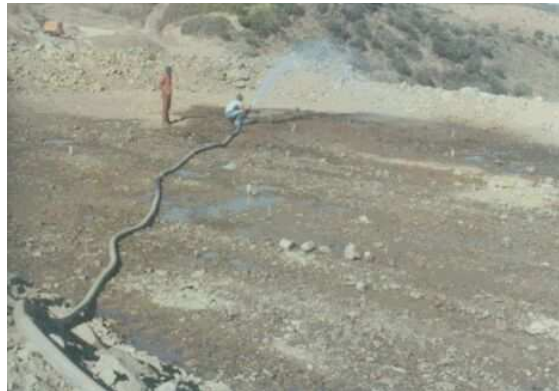
Figure 2 –Beliche Dam. Stage of abundant irrigation in the collapse test

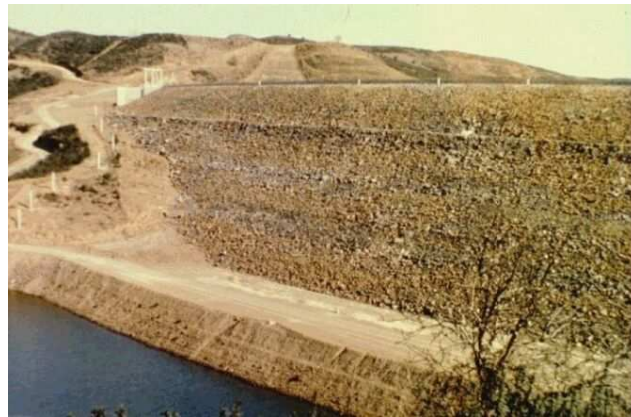
Figure 4 – Beliche Dam. Berm constructed on the upstream face

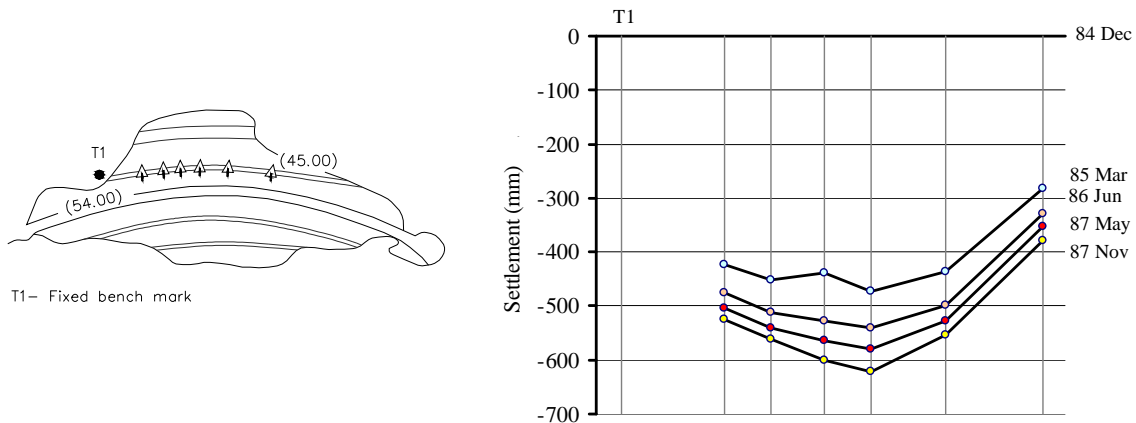
Figure 5 – Beliche Dam. Settlements measured during the first partial filling of the reservoir  
 Subsequently, during the stage of operation of the dam, significant surface displacements continued to occur, which were obtained from measurements made in the geodetic measurement system. Figures 6 and 7 present a few diagrams of those displacements.

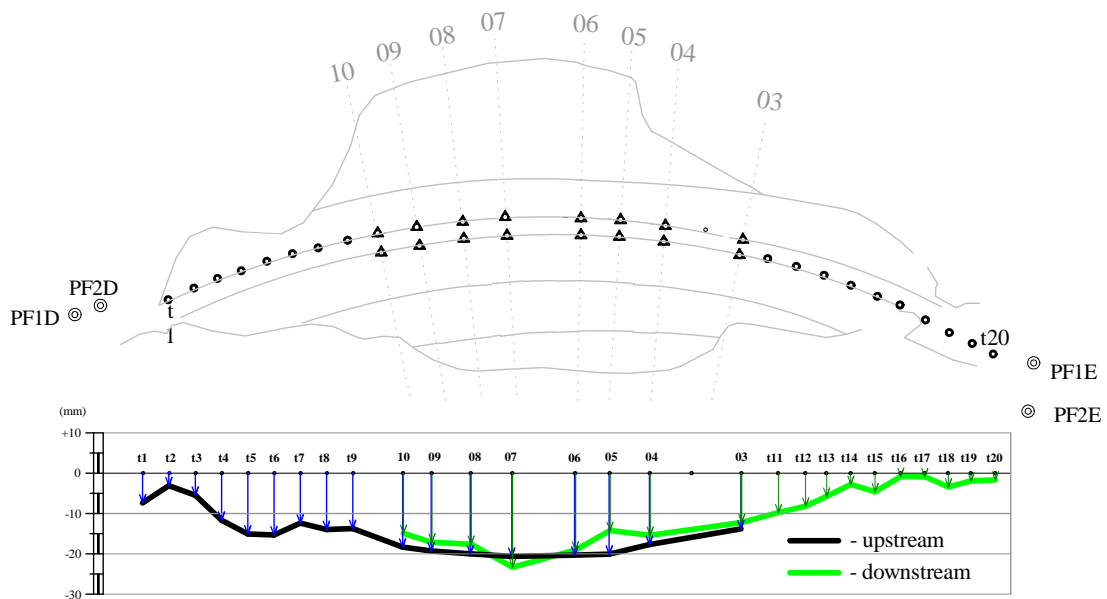
Figure 7 –Beliche Dam. Vertical displacements measured at the crest by geometric levelling

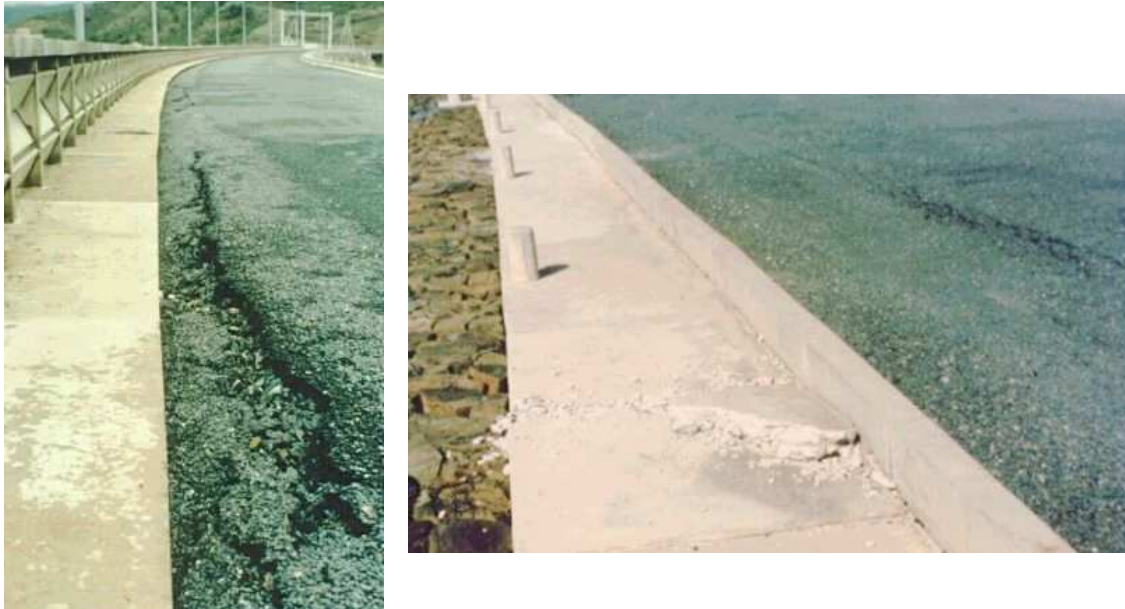
Figure 8 – Beliche Dam. Aspects of anomalies detected at the crest

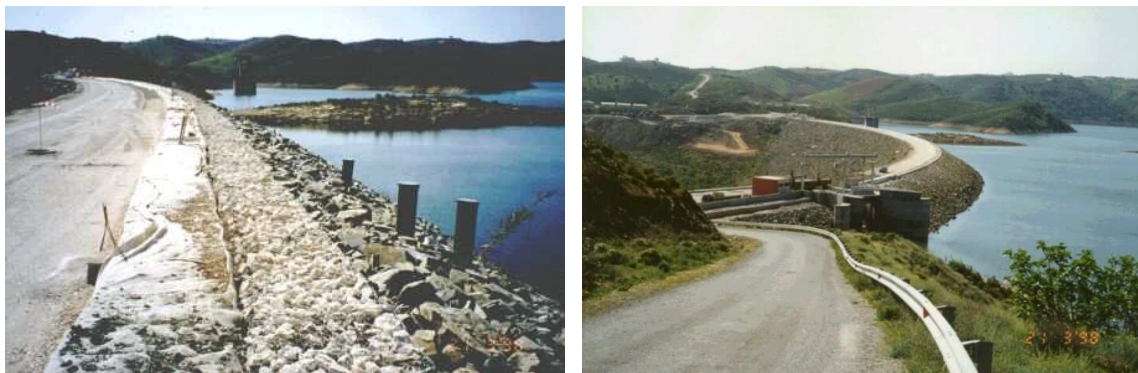
Figure 9 –Beliche Dam. Execution of the rehabilitation works

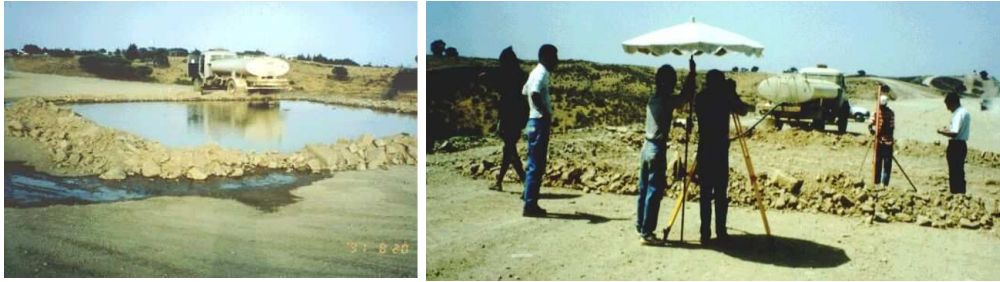
Figure 10 – Fill of VLA. Collapse test

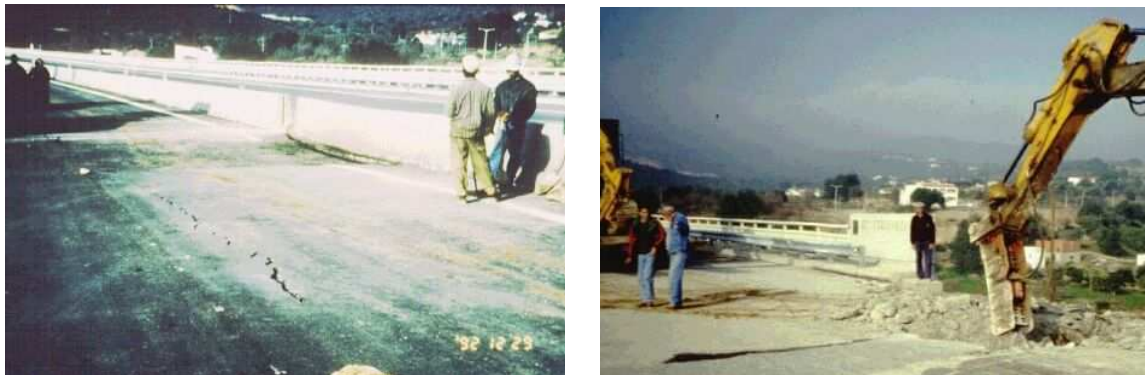
Figure 11 – Fills close to Rio Seco Bridge. Excessive settlements, cracking and rehabilitation works

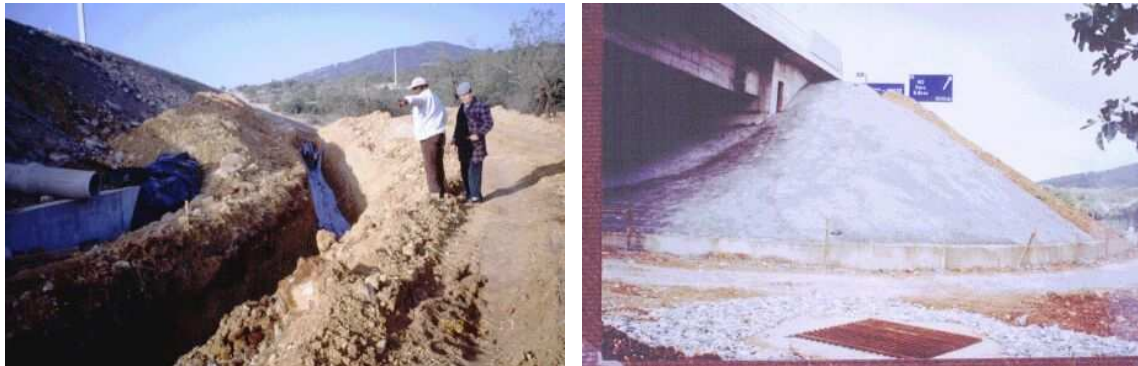
Figure 12 – Fills close to Rio Seco Bridge. Aspect of the drainage works and surface waterproofing  
 The fills were also substantially instrumented to measure the evolution in vertical displacements, namely in heavier rainfall periods. Figure 13 presents the installation of the object points and the diagram with the initial settlements measured in these fills.
