Measurement and Documentation for Structural Integrity Assessment of an In-Service School

Building at Risk

Department Of Civil Engineering, University Of Benin, Benin City (NIGERIA)

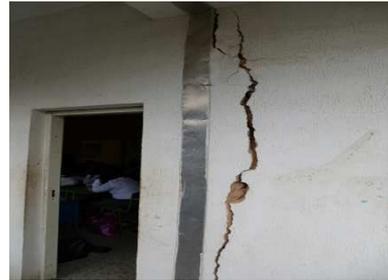
Fig 6: major crack in wall

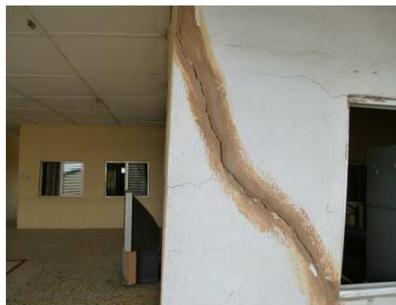
Fig 7: diagonal crack on wall

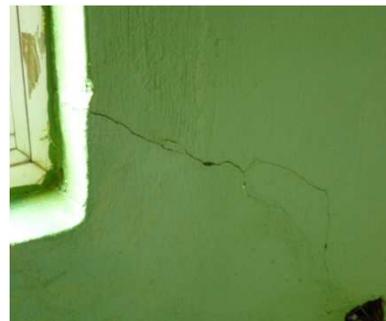
Fig 8: crack in Window

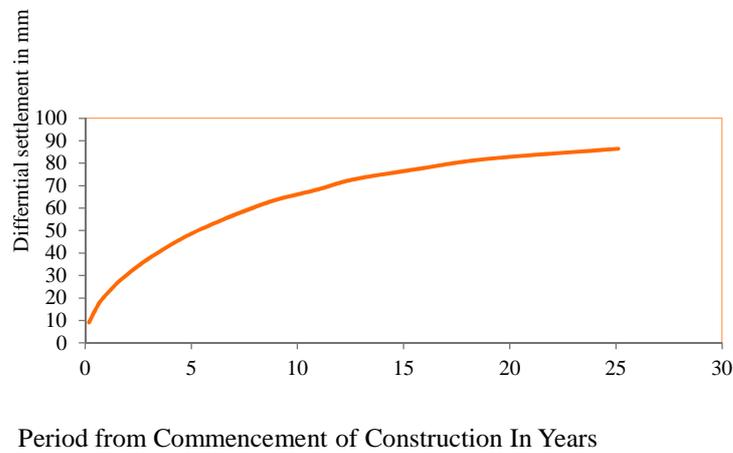
Fig :11 Settlement-duration chart for the foundation footing

- A plot of the differential settlement – duration curve is shown in fig 11 below.

- ❖ In the site under consideration, there is a considerable amount of clay content in the soil
- ❖ and the clay is likely to be saturated.
- ❖ In such case, settlement is likely to occur over a period of about 25years;
- ❖ and within 5years maximum differential settlement would have reached 40mm.
- ❖ As a result, structural distress would have become noticeable
- ❖ as evidenced from the different types of cracks (both longitudinal and transverse)
- ❖ and map shaped cracks noticeable in Block A.

- ❖ From an evaluation of the geotechnical results,
 - the defects at the site can be said to have resulted from inadequate foundation consideration
 - as the foundation has been designed on a consolidating soil strata
 - with high differential settlement.
