Earthquake Repairs at Christchurch WWTP – Lessons for Resilience

Greg OFFER, Mark CHRISTISON, Ian BILLINGS, New Zealand

Key words: Christchurch, resilience, treatment plant, earthquake

FIG Working Week 2016
Recovery from Disaster
Christchurch, New Zealand, May 2–6, 2016

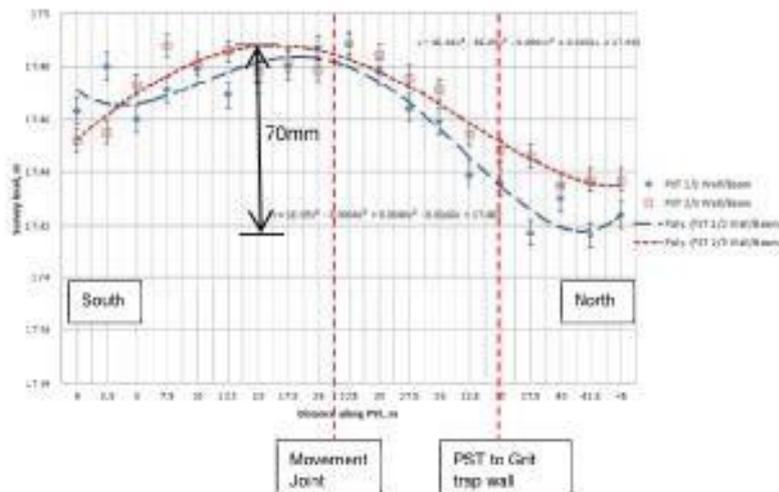
Figure 2: Longitudinal floor survey of PST

The PSTs (7 no.) and grit tanks (5 no.) comprise a series of interconnected 4m-deep in-ground reinforced concrete tanks, built in the 1960s. The PSTs and grit tanks are close-coupled. The 70m-long rectangular PSTs suffered extensive cracking due to forces and deformations induced by the seismic actions in February and June events. Longitudinal surveys of the PSTs over their length (see Figure 2) indicated the floors had suffered differential vertical displacements up to 70mm due to liquefaction forces, causing cracking of the walls and top beams.

Figure 6.1: Survey levels along PST/Grit Trap 2 (South to North), Level vs., Distance

As well as repairs to PST and grit tank cracks using epoxy injection, as part of post-earthquake resilience measures a project to de-couple the grit tanks from the PSTs is currently underway. This project will improve the flexibility of plant operations so that, in the event of a grit trap becoming blocked or otherwise unserviceable, all of the PSTs will remain available.

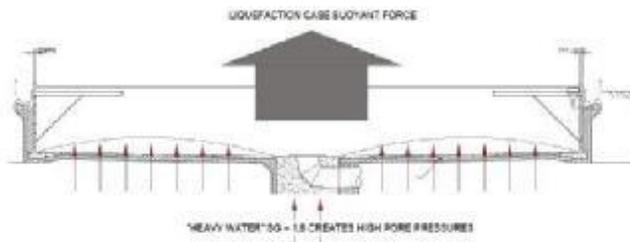
Figure 5: Liquefaction effects on clarifier

Damage to the clarifiers was caused by ground shaking and liquefaction effects. As the soil liquefied, the clarifier bases were subjected to liquefaction-induced uplift forces as well as static buoyancy force due to hydrostatic pressure. Figure 5 shows how the uplift pressures imposed forces on the clarifier structures, causing flotation effects on the entire structure and deforming the floors.

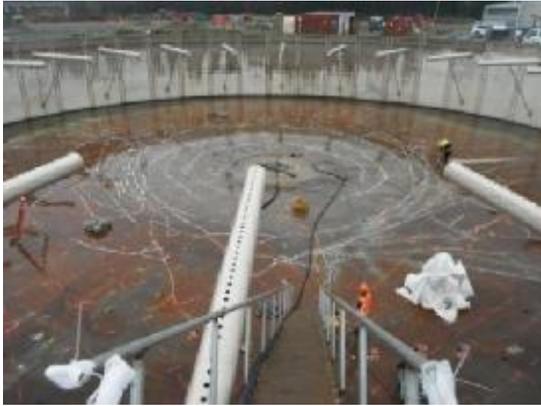
Parameter (mm)	Clarifier 1	Clarifier 2	Clarifier 3	Clarifier 4
Overall tilt	73	45	70	110
Central foundation uplift	80	20	300	100
Floor deformation	90	60	600	200

Investigations found a range of issues; Clarifiers 1 and 2 were relatively less damaged, while clarifiers 3 and 4 had major structural damage, necessitating major repairs.

Figure 6: Inverted floor cone on Clarifier 3

Various options for clarifier repairs were evaluated as set out in Table 2. Of these, the concrete floor overlay slab was preferred. It provided cost-effective reinstatement of clarifier structural performance to pre-earthquake condition, as well as a net improvement in resistance to liquefaction uplift. Other options either did not reinstate the structural performance or were expensive and time-consuming to implement. Photos in Figures 6, 7 and 8 show the damage and repairs to clarifiers.

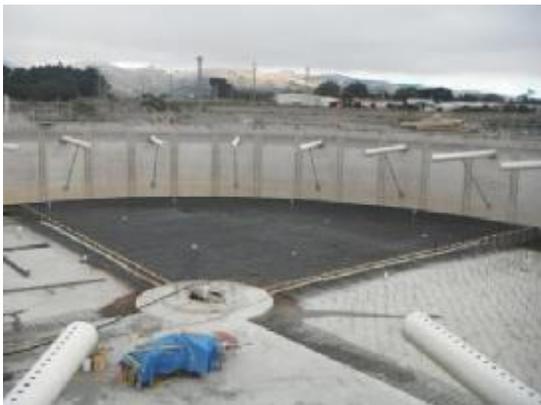
Figure 7: Clarifier 3 floor overlay showing reinforcing mats

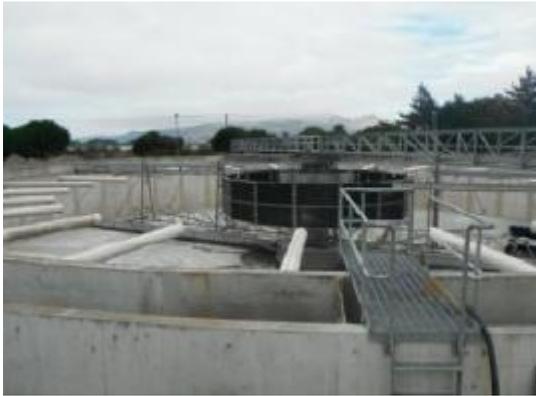
Figure 8: Fully repaired Clarifier 4

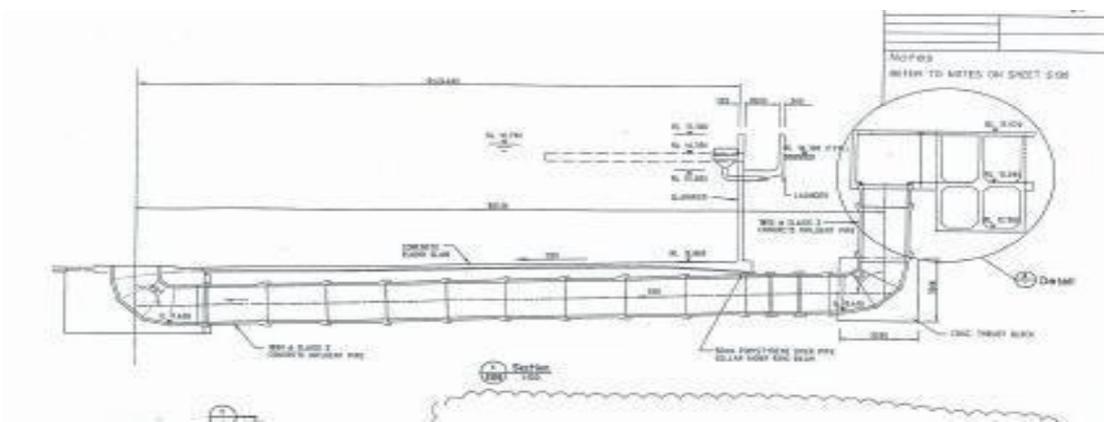
Figure 9: Influent pipe cross section

Hydrostatic head testing of the influent pipes identified significant levels of leakage. A dive survey found pipe movement and spalling at pipe joints indicating impact damage between the pipe sections.

This simple analysis indicated likely ground movement around the pipe, causing shortening, with the attendant risk that subsequent seismic events could cause further movement and damage. Any repair solution needed to be capable of accommodating a similar amount of movement – whilst retaining the integrity of the repair.

The CIPP liner system effectively forms a new pipe inside the existing pipe by using a polyester fabric impregnated with thermo-setting resin, inflated against the existing pipe and cured with hot water or steam. The thickness of the newly formed pipe was designed to suit loading conditions.

The permissible liner elongation is almost entirely dependent on the resin used in the liner given that the polyester fabric into which the resin is impregnated has a very low stiffness and thus does not contribute significantly to the mechanical properties of the composite material. A worst case design condition was set, based on axial movement of 120mm during an earthquake being transferred to just one length of concrete pipe; equating to approximately 5% extension. Uniformly spread over the length of the horizontal section of pipe the elongation is approximately 0.5%. The design approach was to use this range (0.5% to 5%) as one of the criteria for selecting a suitable resin. In consultation with the CIPP liner supplier, a vinyl ester resin was specified, capable of accommodating elongation up to 10%; giving a superior margin over the calculated 5% requirement.

The CIPP liner system was also designed to resist the worst case external pressures arising during a liquefaction event. This resulted in a liner with a wall thickness of 50mm taking into account the reduced mechanical strength (but increased ductility) of the specified vinyl ester resin.

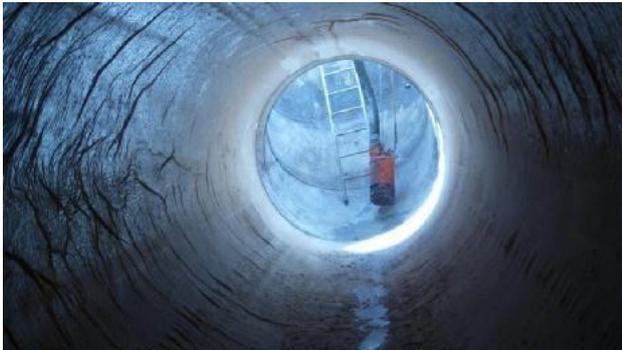
Some creasing was identified on the straight section of the finished liner on Clarifier 4. This can occur with a thick liner because the final internal layer of polyester tends to bunch-up to a minor degree (refer to Figure 10).

Figure 10: Creasing of liner on clarifier 4

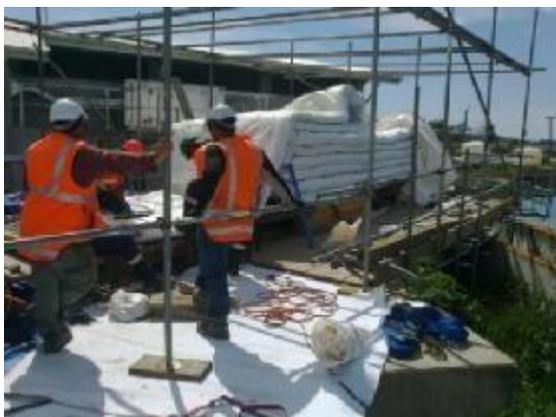
Figure 11: CIPP liner prior to installation

The 1800Ø CIPP liners installed on the CWTP clarifiers by Pipeworks Ltd are the largest CIPP liners installed to date in New Zealand. Figure 11 shows the contractor unravelling the liner prior to installation.

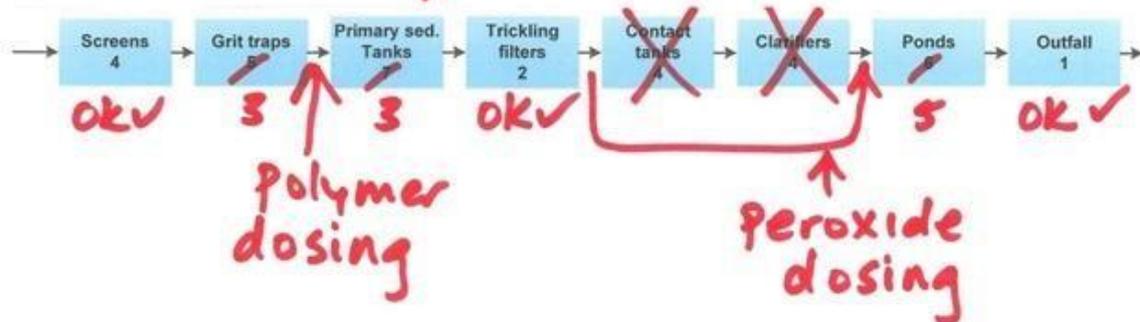
Figure 13: Short-Term Operations Post-Earthquake

The CWTP site is located in an area of liquefiable sands with shallow groundwater, typically at 1.5m – 2.5m depth. Ground shaking and coincident soil liquefaction during the 22 February 2011 aftershock caused varying levels of damage to a range of unit processes at CWTP as shown in Figure 13 at the rear of this paper.
