HISTORICAL-MACROSEISMIC STUDY OF THE TOWN CHURCH IN WITTSTOCK, NORTHERN GERMANY

Andrey M. Korjenkov¹ and Diethelm Kaiser²

Abstract

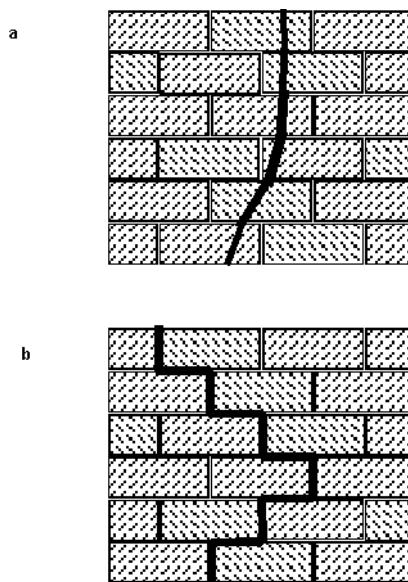
Generally, different sorts of fissures can be divided into two main groups by their configuration: oblique and sub vertical (Fig. 1). The oblique fissures usually use a space between bricks (stones) for their propagation, as "easier way" to break the wall. Such fissures can be produced by both agents: static and dynamic ones (Stiros, 1996).

Fig. 1. Different types of fissures in the damaged walls: a - through-going joints, supposing their seismic origin, b - orthogonal cracks, which can be produced by the static loading or seismic oscillations.

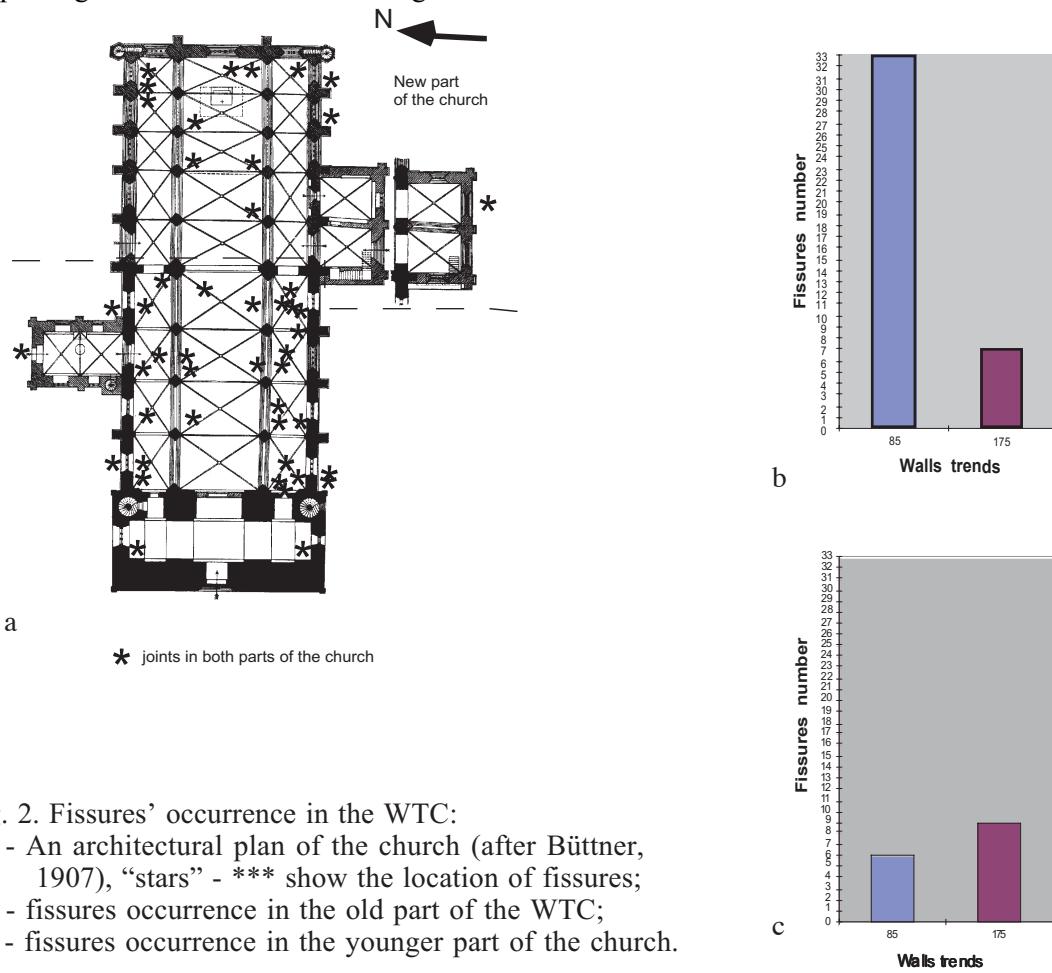
We mapped the fissures, which can be seen in the walls, arches and vaults of the Wittstock church. It is necessary to mention, that internal parts of the WTC walls were recently repaired and the part of the existing fissures are either not observable any more or badly visible under the plaster, so it is difficult to estimate the degree of their development and origin. In the old part of WTC 40 cases of fissures have been mapped (Fig. 2a), almost all of them (82%) occurred in the wall with sub latitudinal (80° - 85°) trend (Fig. 2b). In the “new” part of the church the walls with both trends have almost the same number of the fissures (Fig. 2c), although the walls trending 175° - 180° have a little more fissures (60%). This means that different parts of the church have different history of external influences.

It is important to note, that the walls of the younger part of the church have through-going joints also. They are located mainly in the eastern wall of the church. This fact can be (1) an evidence of another significant earthquake which happened after completion of the new part of the church or (2) a consequence of permanent vibrations arising from trucks and cars passing near the eastern wall along the street located in 1 m distance east of that wall.

Fig. 2. Fissures' occurrence in the WTC:
(a) - An architectural plan of the church (after Büttner, 1907), “stars” - *** show the location of fissures;
(b) - fissures occurrence in the old part of the WTC;
(c) - fissures occurrence in the younger part of the church.

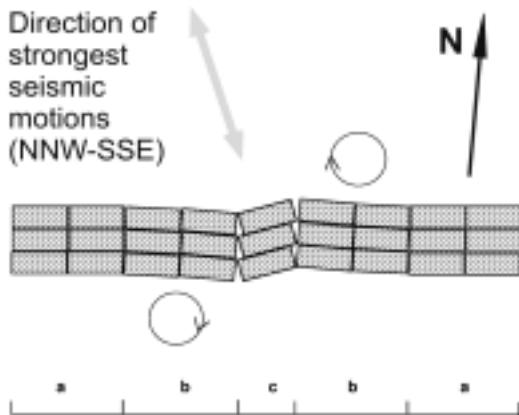
Systematic rotation of wall fragments or entire walls around a vertical axis indicate strong seismic movements at some angle to the wall trend. The theoretical background of this phenomenon has been discussed in detail by Korjenkov and Mazor (1999b, c). Example of case of rotations in the WTC is given in Fig 3. Widths of rotated brick packages are up to 1 m, they are several meters high. Thickness of the walls in this part of the building is 2 m. Two clockwise rotations were observed at the tower of WTC on walls trending 80° - 85° . Thus, the seismic motions were oblique to those walls along the NNW-ESE axis (Fig. 3).

Fig. 3. Rotations in Wittstock church's tower: a model explaining observed rotation pattern. a - undeformed wall, b - parts of the wall underwent clockwise rotations, c - transitional zone of drag (counterclockwise) rotation.

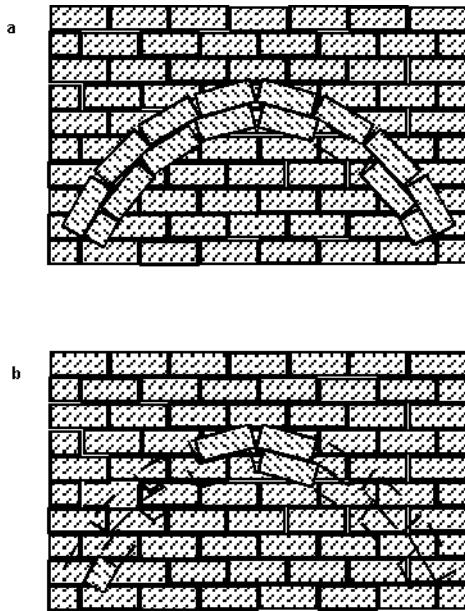
In upper part of WTC tower one can observe that walls with different trends have different degree of the damage. This statement can be clearly demonstrated by different preservation of decorative brick arches attached to the walls (Fig. 4): arches attached to the sub longitudinal walls (trend 170° - 175°) preserved rather well (Fig. 4a), however arches on perpendicular walls preserved only partly (Fig. 4b). It is important to mention here, that sub latitudinal walls have also maximum occurrence of the fissures and rotations, so the fact that arches here had maximum destruction is an additional evidence for the seismic origin of damage.

Fig. 4. Different degree of damage of attached arches in the walls with different trends in upper part of the Wittstock church's tower. a - walls trending 170° - 175° , b - walls trending 80° - 85° .

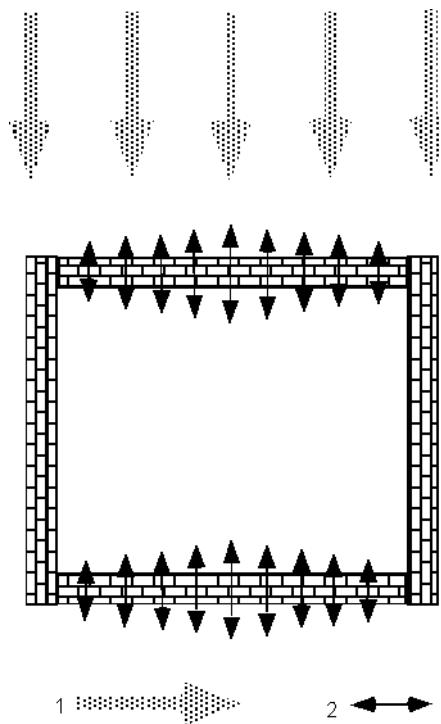
Systematic pattern of deformations in the walls of the same trend shows the influence of a horizontal component of the seismic movements (Korjenkov and Mazor, 1999b, c). Walls, which are perpendicular to the direction of the seismic motions, have maximum damage because of maximum freedom of oscillation (Fig. 5).

Fig. 5. Different freedom of oscillations (2) for walls with different trends, exposed to seismic movements (1).

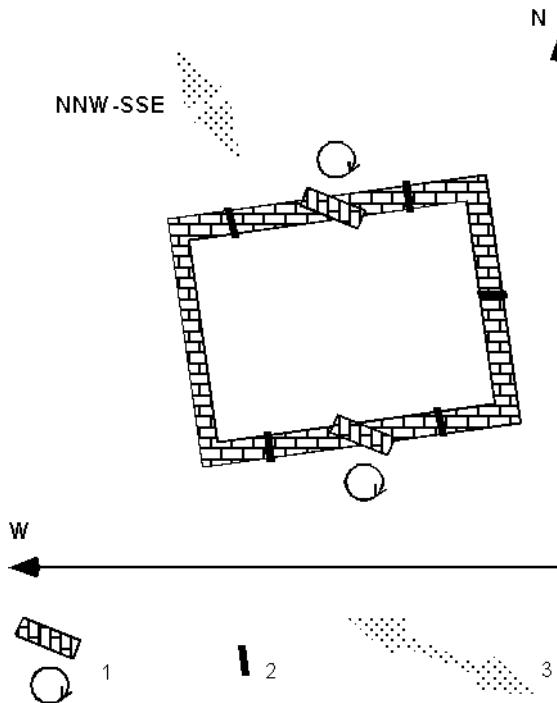
Maximum damage occurrence in the walls of sub latitudinal trend suggests that the strongest seismic movements were roughly perpendicular to the wall of this trend, however the existence of rotated parts of the walls means that strong seismic motions occurred at some angle to the walls of that trend (Fig. 6). So, the most probable direction of the strong seismic movements is along NNW-SSE axis.

Fig. 6 A model explaining the observed damage patterns in upper part of the Wittstock church. 1 - clockwise rotations, 2 - through-going joints, 3 - axis of the seismic movements
