CONTRIBUTION OF GEODETIC POSITIONING TO PREVENTING INCIDENTS IN FILL WORKS AND MITIGATION OF THEIR EFFECTS

António VEIGA PINTO and Maria João HENRIQUES

National Laboratory for Civil Engineering, Portugal

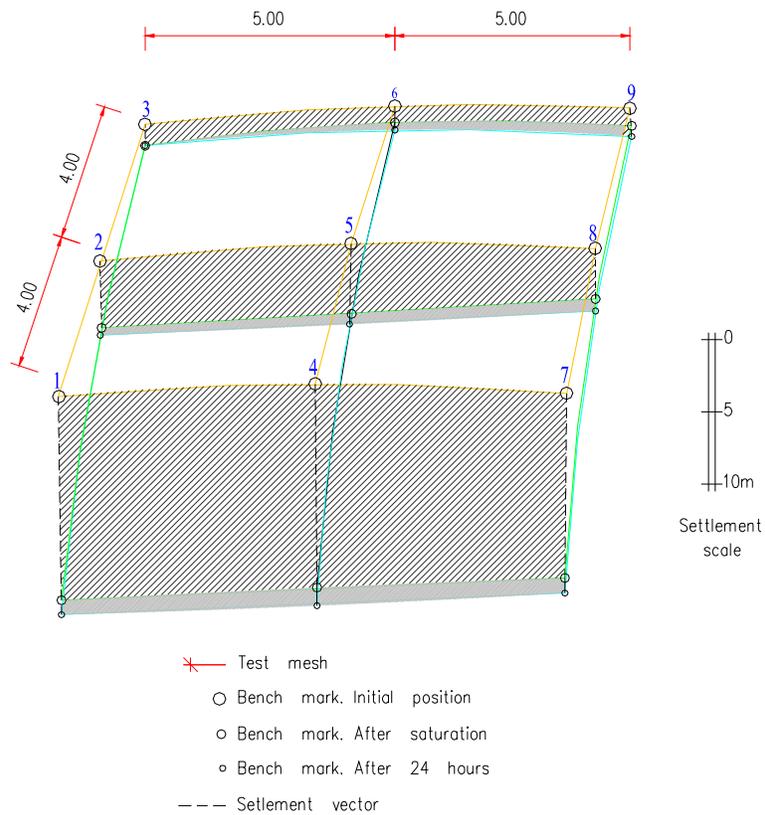
In this test, the settlements measured (Figure 3), under the soaking effect, were about 10 times higher in the transition material (bench-marks 1, 4 and 7), comparatively with the rockfill material, which was placed on the outer part of the stabilising rock mass (bench-marks 3, 6 and 9).

Figure 3 – Beliche Dam. Results of the collapse test

In view of these results, it was concluded that, during the first filling phase, high settlements were likely to occur. Therefore, other than reinforcing the compaction procedures in the transition material, an adaptation to the observation plan was also immediately established. This comprised the inclusion of a berm on the upstream face to act as support to the installation of temporary bench marks to measure settlements, as soon as the submersion of the material of the upstream stabilising rock mass (Figure 4) began. That berm was to be located at a level about 9m lower than the crest.

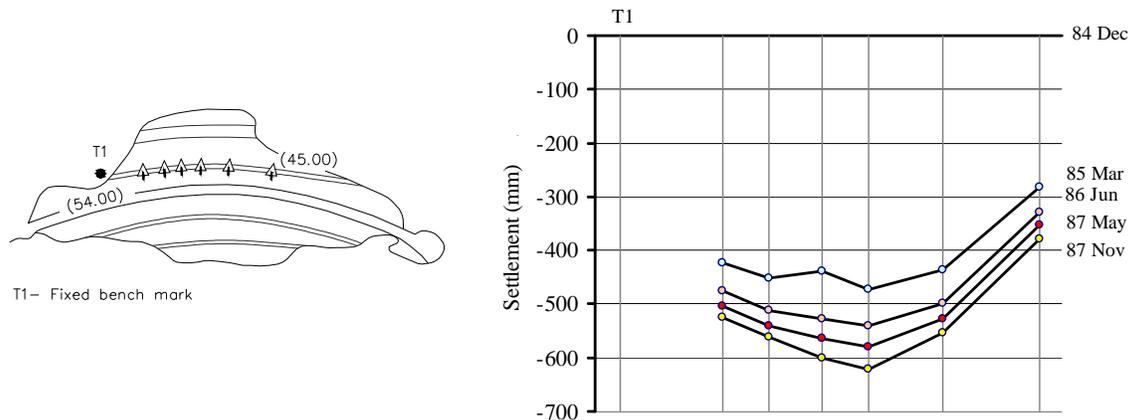
From results obtained (Figure 5), it was observed that the estimation had been correct, since at the time of the first filling of the reservoir, in the 1984-85 Winter period, the maximum settlement on the berm reached a value close to 0.50m, which was fairly higher than the predicted value and close to the over-elevation value, which was only 0.20m.

Figure 5 – Beliche Dam. Settlements measured during the first partial filling of the reservoir
 Subsequently, during the stage of operation of the dam, significant surface displacements continued to occur, which were obtained from measurements made in the geodetic measurement system. Figures 6 and 7 present a few diagrams of those displacements.

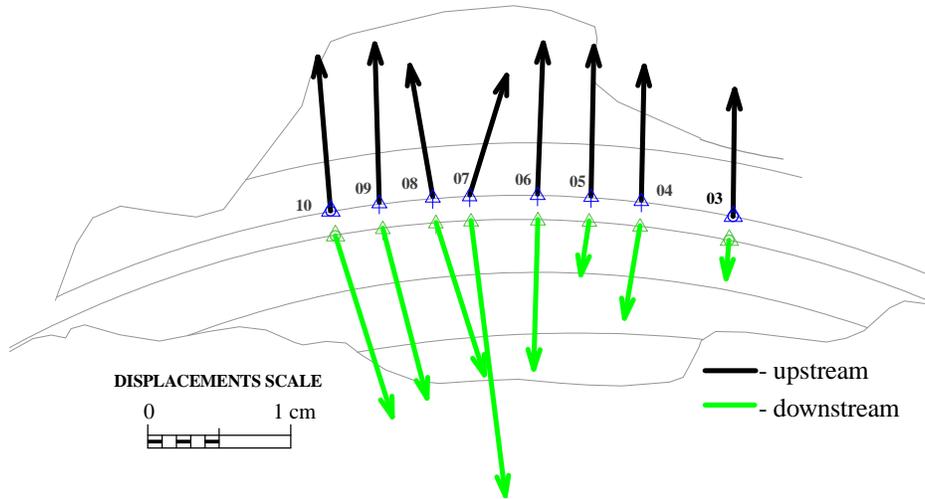
Figure 6 – Beliche Dam. Results of the horizontal displacements

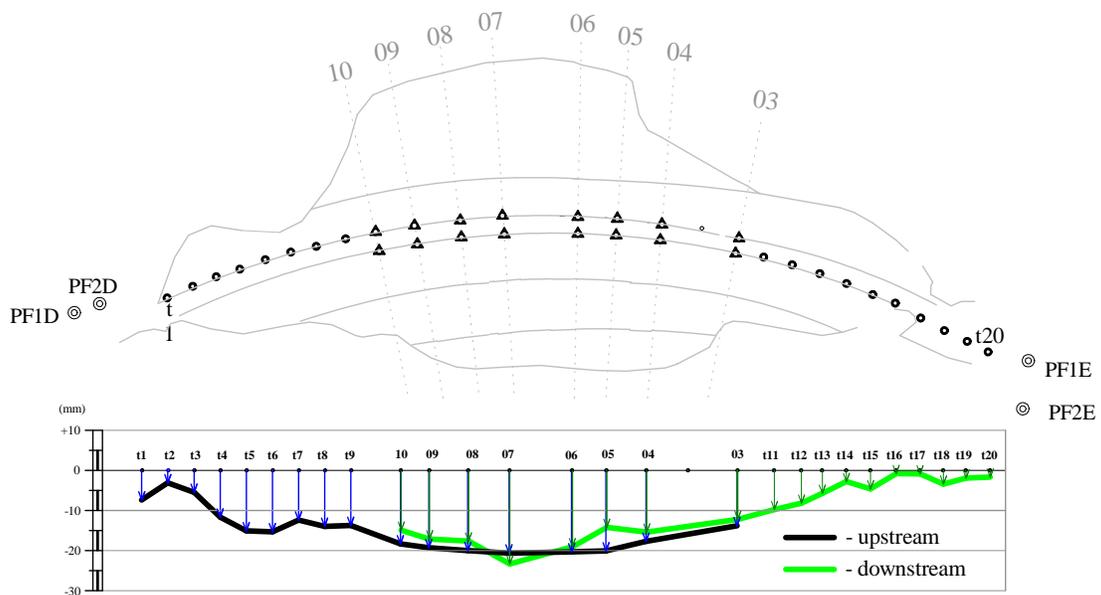
Figure 7 –Beliche Dam. Vertical displacements measured at the crest by geometric levelling

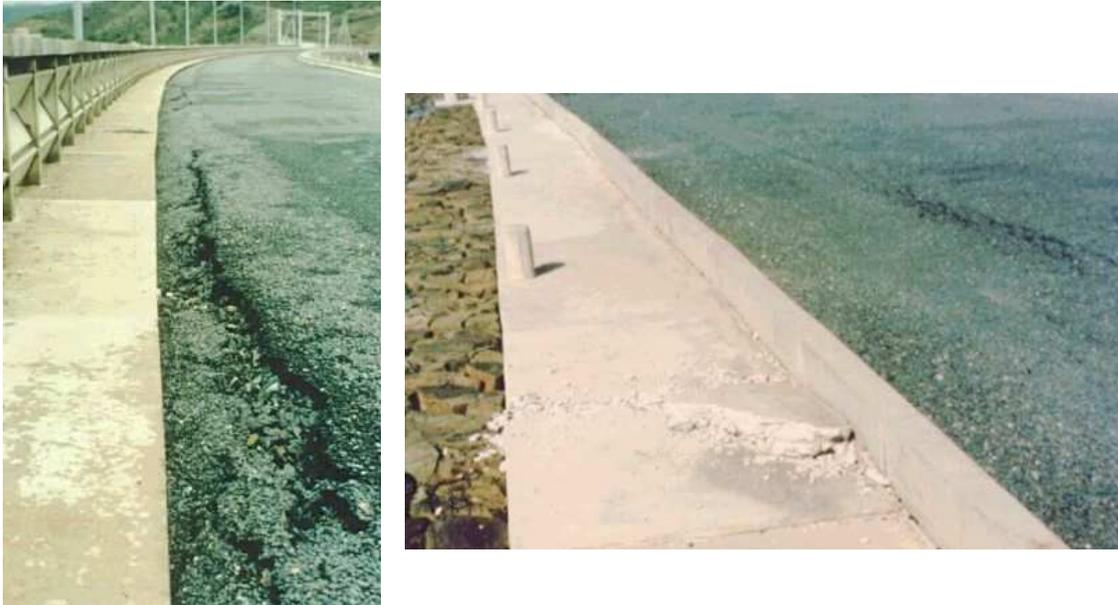
In visual inspections, several anomalies were detected, such as, excessive differential settlements, misalignments, cracking or failure of concrete elements, which were associated with these significant displacements, as Figure 8 shows.

Figure 8 – Beliche Dam. Aspects of anomalies detected at the crest

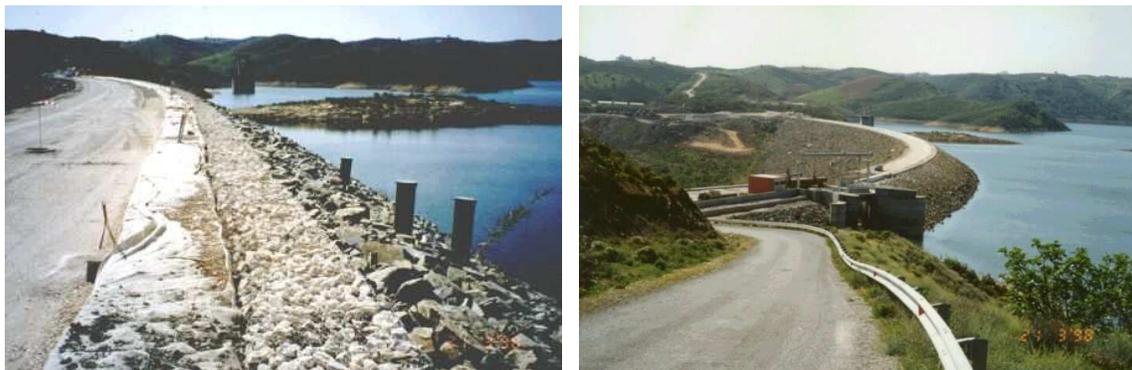
Subsequently, during the operation of the dam, considerable displacements continued to occur, which have led to cracking of the fill surface and to the need of performing a rehabilitation work, because the crest level reached unacceptable safety values for the operation level of the reservoir, and, thus, an overtopping accident was very likely to occur. Figure 9 illustrates the works performed for rehabilitation of the dam.

Figure 9 –Beliche Dam. Execution of the rehabilitation works

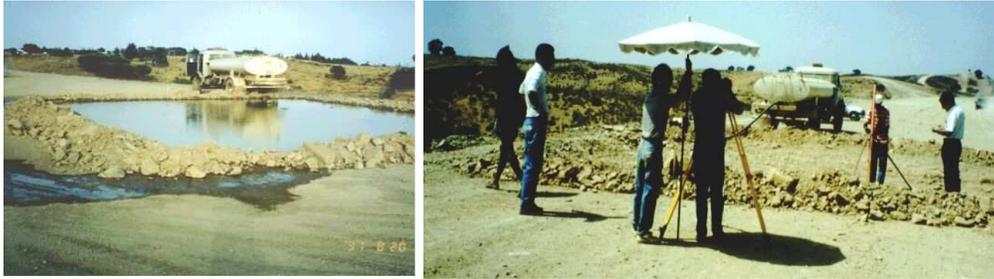
Figure 10 – Fill of VLA. Collapse test

Due to the difficulty associated with the infiltration of water in the fill material, the test was considered to be inconclusive.

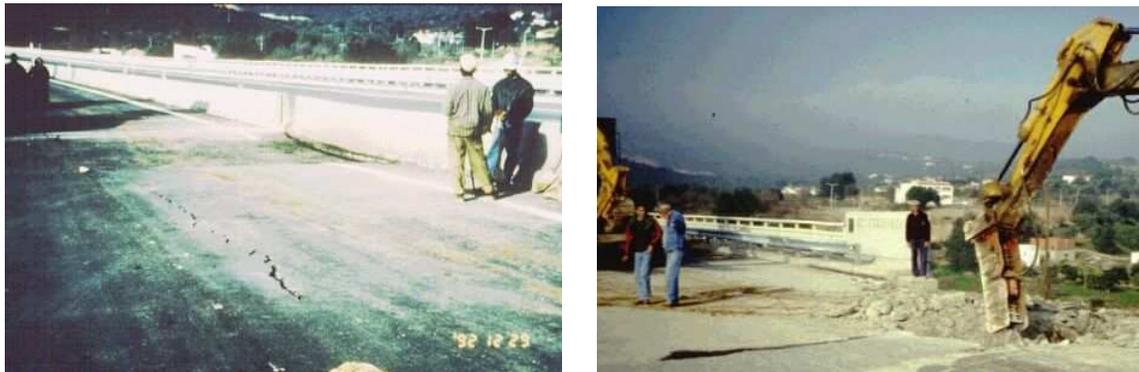
Nevertheless, immediately after the work started operating, an exceptionally heavy rainfall occurred close to Rio Seco Bridge. Due to the impossibility of water drainage through a passage below the traffic line, the water overtopped the road towards the bridge and has profusely infiltrated in the fills of abutments, causing significant settlements in just a few hours, which reached as much as 0.30m in some places. In view of that occurrence, the roadway was closed for repairs, for a certain period, so as to replace the damaged material. Figure 11 illustrates the excessive settlements and cracking after the accident and a stage of the works performed for rehabilitation of the structure.

Figure 11 – Fills close to Rio Seco Bridge. Excessive settlements, cracking and rehabilitation works

After collection and physical-mechanical characterisation of fill materials and the execution of stress-deformation calculations (Veiga Pinto *et al.*, 1995), it is possible to conclude that the collapse of fill materials must also have led, in this particular case, to excessive settlements and to the need of performing corrective measures.

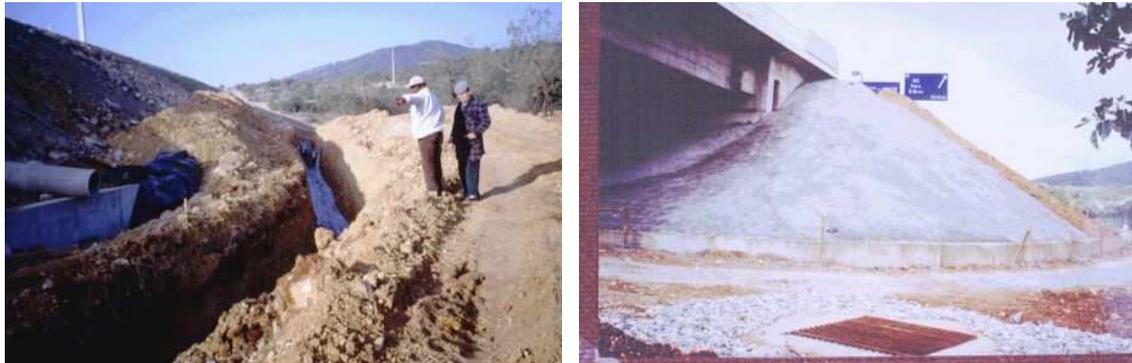
Figure 12 – Fills close to Rio Seco Bridge. Aspect of the drainage works and surface waterproofing
 The fills were also substantially instrumented to measure the evolution in vertical displacements, namely in heavier rainfall periods. Figure 13 presents the installation of the object points and the diagram with the initial settlements measured in these fills.

By taking into account the cause for the incident, and in order to avoid its repetition should the water infiltrate again in the fills, a particular attention was paid to rehabilitation works (Figure 12), to the reinforcement of the drainage system and to the waterproofing of fills.

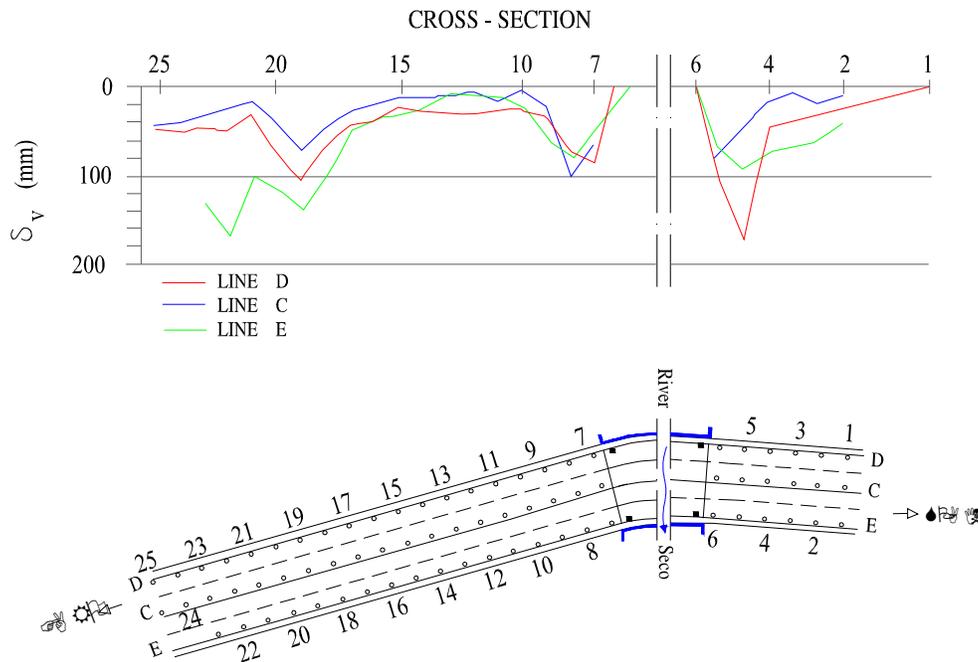
Figure 13 – Fills close to Rio Seco Bridge. Implantation of the object points and results of vertical displacements

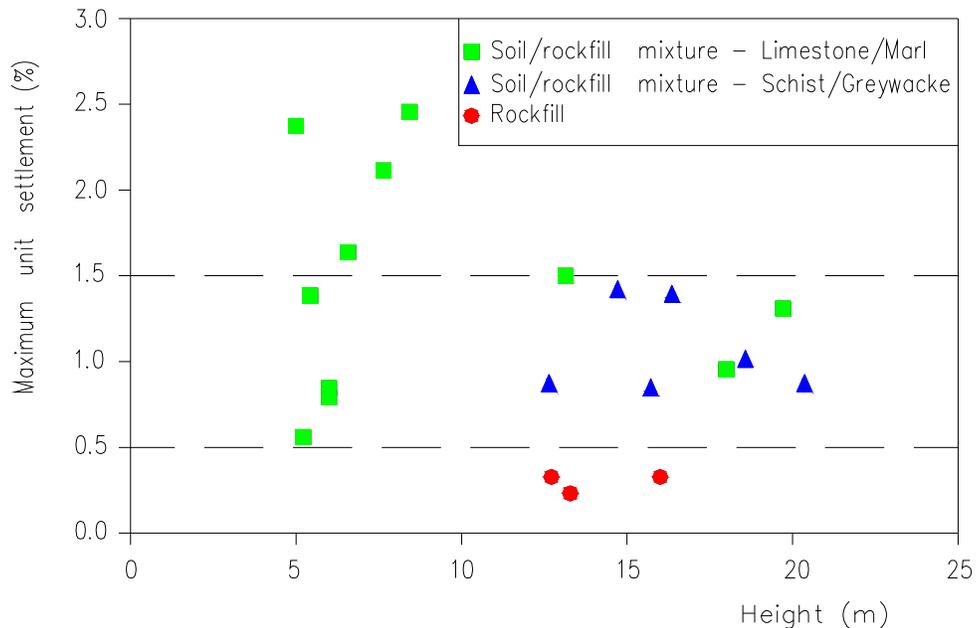
Apart from these fills close to the Rio Seco Bridge, others were instrumented along the expressway, especially close to rigid structures, and precision geometric levellings were periodically performed. Initially, it was assumed that the maximum admissible long term deformations (i.e., settlements) should not exceed 0.5% of the embankment height, so as to avoid the execution of rehabilitation works, in most of these fills. Nevertheless, after a period of just 5 years, in a significant number of fills, higher deformations were measured, which reached values

of about 2.5% (Figure 14), and some more rehabilitation works were carried out. This has led to consider the need for a more thorough characterisation and construction of these embankments with collapsed materials.

Figure 14 –VLA fills. Results of unit settlements on fills of various materials
