# Determination of Structural Deformations Caused by Earthquakes Using Geodetic Techniques

Esra TEKDAL EMNİYETİ, Rahmi Nurhan ÇELİK and Tefvik AYAN, Turkey

The aim of this study is to investigate the deformation occurred on structures (especially the viaduct 1) of the Bolu pass of 114 km long Ankara-İstanbul motorway, after 17<sup>th</sup> August Marmara and 12<sup>th</sup> November Düzce earthquakes by using precise 3D geodetic measurements.

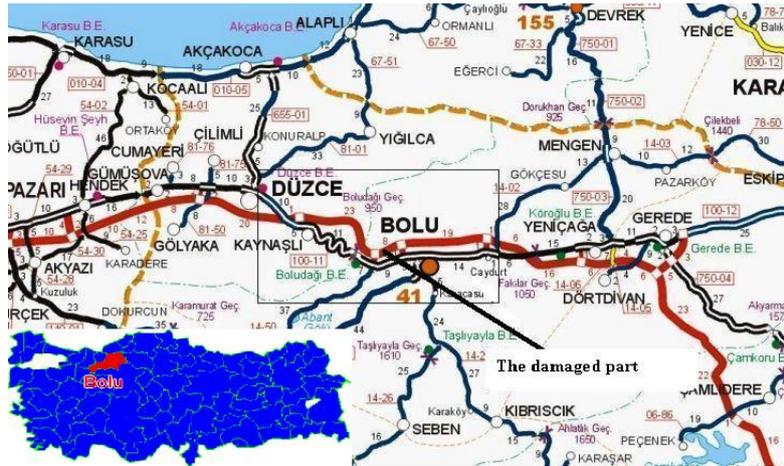
**Figure 2: Location and the damaged part of the Bolu Mountain Project**

The Bolu pass is a part of Trans-European Motorway (TEM) and composed of two viaducts, viaduct 1 and viaduct 2, and a tunnel. This pass starts from Kaynaslı/Bolu and ends at Elmalık/Bolu. The Viaduct 1 consists of two parallel and structurally separate viaducts that totally consist of 117 spans (59 piers supporting the northern lanes and 58 piers supporting the southern lanes). The 2.3 kilometres long span structure, was approximately 95% completed and was waiting for the installation of expansion joints for completion of the project, at the time of November 12, 1999 earthquake (Celik et al. 2004).

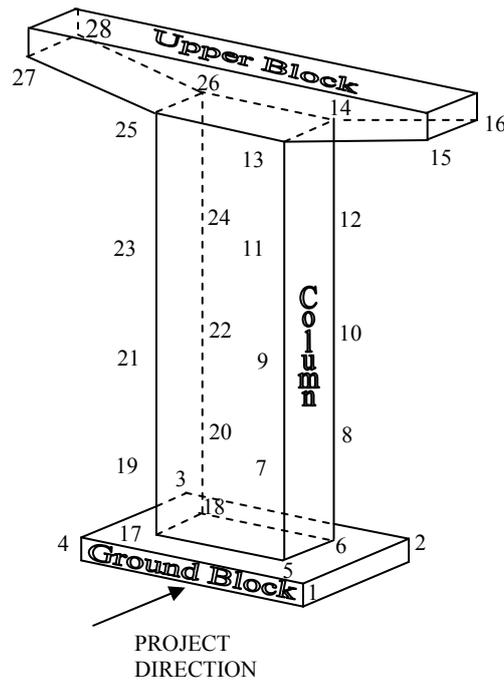
**Figure 4: Measured control points on the viaduct pier**

Viaduct I measurements have been carried out using high-tech reflector-less total station. Using these total stations, detail points can be measured up to 100 meters without using a reflector. Therefore that technology provides speed and precision for such a difficult measurement. By using this technology, 28 detail points have been measured on each of the pier. Number of these points is more than sufficient amount to investigate the displacements of a pier. However in case of the measurement errors all available points on piers have been measured. The detail points measured on piers can be seen in Figure 4.

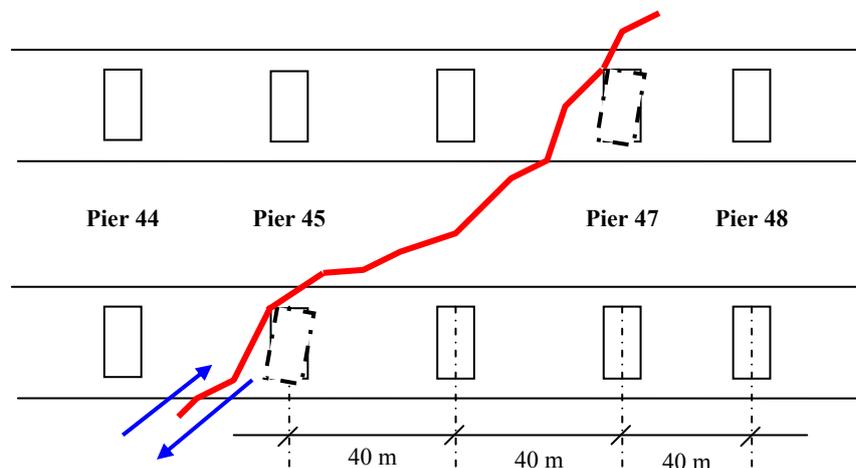
**Figure 5: Fault trace at viaduct (Celik et al. 2005)**

As is mentioned above, there is no alternative to examine the viaduct previous position within a global system, since the viaducts have been seriously damaged by 3 individual cracks of the North Anatolian Fault. Therefore, the damages on the viaduct piers and stretch have been investigated in two parts. First part is, from Düzce to Bolu direction up to crossing crack and the second part is from Bolu to Düzce up to crossing crack. The fault trace at viaduct is demonstrated detailed in Figure 5.

The viaduct region is divided into two parts nearby pier 47. Therefore, analyses from two directions have been examined up to pier 48 from Düzce and up to pier 46 from Bolu. The overlapping region has been evaluated to see the effects of regional passing.

Deformations in viaduct piers, especially the ones (45, 46, 47) located near the fault trace can be observed. Although the damages in piers are obvious it is advised to observe the critical

piers by techniques other than the geodetic methods in detail. After the detailed investigation of the viaduct, some arrangements and updates should be carried on the project (Tekdal, 2007).
