Terrestrial Laser Scanner for Controlling the Deformations and Damage of Buildings

**Fausto MISTRETTA, Andrea DESSI, Flavio STOCHINO,
Giuseppina VACCA,Italy**

SUMMARY

FIG Working Week 2016
Recovery from Disaster
Christchurch, New Zealand, May 2–6, 2016

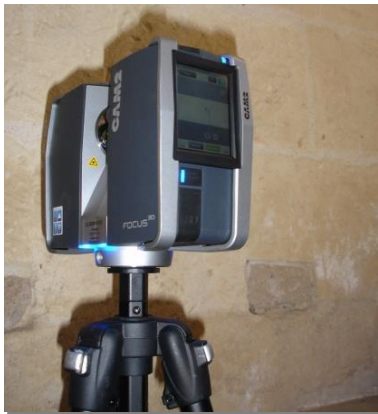
Figure 1: Focus 3D Laser scanner

The Faro 3D laser Focus (fig. 1) was used in all the scan cases presented successively. It is a compact scanner characterized by an operative range that varies between 0.6m and 120m with a linear distance error of $\pm 2\text{mm}$ for scanner-object distances comprised between 10m and 25m, and a noise (that is to say, the standard deviation of the values with respect to the best-fit plan) which varies from between 0.6mm and 10mm with a reflectivity of 90% and 2.2mm to 25mm with a reflectivity of 10%. It has a vertical visual field of 305° and a horizontal one of 360° . The vertical and horizontal resolution is 0.009° . It has a scanning speed of 976.000 points/sec, and a reduced weight. Incorporated into the laser is a color digital camera with a resolution of 70 megapixels.

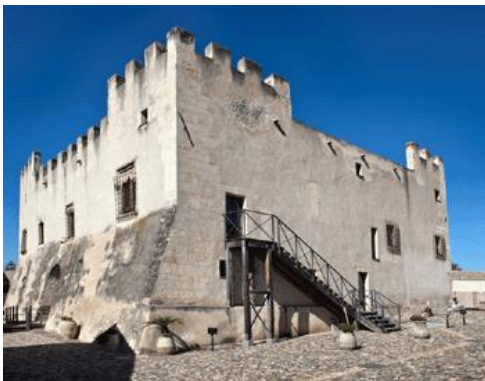
Figur4 2: Siviller Castle

Siviller Castle (fig.2) is one of the most important and representative cultural heritage in Sardinia, with late Gothic architecture. The castle was built in 1415 by Giovanni Siviller in the town of Villasor, 30 km from Cagliari (Italy). After the abolition of feudalism in Sardinia, the castle has undergone many changes of usage: military barracks, prison, school and food conservation warehouse [22]. In 1991, it was acquired as a cultural heritage by the municipality of Villasor and, after an important restoration, it became a library and cultural centre for exhibitions and conventions. In the last few years, the castle has been in a very poor state, and the wooden structures and walls have needed restoration work to halt the progressive dilapidation. As a part of the study for the restoration project, the building was scanned with a terrestrial laser scanner. The scanning provided detailed dimensional information of the building, and has enabled the study of the structural deformations and damage; in particular, the deformations in the bearing walls.

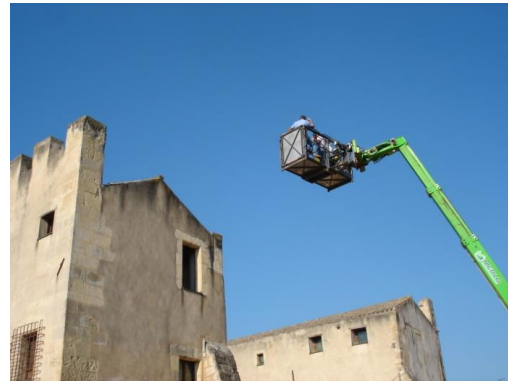
Figure 3: Airborne platform survey

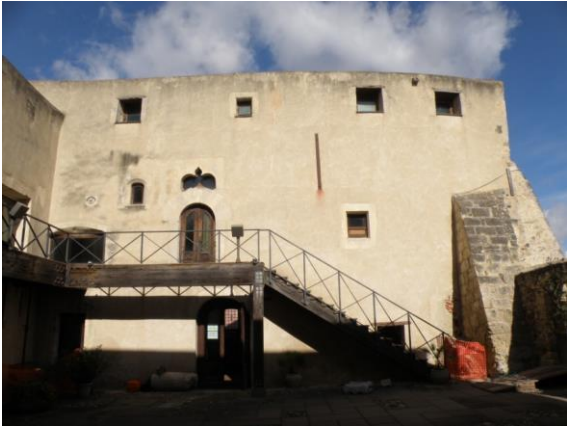
Figure 8: North-West Facade

After laser scanning, and the following realization of the 3D model, it was possible to study the geometrical and structural characteristics of the castle. In particular, the deformation of the castle walls with respect to the vertical plane [7]. In fact, as can be seen in fig. 5, the vertical closure walls are completely out of plumb. The study of the verticality and deformations of the walls was carried out internally with Reconstructor software. First, a plane containing the Z axis was generated (vertical), successively, identified the two extreme points of the facade (determined from the intersection between the plane of the facade and the horizontal one), and positioned according to the latter, the vertical plane was shifted and rotated around the Z axis until it contained these points. Having defined the vertical plane of the facade in this way, the distances between the points of this plane and those of the real wall were calculated, and finally the contour line of such distances were generated, with equidistance equal to 1 cm. With ArcGIS (ESRI) software, and starting from the contour line, the grid of the Digital Model of the Surface (DSM) was generated, with 2 cm pixel, and successively classified in order to obtain the verticality map of the wall. The paper reports only the study of two walls – North-West and North-East. The image of the North-West facade is shown in fig. 8, 9 and 10 instead, respectively show the contour line of the distances of the real wall – vertical plane and DSM of the verticality for the internal wall of the courtyard. In fig. 11, 12 and 13 are shown the same study for the North-East wall. In both cases, as can be inferred from the verticality DSM, the walls have a geometrical pattern which is completely different and anomalous with respect to the vertical plane, and little inclined towards any structural geometrical plan. The North-West wall has a part, at the top on the right, which is completely out of plumb, with a difference of as much as 40cm from the vertical plane. The same can be said of the of the rest and greater part of the wall with, even in this case, receding displacements of 40 cm from the vertical plane. Regarding the North-East wall is concerned, he situation is similar, even if the pattern is completely different. The higher part has receding displacements from the vertical plane of up to 35 cm, while the lower part is out of plumb by up to 15 cm. In fig. 9 and 12, the green contour line represent the receding part; the red, the out of plumb; the black, the intersection of the vertical plane with the wall in question.

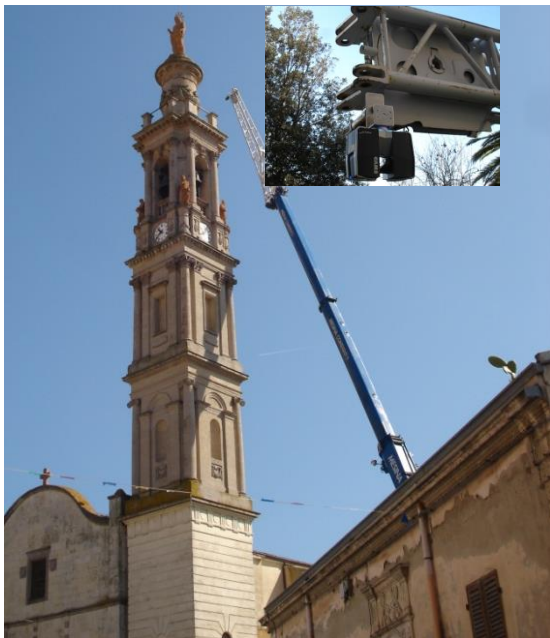
Figure 14: The Bell Tower

The church bell tower of Santa Caterina, built in 1871 by the architect Salvatore Calvia Unali, is the highest bell tower in Sardinia (about 40m high), and is considered the finest example of neo-classic architecture in Sardinia [20]. Of particular interest are the five terracotta statues of the four Evangelists and Christ the Redeemer. Over the last few years, these statues have shown a high level of deterioration. This situation convinced the Municipality of Mores that it was necessary to undertake a study for a project (involving structural engineers, geomaticians and geo-technicians) of proper restoration of the statues, as well as parts of the bell tower itself. In particular, an accurate scanning was requested. Moreover, the determining of the exact height of the bell tower and any out of plumb of it was requested.

In order to carry out a complete scanning of the structure, given the considerable height of it, a Liebherr motorized crane, complete with an extendible (up to 60m) telescopic arm, was used. A laser scanner (fig. 14) was mounted on the crane arm. By operating the laser with a computerized remote control, all the parts of the bell tower were scanned at a distance of no more than 10 m, which allowed for laser ray inclinations which were not too high. The scannings were carried out in the absence of wind and with the crane engine turned off to avoid any vibrations that would have disturbed the scanning. A total of 93 scannings were carried out, both internally and externally, with a resolution of 7 mm. The scanning of the statues was carried out with a resolution of 3 mm, and the laser positioned at a distance of 5 metres. Moreover, the scanning operation had been planned in such a way as to guarantee the superimposition among the scannings of at least 30% (fig. 15).

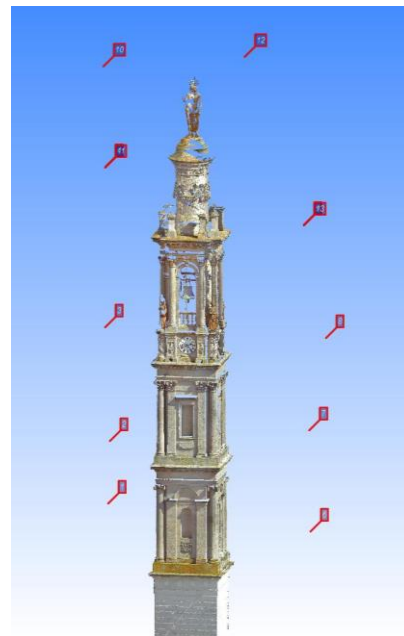
Figure 15: Laser scannings outdoor

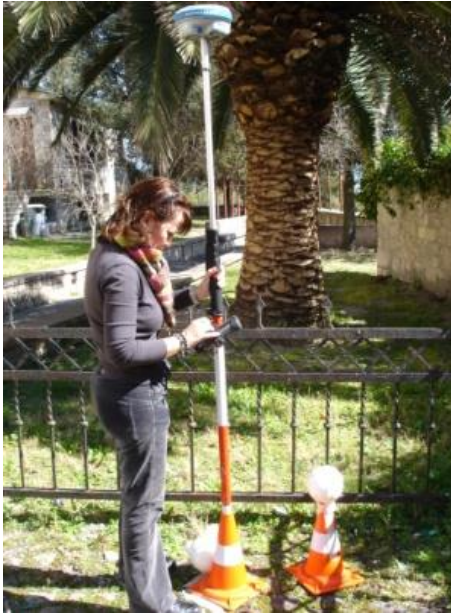
Figure 16: GPS-RTK survey

With the Reconstructor software, the point clouds were initially pre-processed and successively, utilizing exclusively natural features (at least 5 for each pair of scannings), the point clouds were pre-aligned, and then aligned with an error margin inferior to one centimetre. The geo-referring of the point clouds was carried out in the ETR2000 system (with geodetic datums), by way of signals which were distributed at ground level, and which were surveyed during the scannings. It was not possible to insert targets along the height of the bell tower because there were no buildings around it of a similar height. The coordinates of the points at ground level were determined by way of a GPS scanning, in RTK modality (fig. 16). Also in this case, the SARNET network of permanent stations was used; the network transmitting the differential corrections via Internet in the ETRF2000 reference system.

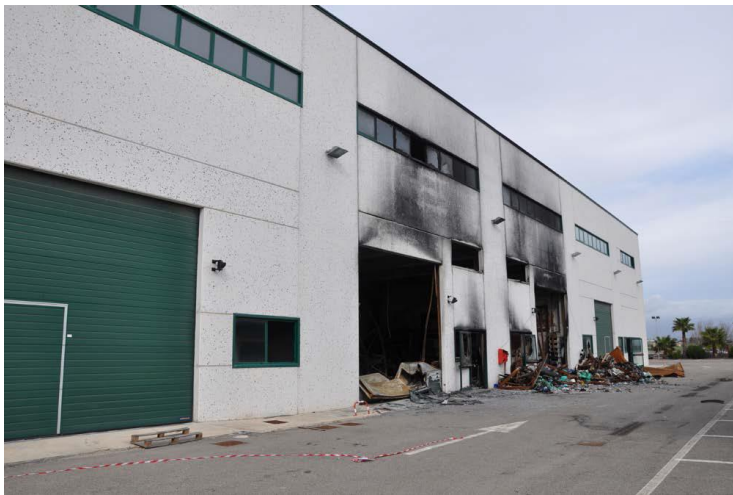
Figure 23: Industrial building

The last case is that of an industrial building (Fig. 23) whose structure was partly damaged by a fire. The effects of extreme actions like blast load or fire is the subject of a current research trend (see for example [4] [5] [6] [8]), and the information obtained from a geomatic survey can be of paramount relevance in the structural analysis [2] [3].

The structural assessments of this building have been presented in [1]. The building is prefabricated and characterized by a rectangular structured plan, with a width of 40,00m and a length of 60,00m. The building has two floors above ground: the ground floor, approximately 6,00 m high from the floor slab, is subdivided into three parts with the same surface area; of which, only one was directly damaged by the fire. The first floor, approximately 3,50 m high from the floor slab, which is not subdivided.

The building has a reinforced concrete load-bearing structure consisting of columns with rectangular cross section, precasted and prestressed beams with T shaped cross section which support the “Omega” shaped girders. Another kind of prestressed beams can be found in the roof structure, they are characterized by a V-shaped cross section and labelled as “Aliant beam”.

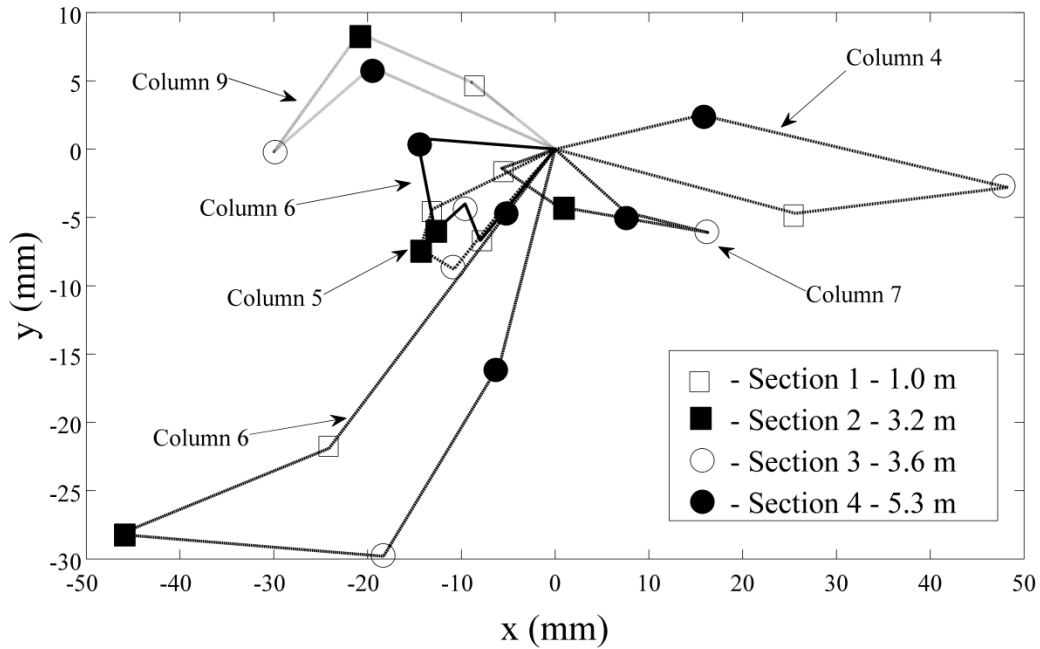
Figure 28: Centre of gravity position of columns cross section at different heights

The variation of the centre of gravity position through the column height is reported in fig. 28. Looking at this picture, it is clear that the variations of the centre of gravity position are localized in the central part of the column (Section 2 and Section 3), this confirms the hypothesis of the each column having a constrained end.

Some lateral columns, like Column 6, were dramatically dug during the fire and present important cross section reduction on the fire exposed side; instead, the other side presents negligible damage.

The central Column 5 and Column 8, exposed on the whole perimeter, present very few centre of gravity positional variations: less than 10 mm in the latter case and less than 5 in the former.

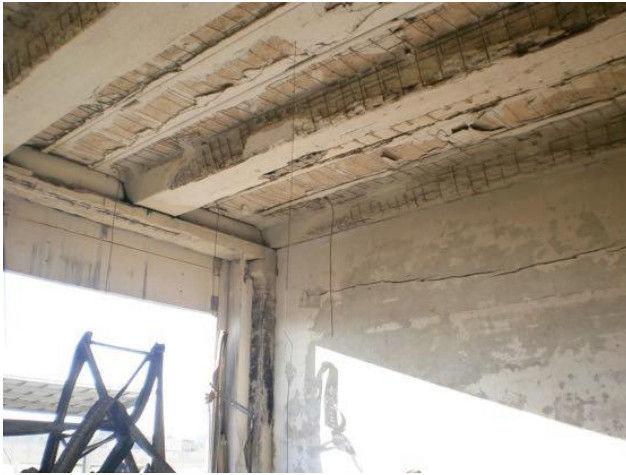
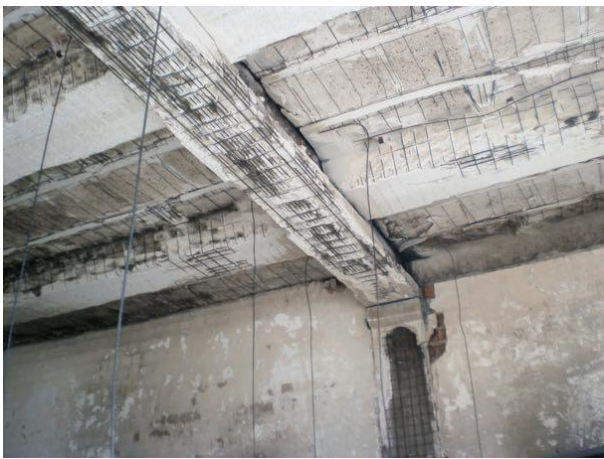
Figure 32: Laser scanning of the beams

The maximum deflection recorded (Fig. 29) for each beam is reported in Table 1. The negative sign indicates upward deflection, while the positive one refers to downward deflection.

The higher negative deflections for T-shaped beams (corresponding to code T, see Figure 26) are located in the right side of the plant (beams T2-T4-T6) while the other beams (T1-T3-T5-T7-T9) present a positive one (see Figure 26). In order to explain these results it must be highlighted that each beam is designed with a negative deflection due to the prestressing tendons. So, in some cases the local damages due to fire were so high to invert the sign of the deflection, in the other cases the negative deflection has survived to fire. The longitudinal omega-shaped beams (corresponding to label L, see Figure 26) present high deflections in the bottom part of the plant (see Figure 26). In particular beam labeled L4 has a maximum deflection of 74.23 mm corresponding to 6/1000 of the span. This results proves that the fire

effect in addition to the dead load of the structure has neglected the initial negative deflection (equal to 25-30 mm, see the undamaged beams labeled La and Lb, present in all L-beams), only in several damaged elements.
