Monitoring Slope Failure at Kadoorie Agricultural Research Centre with a 3D Laser Scanner

Andrew Wong, Alan K. L. Kwong and Jacky Ng, Hong Kong SAR, China

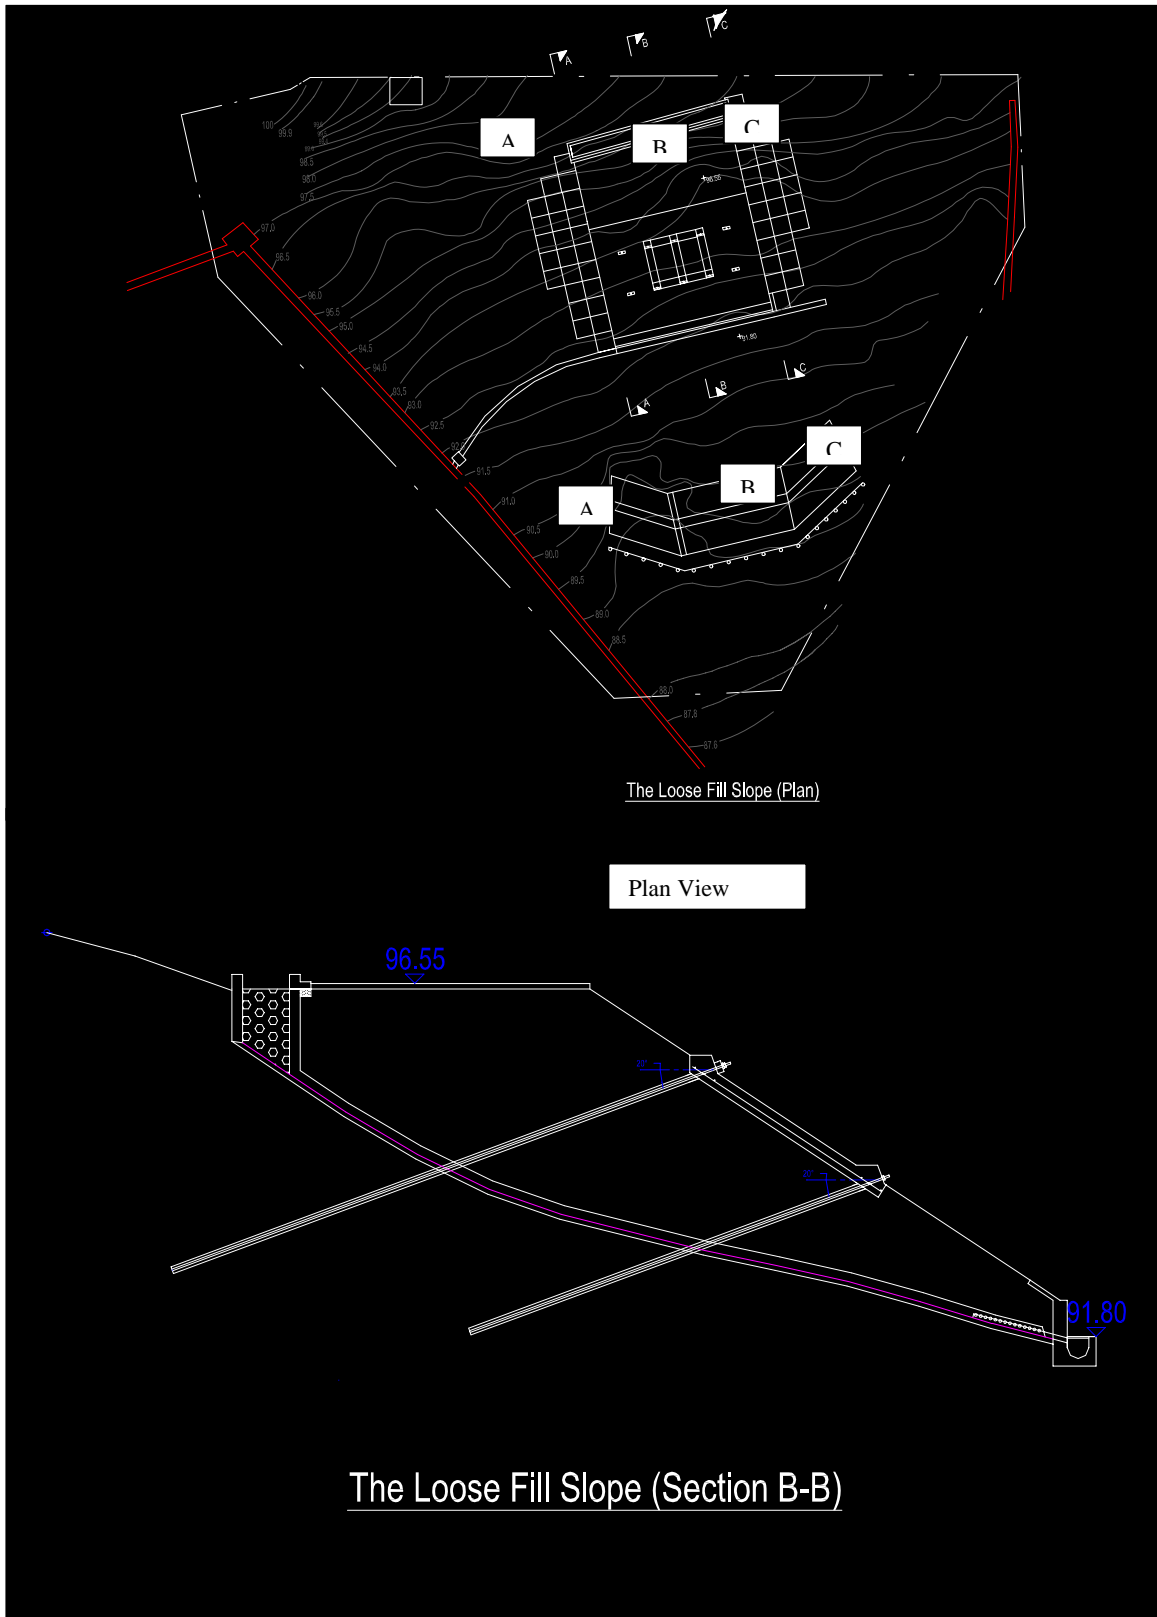
Figure 1 Plan and Section of Installed Soil Nails

Two rows of grouted nails were installed at a grid of 1.5 m x 1.5 m at an inclination of 20° from the horizontal. Holes of 100 mm diameter with two different lengths (8 m and 6 m) were drilled. A 25 mm diameter steel ribbed bar was inserted into each hole and the hole was filled with grout from the bottom up using a plastic hose. Figure 1 shows the plan and cross sectional view of the installed soil nails in the slope.

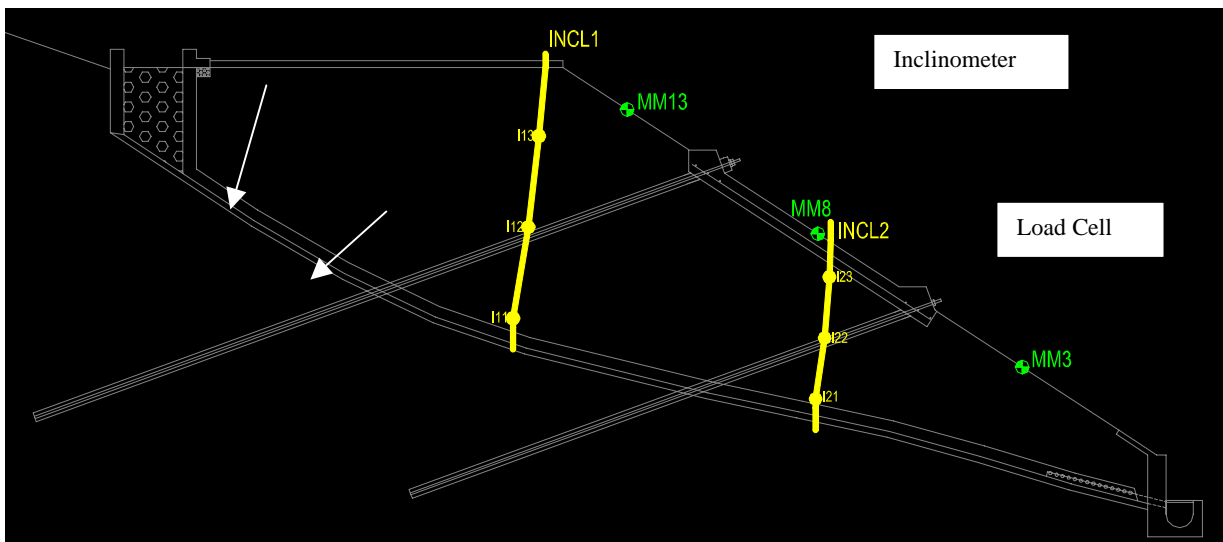
Figure 2 Instrumentation Details

Instrumentation comprised of 2 nos. of in-place inclinometer strings (a total of 6 measuring elements), 7 nos. of vibrating wire piezometers, 24 nos. of soil moisture probes and 6 nos. of tensiometers, 6 nos. of vibrating wire earth pressure cells, 2 nos. of load cells, 46 nos. of vibrating wire strain gauges, 12 nos. of flow meters and 2 nos. of automatic data loggers. Figure 2 shows the plan and cross sectional view of the instrumentations.

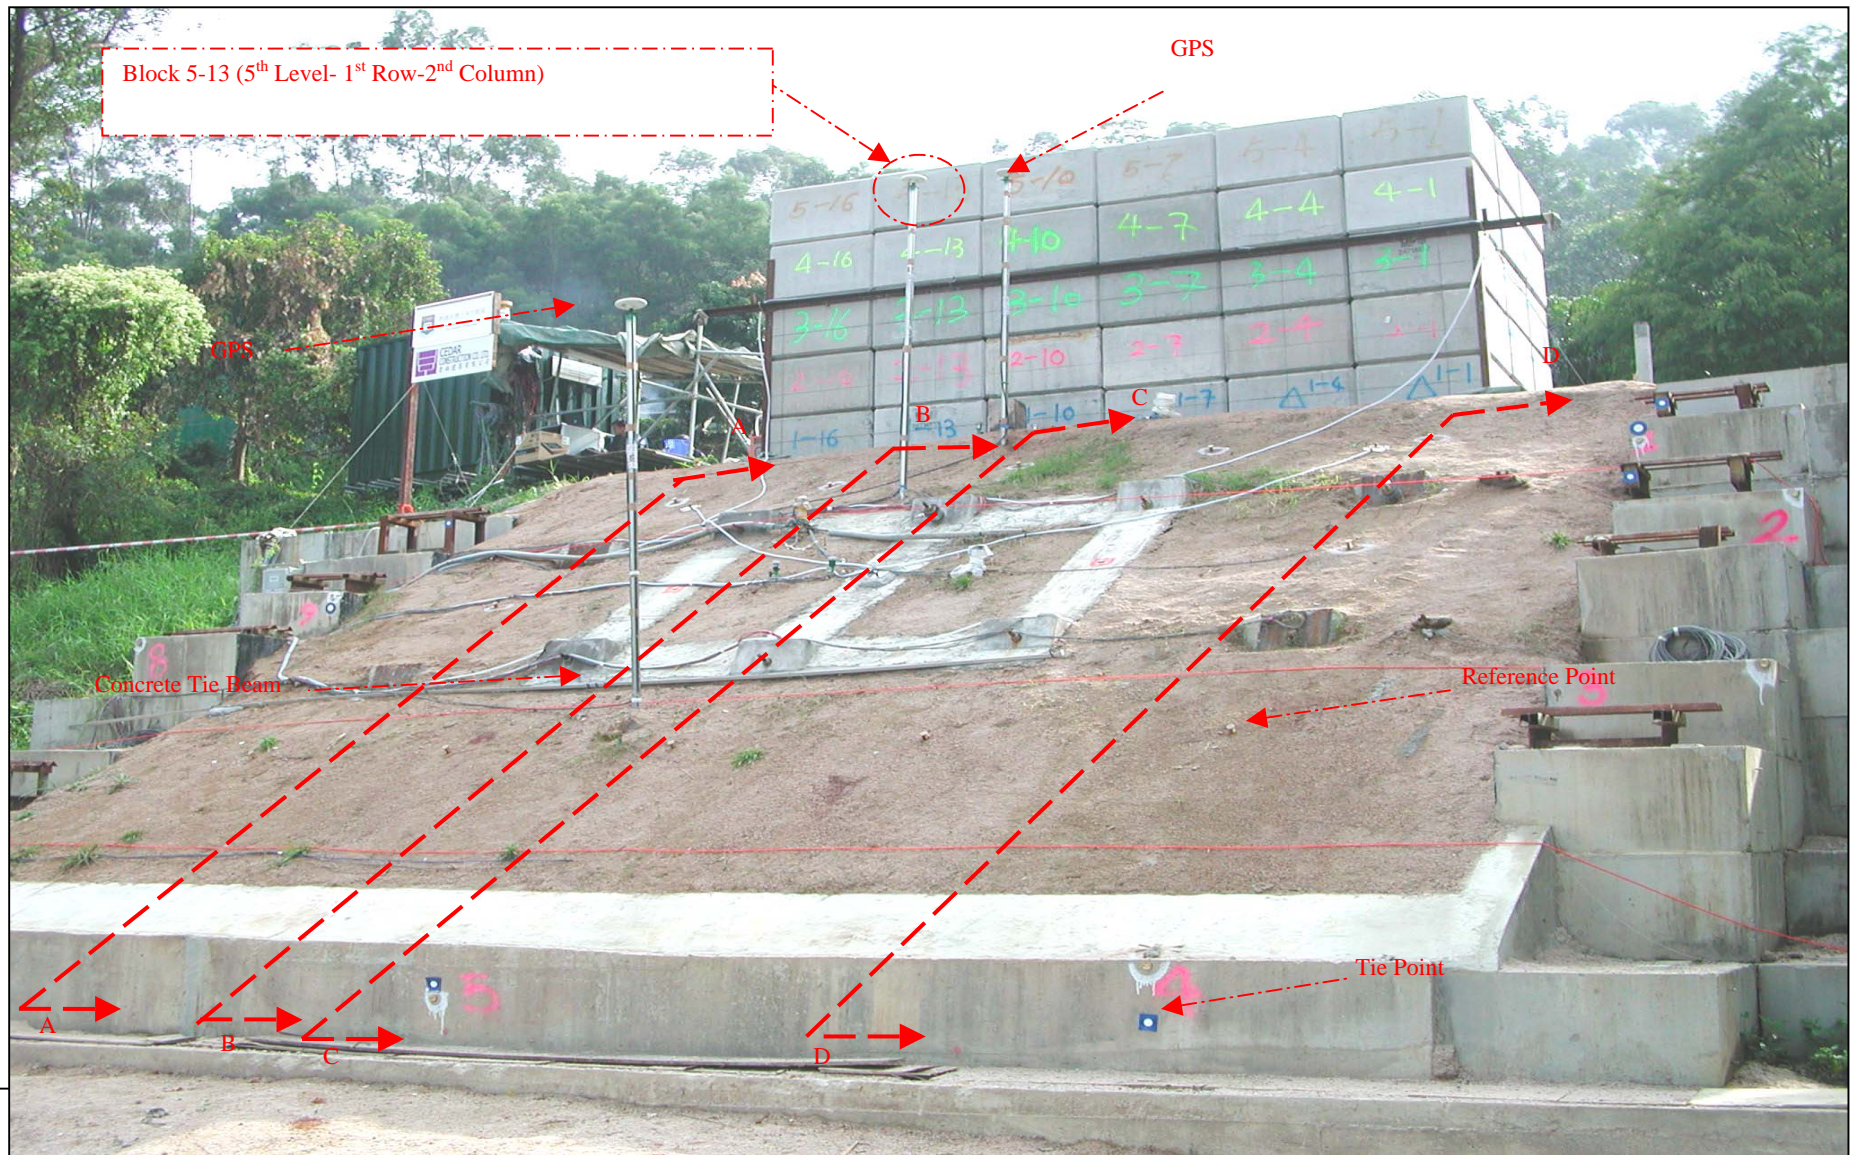
Figure 3 General Layout of Slope at Agricultural Research Centre with a 3D Laser Scanner

The general view of the slope surface is presented on Figure 3. In this figure, the location of GPS, concrete tie beam, settlement reference points, scanner tie points and reference cross sections are shown. Figure 4 shows the point cloud (3D scene) taken at 0930hr, 23 November 2002, before the groundwater table was raised and toppling of the surcharge blocks. Details of the surcharging and program of inducing rise in groundwater table and subsequent failure of the blocks can be found in Li (2003). In order to capture the surface movement with time during the induced rise in groundwater table, the slope surface was scanned at half an hour interval and each scan was referenced to the same tie points as those shown on Figures 3 and 4. Since the tie points were stationary and each scan was referenced to the same local coordinate system, therefore it was possible to record the change in point cloud positions with time. In this paper, only cross sectional profile A-A (with a close-up view of the point cloud on Figure 5) is presented to demonstrate that movement of 28 mm
