# Usefulness of Terrestrial Laser Scanner for Determining Bank of the River

# Beata WIECZOREK and Joanna KUCZYŃSKA, Poland

Key words: terrestrial laser scanning, Biebrza River, river bank, digital terrain model

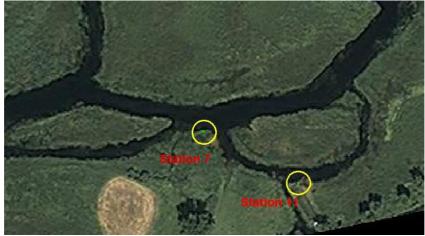
Figure 3. Terrestrial scanner stations.

After consultation with hydrologists from University of Warmia and Mazury in Olsztyn, accuracy of the Biebrza River bank measurements was set to 10 centimeters. Because the river bank is not available for the direct measurements due to the mashes area, this setting covers high accuracy requirements. Terrain was grassy, what impeded terrain surface identification. Local conditions imposed terrestrial laser station position. Laser scanning and photographs were done on two stations. The first was situated on wetland (Station 7), close to the river bank. The second (Station 11) was situated on the bridge, further off the object (Figure 3).

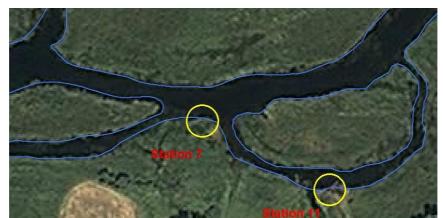
Figure 11. Orthophotomap generated from the satellite images (2008, Ikonos) and the Biebrza River bank.

Topographic map and orthophotomaps pose the datum documentation which was used in the analysis. Figure 9 presents the determined river bank and the vectorized river bank from topographic map in 1:10000 scale. The object boundaries do not coincide. This is the result of map generalization. In Figures 10 and 11 the river bank in the background of the orthophotomaps are shown. In these cases the boundaries coincide.
