# Using New Techniques of Geomatics and Structural Control in the Old City Center of L'Aquila after the June 6, 2009 Earthquake

**KEY WORDS:** Post earthquake structural monitoring, Geomatics, Topographic Survey, NDTM, Thermography.

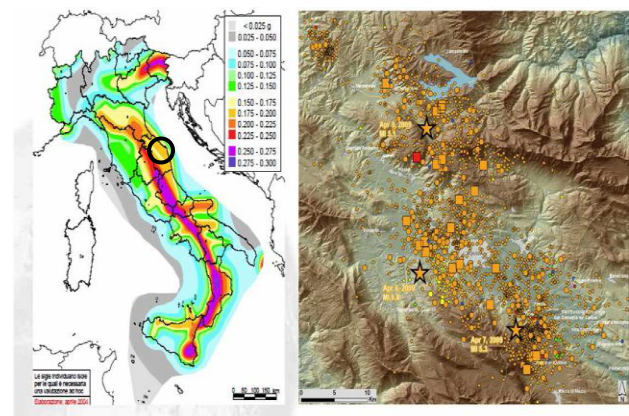
Figure 1. On the left: localization of L'Aquila on the Italy map of seismic hazard. On the right: map of instrumental seismicity around the city of L'Aquila (December 2008–September 2009).

According to the geophysics Italian institute (INGV), the magnitude of the earthquake was estimated as high as  $MI = 5.8$  ( $M_w = 6.2$  respectively). Figure 1 also shows the long-lasting seismic sequence including the main shock and more than 30 minor earthquakes with magnitude  $3.5 < MI < 5.0$ , and several thousand of others lower magnitude events. Three large aftershocks ( $MI = 4.8, 4.7$  and  $5.3$ ) occurred on April the 7<sup>th</sup> with epicentres in the south-eastern vicinity of L'Aquila, and fourth significant events occurred on April 9 ( $MI = 5.1$ ) with epicentres located in the northern vicinity of L'Aquila. Overall, the region affected by the seismic activity covers an ellipse-shaped area measuring about 15 km in length (parallel to the Apennines mountain chain) and 5 km in wideness.

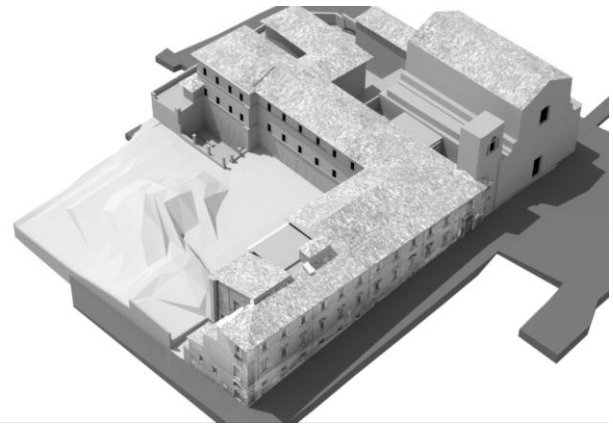
Figure 2. Rendering of Palazzo Camponeschi, L'Aquila (Italy)

The research work presented in this paper concern the survey carried out on Palazzo Camponeschi, a monumental building of the XVI century, headquarter of the Humanities Faculty of the University of L'Aquila, situated in the heart of the old city center seriously damaged by the earthquake.

From a structural viewpoint, Palazzo Camponeschi's original resistant system consists of vertical masonry walls composed of irregular stone units and poor lime-clay mortar. Large inclusions of bricks or other low-quality materials are found in the masonry volume, so that a chaotic masonry texture is generally recognized in the building. Although a number of local reinforcements (tie rods and concrete riddles) have been inserted over the years to fortify single parts of the complex building structure, the overall poor connection among orthogonal walls and the inhomogeneous masonry in the walls thickness were causes for heavy structural damages during the April 2009 earthquake. Majority of barrel and coved vaults covering most of the buildings rooms suffered partial collapse; outside layers of composed masonry walls failed; diagonal cracks due to in plane action resulted in extended portions of the resisting walls; out of plane displacement have been recognized in few front sides of the building.

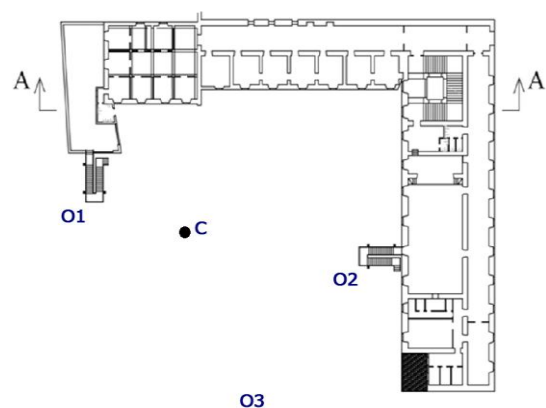
Figure 3. Palazzo Camponeschi plan: spot C represents the location of total station; spots O1, O2, O3 represent reference points.

In order to recognize the signs of ongoing kinematics and possible collapse mechanisms, a visual inspection of the structure was first required. Evidence of structural damages was found at any level of both the internal fronts of the building, so that a grid of 27 points distributed along 9 vertical alignments and 3 rows was decided as monitoring network. In particular, grid's columns were made to correspond to selected vertical alignments of window along the buildings fronts, and the grid's rows to the internal building floors respectively. Figure 6 shows the distribution of the 27 control points: note the grid spacing was reduced to better investigate the possible overturning of the middle SW facade. In addition, three more points ( $O_1$ ,  $O_2$ , and  $O_3$  respectively) were selected independently from the structure to assume their position invariant and to serve as reference for the local coordinate system orientation (figure 3). Then, a total number of 30 control points finally constitute the designed surveying network.

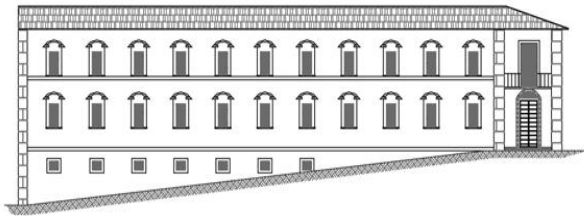
Figure 4. SE front of the building (facing the street)

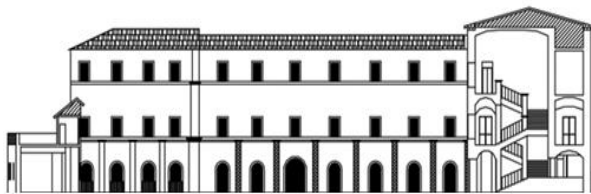
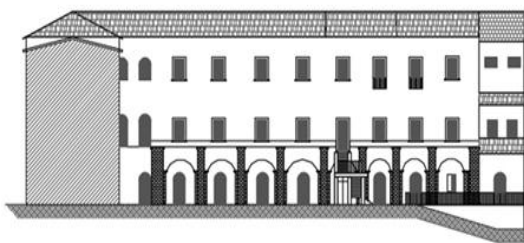
Figure 5. SW and NW internal fronts of the building (facing the courtyard)

The building sits on a sloping site and it consists of three stories, the first of which partially set below the sloping ground level, with the highest fronts measured at the end of the two arms respectively. A traditional gable roof in wood truss, secondary wood elements, planking and brick tiles covers the buildings on top. Along the public road, the building's south-east facade presents a regular vertical and horizontal distribution of two orders of rectangular windows and an arched portal on the right side (Figure 4). At the basement, the internal fronts facing the internal courtyard are characterized by regular arches supported by masonry columns (Figure 5).

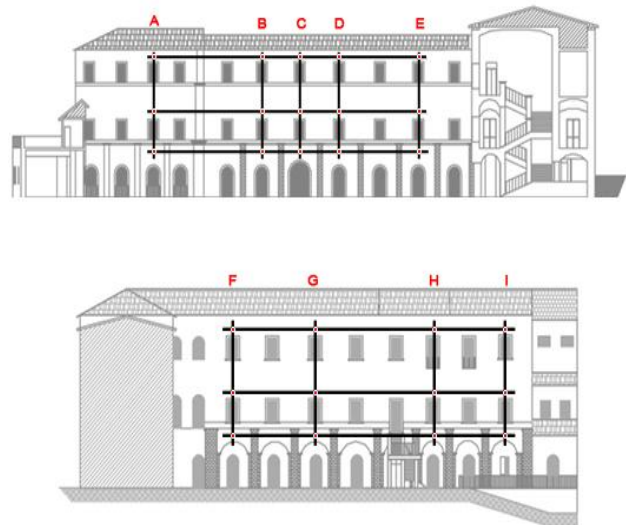
Figure 6. Grid of the monitored points on the SW and NW internal fronts.

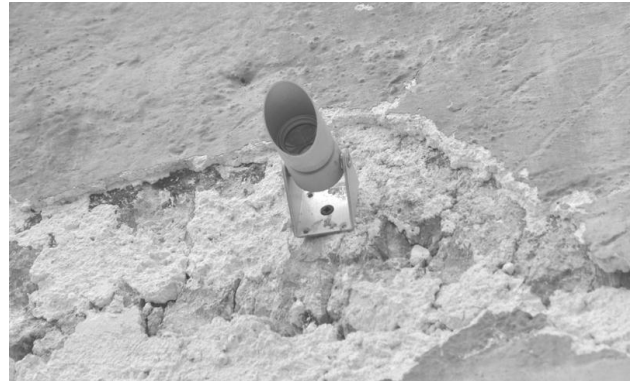
Figure 7. One of the reflectors installed on the Structure's surface.

**2.2.3 Reflectors:** In order to maximize the measurement's accuracy and to minimize possible sources of errors (such as non optimal surveying conditions, atmospheric refraction, bad signal response quality) high accuracy mini reflectors were properly installed on the structure. This type of prisms are characterized from a special coating on the reflective surfaces named Anti-Reflex Coating, and a copper coating on the reverse side. With this construction the distance measuring range, ATR and power-search is increased to by up to 30% reaching a signal centring capacity up to 0.3mm while the durability of the copper coating and the outer allumin case gives a decisive background for a long life surveys. The glass dimensions, the position in the holder and with it the spatial orientation, are important for measuring accuracy (figure 7) . In this project both the position and the orientation of each reflector is steadily fixed to the surface of the contraction to guarantee minimum reflection constant by up to 17.5mm. To sum up, choosing to set a surveying network made with this instruments combines

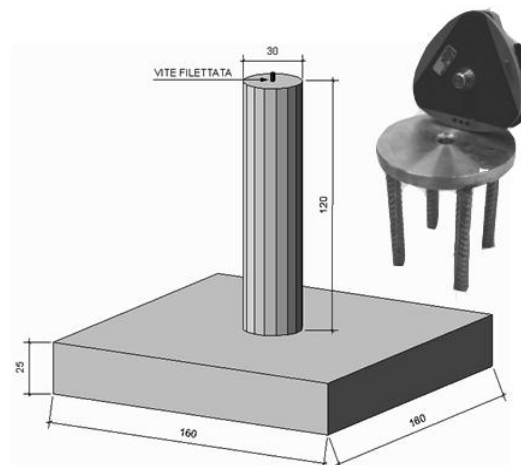
Figure 8. Reinforced concrete pillar layout and view of the still base.

Monitoring a number of 30 points within an under-millimetric precision is not a simple operation. The correct positioning and orientation of the total station, the high quality of all measurements and a careful data elaboration are all crucial parts for the final result. To guarantee perfect positioning and orientation of the instrument a concrete pillar with notable dimensions and a deep foundation was constructed, moreover three mini reflectors have been installed in stable constructions of the surrounding area to be used as orientation points. Before each set of measurements the total station is placed on its special steel base attached to the pillar (figure 8). An accurate orientation is obtained both by surveying the three auxiliary reflectors and by attributing the correct coordinates of two extra points of the surface decided by a separated survey. An even further stability control of the central pilaster's position is obtained by a geomatic triangulation using a GPS measurement. Three permanent GPS receivers, well distributed in the city's space to form a possibly isosceles triangle are used on a static GPS measurement to ensure that the hypothesized stable points remain steady over time. In this way the correct positioning of the three-dimensional reference system on which all coordinates will be placed is guaranteed.

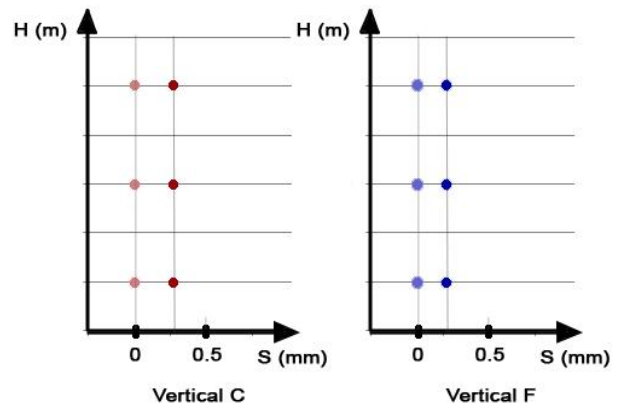
Figure 9.No evidence of displacement for monitoring points belonging to verticals C and F in Figure 6

In this project, the first correct position of each point is registered after the testing period of the whole surveying network. This set of measurements, called zero circle, is now used in order to estimate each movement. The first results already gives an idea on structures' dimensions and state during the hot months of this year. All these information are expected to be used in order to draw the whole situation after the seasonal change and the temperature reduction on near future. In this way a complete imagine of the whole structure is drawn to permit a careful estimation of every possible future deformation. Graph in figure 9 represents the displacements recorded for the tree point aligned on vertical C of figure 6: no evidence of a specific trend was recognized, probably due to the short time period of observation and proving, so far,

effectiveness of the scaffolding and prop mounted into the building to stabilise the structures against future minor earthquakes.

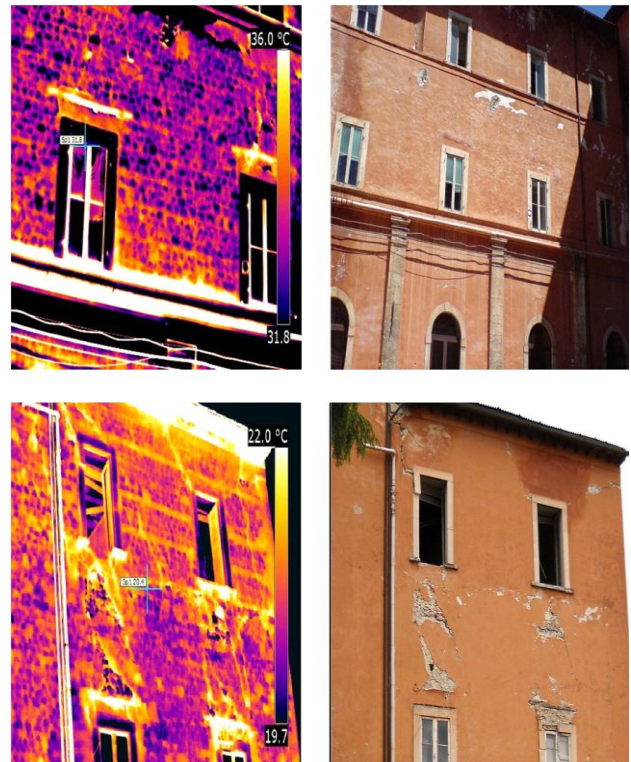
Figure 10. Thermographs revealing masonry typology behind the plaster (above) and different masonry types in the same wall (below).

To achieve a dipper knowledge of the building and to gain information about its structural characteristic and behaviour, results from the structural monitoring performed with topographic techniques were enriched with information obtained from other Non Destructive Test Methods (NDTM) performed on the structures and including tomography and Sonic Pulse Velocity Test (SPVT). Figures 10 shows examples of images captured with a thermo-camera: they allow to recognize the nature of masonry when hidden by the plaster and the change in masonry quality from part to part of the same wall.

This information were useful in selecting the grid spacing when deciding the survey network, focusing on that part of the buildings front potentially less stable. On the other hand, measuring the sound pulses velocity in traversing the wall thickness allows to evaluate homogeneity of the masonry in its volume and quality of the walls in their thickness. Graphs in Figure 11 report the results obtained from SPVT performed on different representative portions of the SW front of the building, at the first wall elevation above the ground level. Different values of the pulse velocity are reported in the two pictures, and two representative average velocity values can be computed, so that two different masonry types are recognized (less dense and probably weaker the former, more dense and probably stronger the latter). Moreover, variability of the pulse velocity found in different points of the same picture highlight the inhomogeneous nature of the masonry in the wall thickness (in both the graphs).

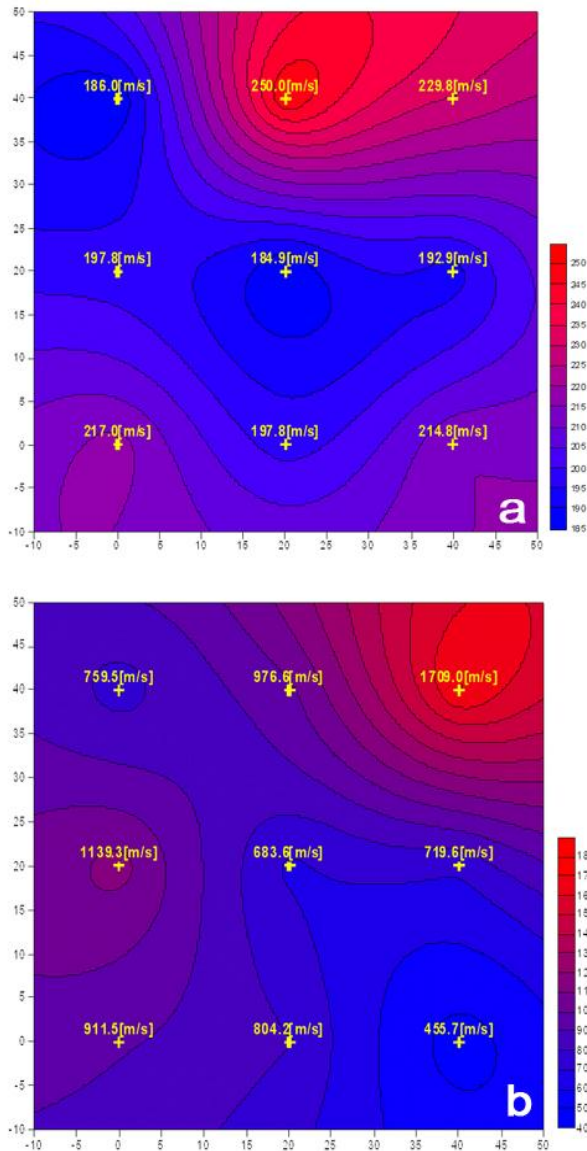
Figure 11. Sound Pulse Velocity Tests: lower velocity values in graph a) correspond to less dense and probably weaker masonry than in graph b). Values dispersion indicate masonry were inhomogeneous in both cases a) and b).

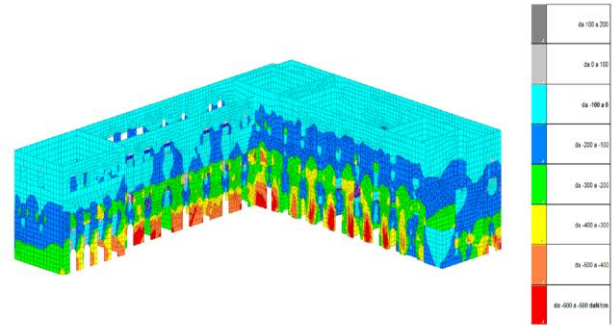
Figure 12. Stress concentration in structural elements resulting from an elastic analysis of the building.

Such information are useful in predicting global and local response of structure to seismic actions, helping calibrating material properties when defining numerical models of the building. Once masonry quality is well known in all part of the building structure, elastic and dynamic analyses of the building are possible at the computer. Figure 12 shows the graphic results from elastic analysis carried out to evaluate stress concentration in the structures under vertical loads.

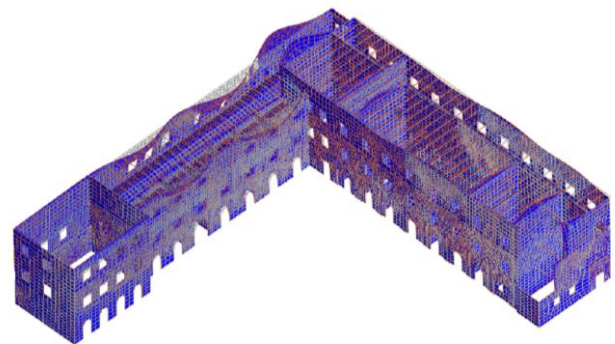
Figure 14. Global and local modal properties of the structure.

Some hypothesis on global and local modal properties of the building are reported in figure 14: part of the structure characterised by a poor connections among orthogonal masonry walls, reduced floors stiffness, wrong mass distribution and absence of restrains to wall overturning were recognized as causes for possible local or global collapse in the building to be monitored.
