Changes in the Coastline and Water Level of the Akşehir and Eber Lakes Between 1975 and 2010

Murat UYSAL
Saffet ERDOĞAN
Ünal YILDIRIM

FIG Working Week 2011
Bridging the Gap between Cultures
Marrakech, Morocco, 18-22 May 2011

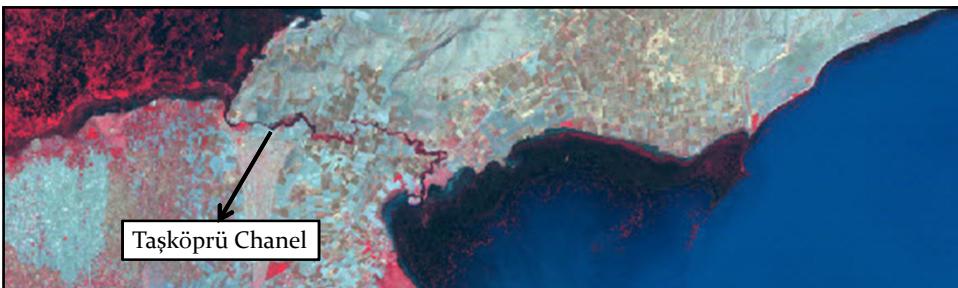
- The Akşehir and Eber lakes which are the subject of this study are also important lakes in the Akarcay basin in the Lake District.

- At present, there is no direct surface water connection between the two lakes.
- However, an aqueduct and an open channel existed until 1990.
- The Eber Lake provides a direct sustained outflow to the Akşehir Lake through the Taşköprü channel.
