MONITORING GULLY FORMATION AND DEVELOPMENT FOR EFFECTIVE REMEDIATION AND CONTROL

Jacob Odeh EHIOBO and Osadolor Christopher IZINYON (Nigeria)

GPS, Gully Erosion, DEM, Morphology, Land Reclamation

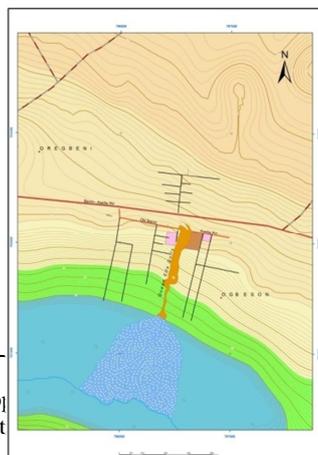
Fig 1: Queen Ede Catchment Area

The gully area is bounded by UTM coordinates 700800mN to 702500mN and 795800mE to 79600mE. The gully runs in a south – easternly direction down to Ikpoba river. The elevation of the study area ranges from 16m to 110m above sea level (fig1). The average temperature in this area is 280c. The raining season commences usually from April to October with a break during the month of August commonly referred to as August break. Maximum recorded rainfall 2001–2011 was 439mm with a minimum of 3.75mm. There is however a sharp deviation this year 2012, probably as a result of climate change, as heavy rains have been experienced from January to date. Humidity is generally high about 98% for most of the year. The area lies within the tropical rain forest zone of Nigeria.

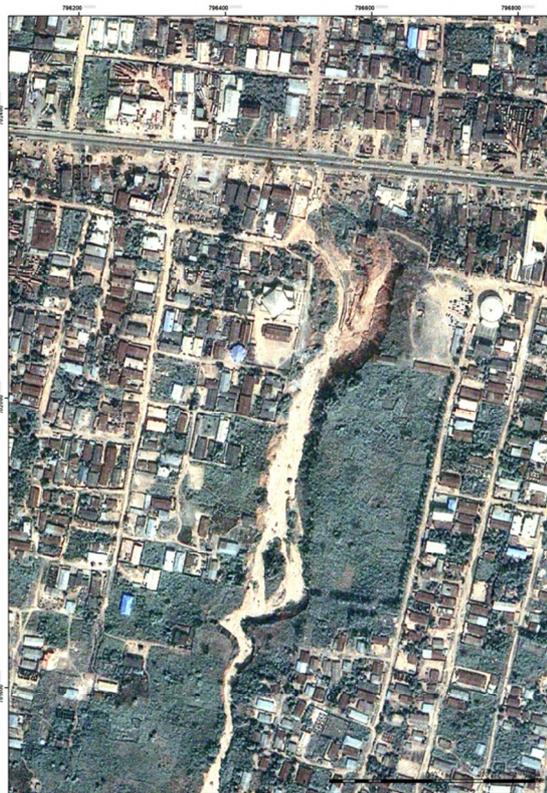
Fig 3: Ikonos Imagery of Queen Ede Gully Site

Ikono imagery was acquired to measure and monitor the extent of the eroded area as well as providing a quantifiable estimate of the landed area and in the analysis of physical structures that have been affected or endangered by the gully (See Fig 3).

Satellite imagery delineation and field measurement of the gully growth indicated that the planimetric area of the gully has increased from 9.48 Hectares to 10.44 Hectares. From Table I, it can be shown that the value of soil loss increased from 375,322m³ in 2010 to 393070m³ in 2011.
