Measurement and Documentation for Structural Integrity Assessment of In-Service Building At Risk.

Ehiorobo J.O, Izinyon O. C and Ogirigbo R.O., Nigeria.

Keywords: Structural Integrity Assessment, Differential Settlement, Strain, Stress and Consolidation

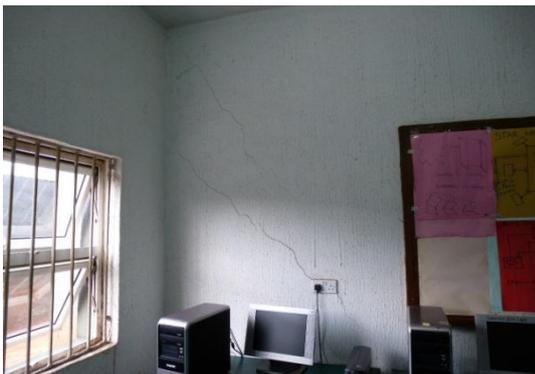
Fig 3: crack in office wall

Visual inspection of various parts of the building show that Block A has sufficiently suffered serious structural deterioration. Several cracks both longitudinal and transverse were observed particularly in the west wing of the block. Many of the cracks run from the ground floor to the roof. Photographic images of many of the cracks are shown in fig 3 to fig 8.

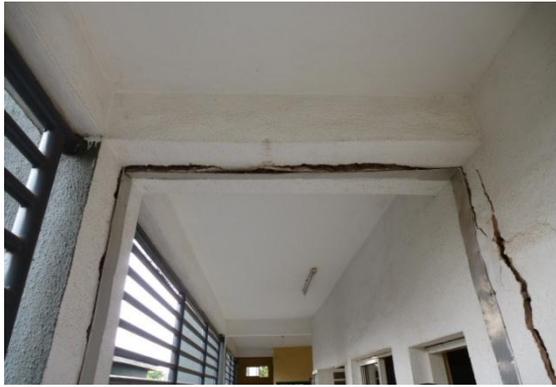
Fig 5: crack around Beams

Along the walls, the length of the cracks varied from 525mm to 2800mm while the width varied from 15.50mm to 31.50mm. The only crack noticeable on the beams was at D34 with a length of 600mm and mean width of 0.75mm. The cracking follows patterns characteristically associated with flexural and shear failure.

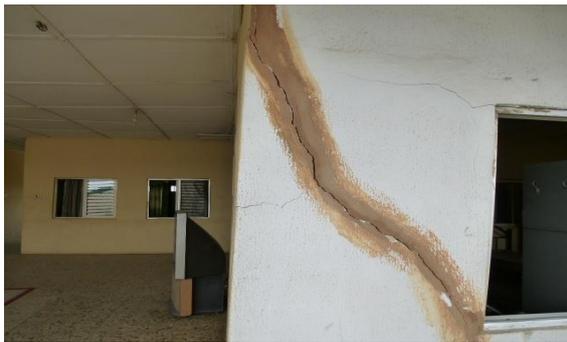
Fig 7: diagonal crack on wall

Diagonal cracking was found to be approximately 1.2m in length and initiated at about 0.55m from the support. In general, cracks vary in size from 0.75mm to 31.50mm.
