Change Detection and Assessment of Fire-Damaged Concrete Using Terrestrial Laser Scanning

**Wallace MUKUPA, Gethin Wyn ROBERTS, Craig Matthew HANCOCK,
Khalil AL-MANASIR, China.**

FIG Working Week 2016
Recovery from Disaster
Christchurch, New Zealand, May 2–6, 2016

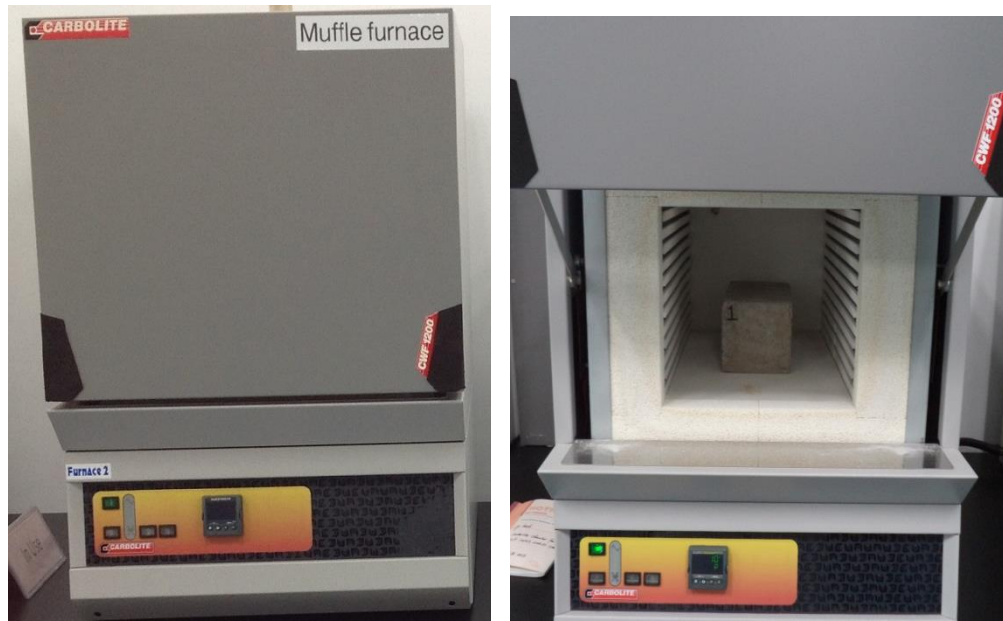
After scanning the unheated concrete specimens with the laser scanner, the specimens had to be heated. A Carbolite CWF 12/23 electric furnace (Fig. 2) was used for the thermal treatment of the specimens. It is worth mentioning that the furnace used in this study is not a typical high end furnace used in civil engineering. The specimens were placed in the furnace chamber and thereafter heated at designated temperatures of 250, 400, 700, and 1000°C with a ramping rate of 10°C/min. The peak temperatures were maintained for 1 hour (fire exposure time) and after that time, the furnace was switch off with the specimen inside and left to cool down to room temperature in order to avoid thermal shock. For comparison purpose with the other heated specimens, one specimen was left unheated.

Fig. 2: Carbolite Furnace, shown is the outside and the chamber with a concrete block inside

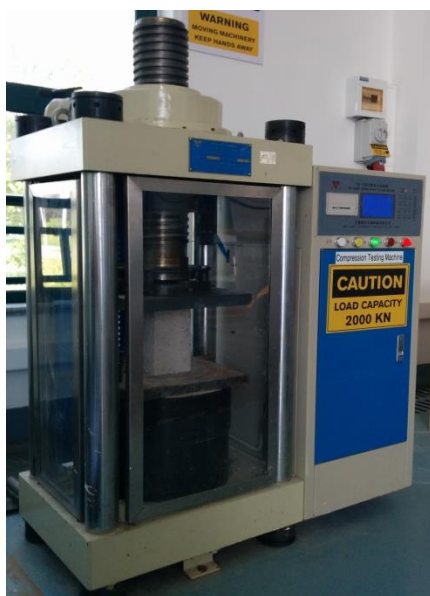
Compressive testing of the heated concrete blocks was conducted as shown in Fig. 6a and the relative compressive strength values of the concrete specimens after temperature exposure are presented in Fig. 6b. The relative strength was calculated as the percent retained strength of concrete with respect to the strength of the unheated concrete specimen. The relative strength of concrete significantly decreased after heating the blocks to the various temperatures. Between a temperature range of 250°C to 1000°C, the concrete strength degraded from 49 to 4% of original strength of unheated concrete.

Fig. 6a: Compressive Strength Testing
