ANCIENT CONSTRUCTIONS AS MARKERS OF TECTONIC DEFORMATION AND OF STRONG SEISMIC MOTIONS

Carla Bottari

Seismological Observatory – D.I.C.T.A., University of Messina (Italy)

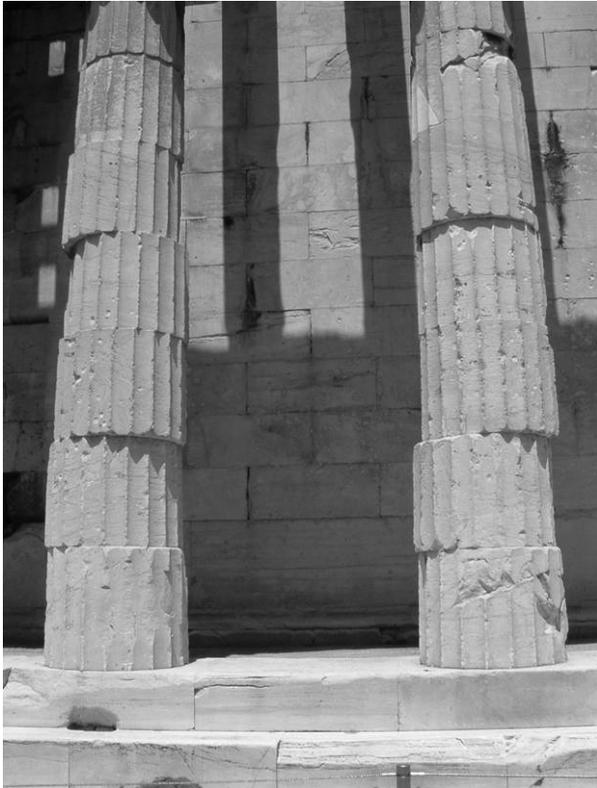
According to Galanopoulos (1956) the temple suffered an earthquake, which probably occurred after the Byzantine restorations (Stiros personal communication). The seismic event was not strong enough to cause the collapse of the building, but the southern side of the temple suffered a deformation that is still preserved today (fig.1). The sinusoidal offset of the column drums is indicative of seismic deformation. This was caused by the different mechanical behavior of the two types of limestone in the substructure during the seismic shaking.

Fig.1 - Sinusoidal offset of the column drums indicative of seismic deformation in the Hephaisteion (Theseion), Athens according to Galanopoulos (1956).

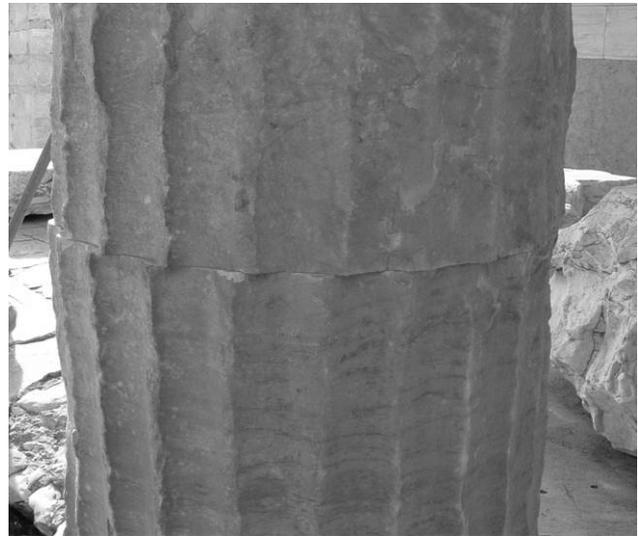
Fig. 2 - Characteristic rotation in the column drums of the Propylaea after the 1999 Athens earthquake.

On September 7th, 1999 an earthquake caused an offset in the drums of the columns on the central ramp. This seismic event was not stronger than the average earthquake recorded in Athens -- in fact the calculated M was around 5.5-5.9 -- but the peak ground acceleration was high enough (0.30 g) to produce a rotation of the drums (fig.2).

The offset of column drums of ancient Greek or Roman buildings, when their base is stable, is indicative of the seismic oscillations produced by high acceleration seismic motion. The ground acceleration of the 1999 earthquake (with its epicentre about 15 km from Acropolis) was high enough to produce a rotation of the drums of the Propylaia while the previous studies on seismic risk for Athens had estimated a maximum acceleration of 0.16 g (Anastasiadis et al., 1999). Another very strong earthquake that caused damage at Athens was the 1981 Corinth earthquake, with $M_s=6.7$, $PGA=0.29g$ and with an epicentral distance of about 77 km (Anastasiadis et al., 1999). This earthquake produced no damage in the nearby archaeological site of Corinth while in the Parthenon at Athens it opened joints (around 1 cm between the blocks) in the western part of the S wall (Korres, 1996).
