The second classical and new-age technologies for monitoring and early alarm-systems

Desislava STAYKOVA and Dr.Ivo MILEV, Germany

FIG Working Week 2016

CHRISTCHURCH, NEW ZEALAND 2-6 MAY 2016

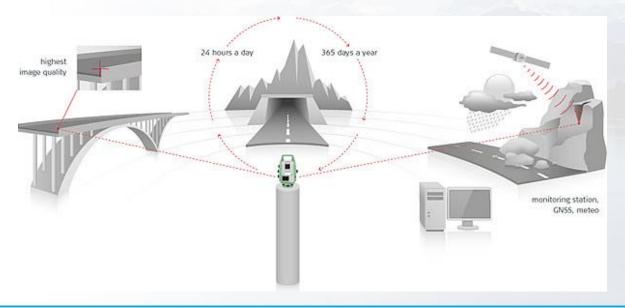
From classical to new-age geodetic surveying instruments and methods

- Long-term monitoring of structural objects such as bridges, dam walls, buildings, tunnels, wind powers and etc.
- Automated angular and length measurements in minute, hourly, daily or weekly intervals
- Automated network adjustment and near-real time deformation analysis.
- Data storage and management system

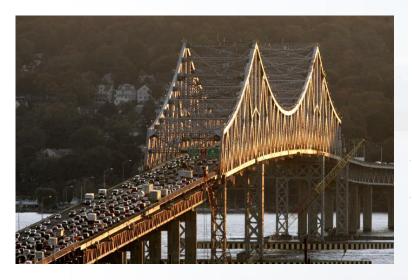
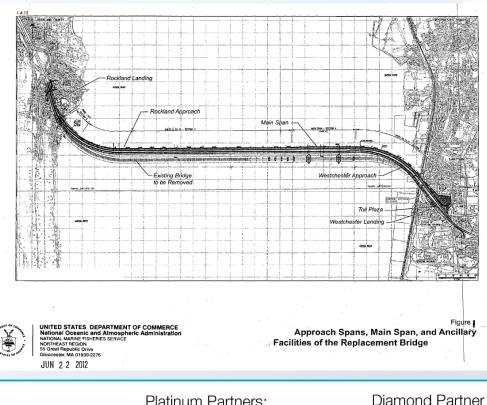
Tappan Zee Bridge- New York Jersey

- 24/7 Monitoring process during reconstruction process.
- The old bridge must not be damaged
- New railway line is built simultaneously on the bridge

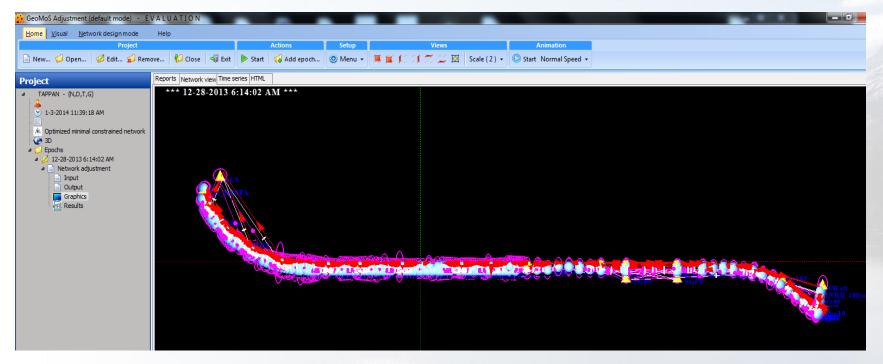
- 16 Leica AMTS and 491 Prism mounted on the bridge pillars outside and inside the deformation area
- Automated process of data collections, simulations network adjustment, deformation analysis, early –alarm system in case of deformation, data management system

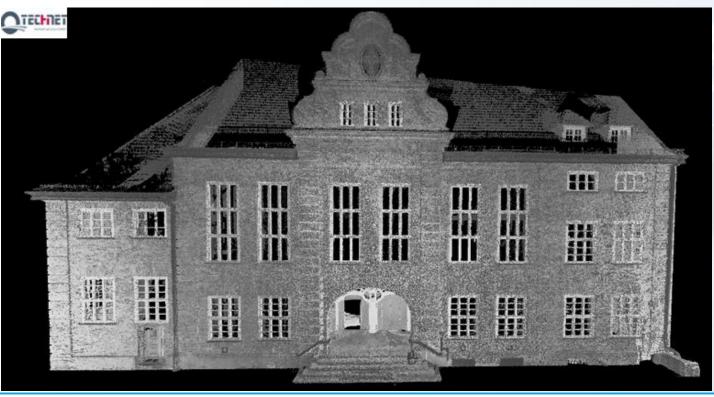
Terrestrial Laser Scanning for structural monitoring

- Complete surface representation and high data redundancy
- Deformation analysis not only is single benchmarks but for the whole surface nor only

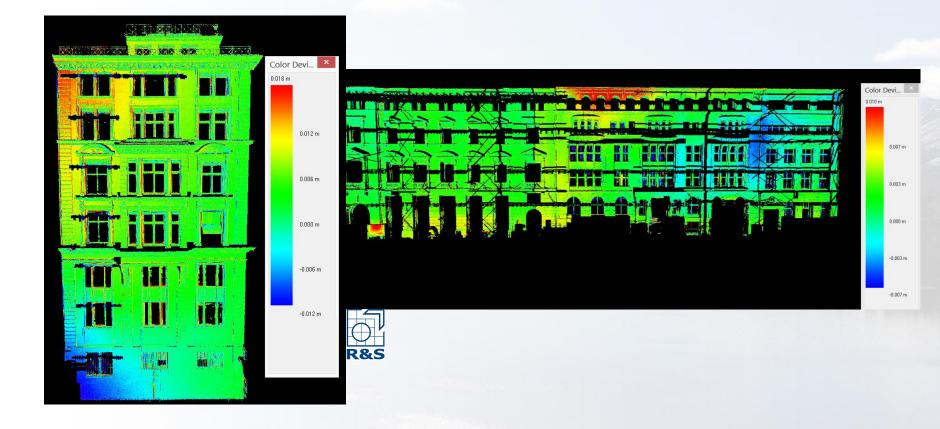
Terrestrial Laser Scanning for structural monitoring

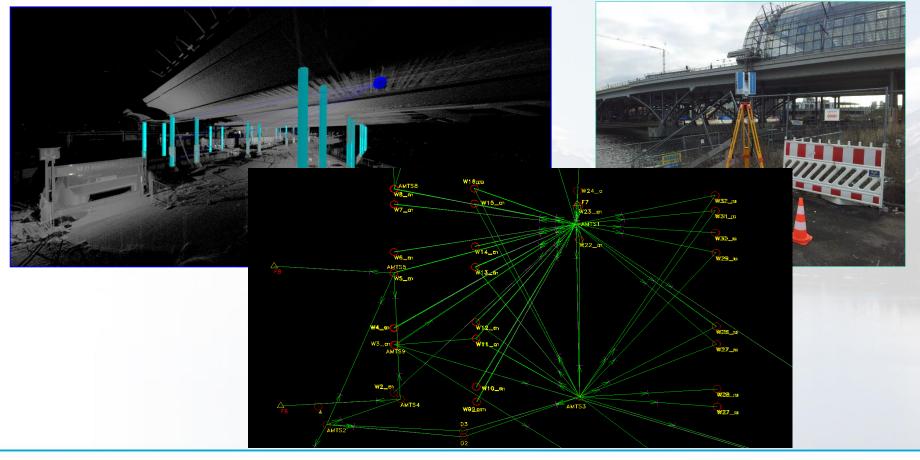
Combined approcah between Terrestrial Laser Scanning and ATMS for structural monitoring. 24/7 monitoring process

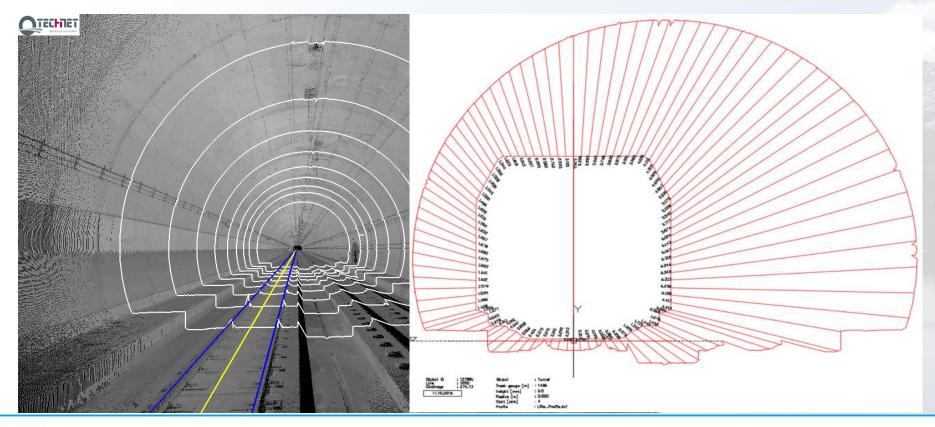
MLS for railway infrastructure monitoring

• Tunnel deformation monitoring designed-as built and clearance analysis

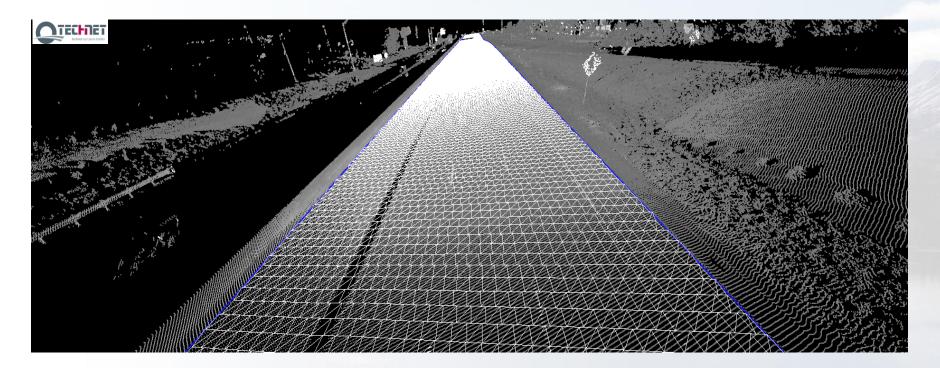
MLS for road infrastructure management

• Automated calculation of the road boundary lines and road surface model

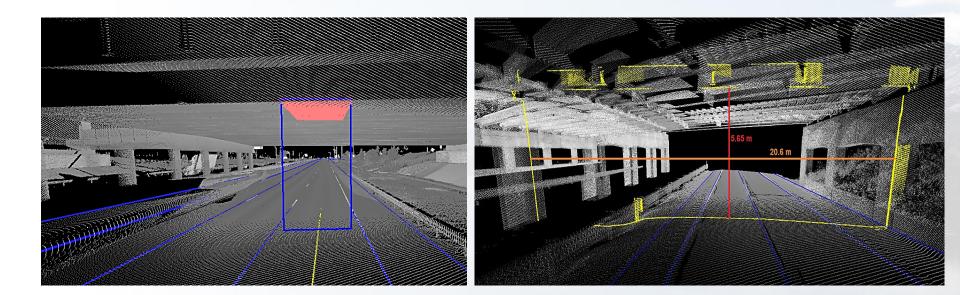
- Road detected clearances
- Automated as-built measurements from road surefcae to the sinfrastructure object

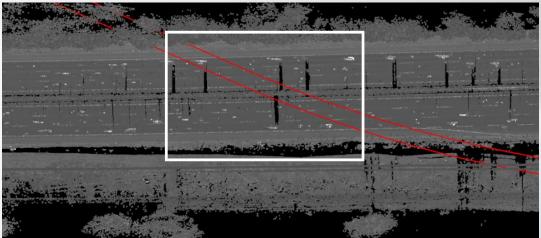
- Deformation monitoring of current operating national highway with unground TBS tunnel drilling
- New construction of 400 km culvert
- Object: Culvert (up to 3m diameter, up to 40m depth) crossed national roads and highways
- Task: Determination the vertical deformation of the street surface of highways through the construction culvert
- Result: Comprehensive statement about the vertical deformations from highway

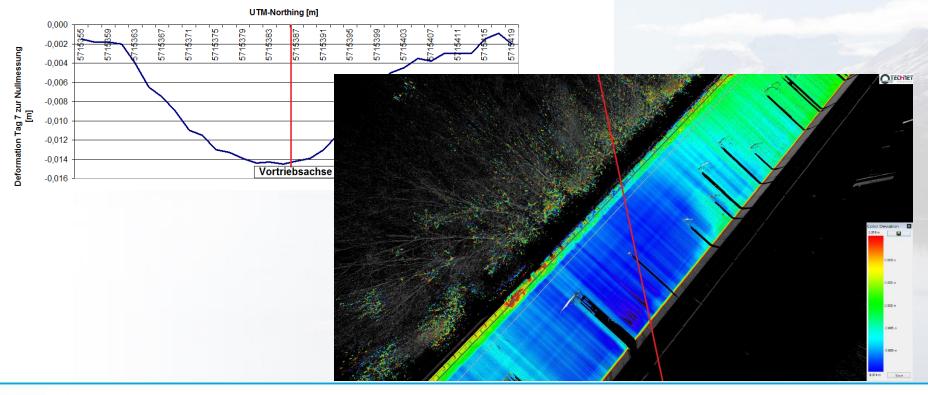
BAB45 Dortmund Westseite-Standspur

- Epoch-wise deformation analysis. Comparison between the zero epoch and current measurement
- Results of the analysis in color-coded images and as subsidence curve
