STRUCTURAL DEFORMATION MONITORING ANALYSIS USING GEODETIC TECHNIQUES AFTER THE EARTHQUAKE AT BOLU PASS OF TRANS-EUROPEAN MOTORWAY

Esra TEKDAL EMNİYETİ, Rahmi Nurhan CELİK and Tefvik AYAN

*Istanbul Technical University, Civil Engineering Faculty, Division of Geodesy, 34469 Maslak
Istanbul, Turkey*

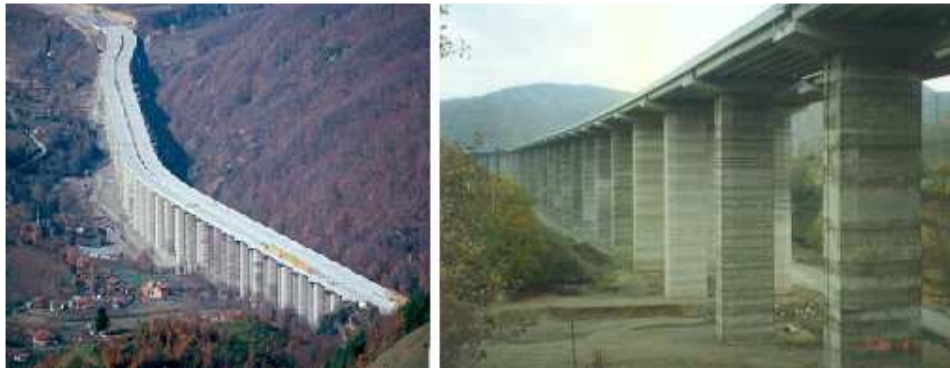
Figure 3 - General view from the Viaduct 1

The spans of viaduct 1 are typically 39.2 m with each deck span consisting of 7 precast pretensioned U-beams with an in-situ reinforced concrete slab. The pretensioned U-beams are seated on pot bearings with a stainless steel/polytetrafluoroethylene (PTFE) slider interface. The deck slab acts continuously over 10 span segments. The deck slab is continuous across pier tops except at movement joints. Piers are up to 50 m in height and consist of single hollow rectangular reinforced concrete pier shafts with a capping beam. Foundations comprise 3 m thick pile caps with typically twelve 1.8 m diameter reinforced concrete bored cast in-situ piles up to 37.5 m long (Ghasemi et al. 2000, Barr et al. 2000).

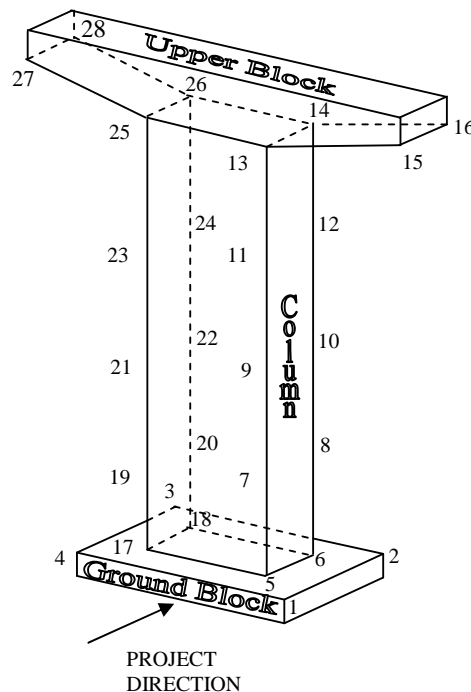
Figure 4 - Measured control points on the viaduct pier

Viaduct I measurements have been carried out using high-tech reflector-less total station. Using these total stations, detail points can be measured up to 100 meters without using a reflector. Therefore that technology provides speed and precision for such a difficult measurement. By using this technology, 28 detail points have been measured on each of the pier. Number of these points is more than sufficient amount to investigate the displacements of a pier. However in case of the measurement errors all available points on piers have been measured.

The final control is the bending check. To observe the bending in piers, upper and lower midpoints of piers are used. The lower and upper midpoint coordinates are calculated from the coordinates 1,2,3,4 and 13,14,25,26 respectively. The distance between project coordinates and measured coordinates are calculated (Tekdal, 2007). The results of these calculations can be seen in Table 5. According to the results, bending can be observed on piers 45R as 8 cm, 47R as 8 cm and finally 47L as 12 cm.

Deformations like rotation, bending and torsion in viaduct piers, especially the ones (45, 46, 47) located near the fault trace can be observed. Although the damages in piers are obvious it is advised to observe the critical piers by techniques other than the geodetic methods in detail.
