Earthquake Repairs at Christchurch WWTP – Lessons for Resilience

Greg OFFER, Mark CHRISTISON, Ian BILLINGS, New Zealand

Key words: Christchurch, resilience, treatment plant, earthquake

FIG Working Week 2016
Recovery from Disaster
Christchurch, New Zealand, May 2–6, 2016

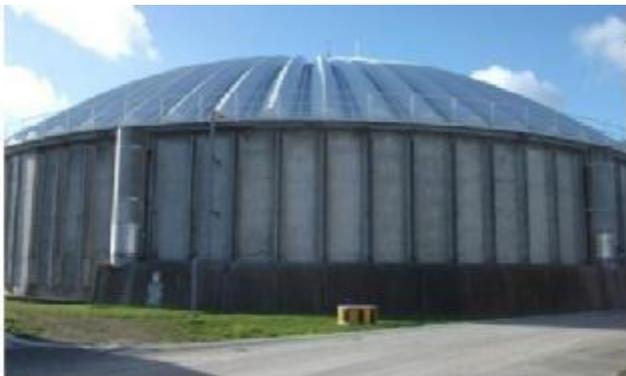
Figure 3: Trickling filter at CWTP

The two trickling filters are 50m diameter shallow-founded concrete tanks containing plastic media (see Figure 3). Damage to these concrete structures has been assessed as relatively light, although internal inspections have only recently been conducted as these units operate continuously and are rarely taken offline. Trickling filter damage comprises vertical cracks at the joints between post-tensioned vertical wall panels and possible internal floor damage. Both trickling filters remained operational throughout the earthquake sequence, playing an important role in maintaining treatment function while downstream solids contact tanks were out of service.

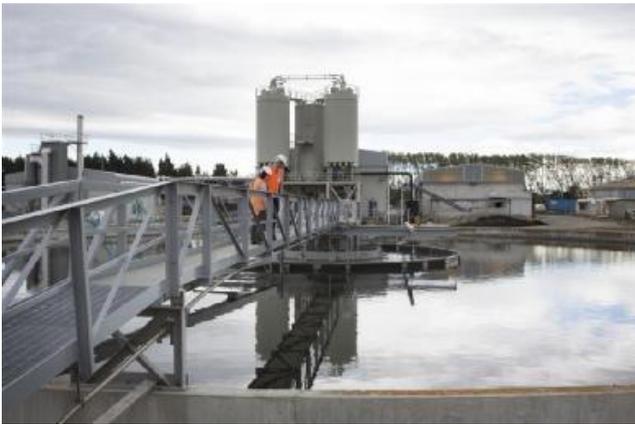
Figure 4: CWTP Clarifiers

Damage to the clarifiers was caused by ground shaking and liquefaction effects. As the soil liquefied, the clarifier bases were subjected to liquefaction-induced uplift forces as well as static buoyancy force due to hydrostatic pressure. Figure 5 shows how the uplift pressures imposed forces on the clarifier structures, causing flotation effects on the entire structure and deforming the floors.

Parameter (mm)	Clarifier 1	Clarifier 2	Clarifier 3	Clarifier 4
Overall tilt	73	45	70	110
Central foundation uplift	80	20	300	100
Floor deformation	90	60	600	200

Investigations found a range of issues; Clarifiers 1 and 2 were relatively less damaged, while clarifiers 3 and 4 had major structural damage, necessitating major repairs.
