CONTRIBUTION OF GEODETIC POSITIONING TO PREVENTING INCIDENTS IN FILL WORKS AND MITIGATION OF THEIR EFFECTS

António VEIGA PINTO and Maria João HENRIQUES

National Laboratory for Civil Engineering, Portugal

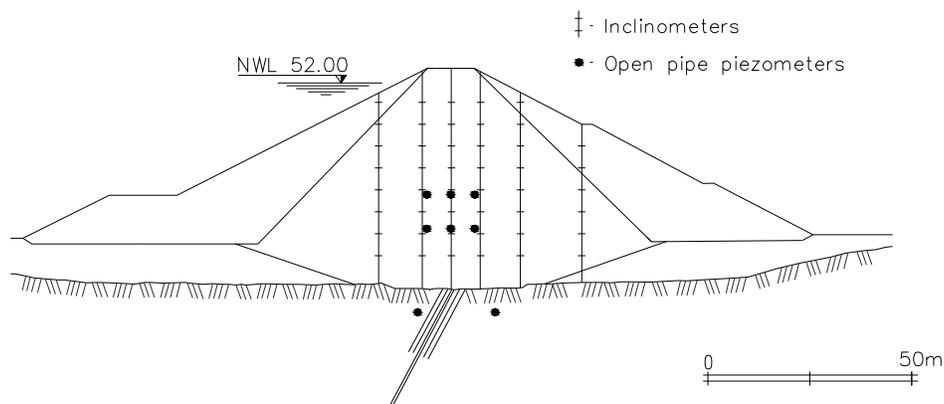
The observation plan was prepared on the basis of that prediction, with instruments being placed on the sites supposed to be the most critical ones. Especially, inclinometers were installed on the maximum cross-section (Figure 1), so as to be possible to draw conclusions about settlements occurred, even during the construction stage.

Figure 1 – Beliche Dam. Devices on the maximum cross-section

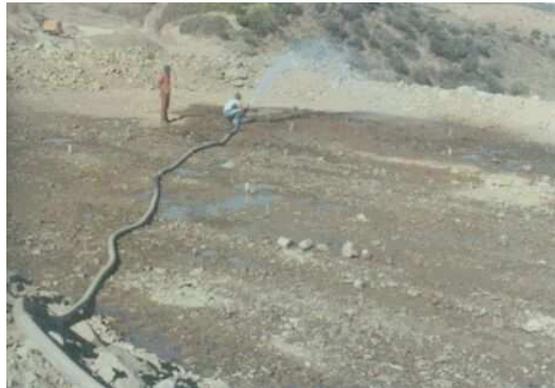
This very simple test consists of defining a test area where metallic plates are riveted, the collapse being quantified by the variation in the level of those plates, before and after abundant soaking of the fill. Vertical displacements are measured by geometric precision levelling. Figure 2 shows a phase of abundant irrigation, with about 20% of the water volume of the rockfill tested.

Figure 2 –Beliche Dam. Stage of abundant irrigation in the collapse test

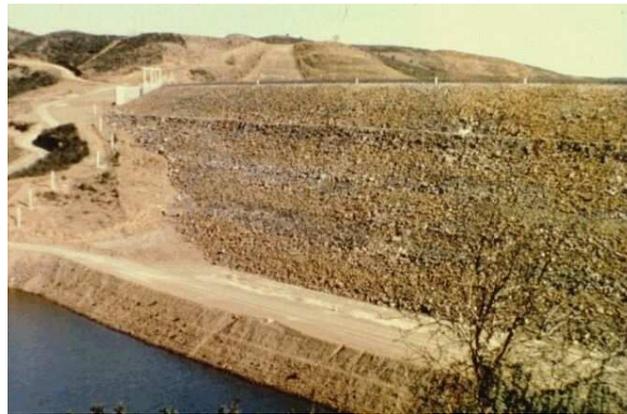
Figure 4 – Beliche Dam. Berm constructed on the upstream face

In view of these results, it was concluded that, during the first filling phase, high settlements were likely to occur. Therefore, other than reinforcing the compaction procedures in the transition material, an adaptation to the observation plan was also immediately established. This comprised the inclusion of a berm on the upstream face to act as support to the installation of temporary bench marks to measure settlements, as soon as the submersion of the material of the upstream stabilising rock mass (Figure 4) began. That berm was to be located at a level about 9m lower than the crest.
