# Determination of Structural Deformations Caused by Earthquakes Using Geodetic Techniques

Esra TEKDAL EMNİYETİ, Rahmi Nurhan ÇELİK and Tefvik AYAN, Turkey

The aim of this study is to investigate the deformation occurred on structures (especially the viaduct 1) of the Bolu pass of 114 km long Ankara-İstanbul motorway, after 17<sup>th</sup> August Marmara and 12<sup>th</sup> November Düzce earthquakes by using precise 3D geodetic measurements.

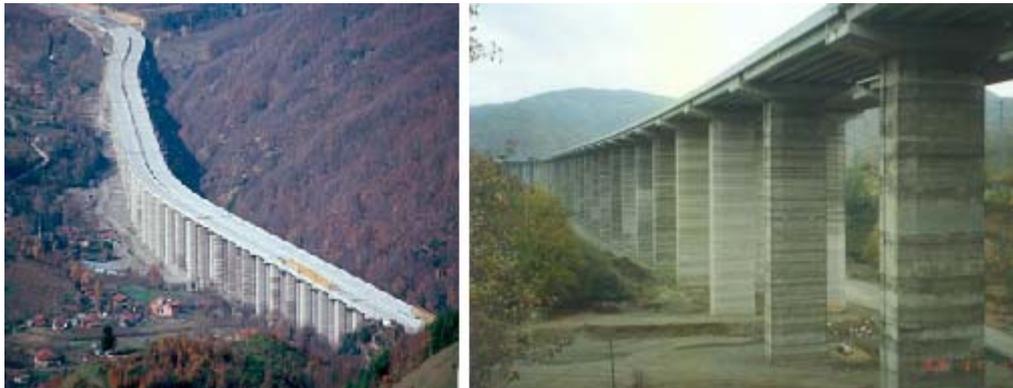
**Figure 3: General view from the Viaduct 1**

The August 17, 1999 earthquake with a moment magnitude of 7.4 and, November 12, 1999 earthquake with a magnitude of 7.2 took place in the NAF. As a result of these earthquakes many engineering structures, one of which is the Viaduct 1, are seriously damaged (Ghasemi et al. 2000).

The spans of viaduct 1 are typically 39.2 m with each deck span consisting of 7 precast pretensioned U-beams with an in-situ reinforced concrete slab. The pretensioned U-beams are seated on pot bearings with a stainless steel/polytetrafluoroethylene (PTFE) slider interface. The deck slab acts continuously over 10 span segments. The deck slab is continuous across pier tops except at movement joints. Piers are up to 50 m in height and consist of single hollow rectangular reinforced concrete pier shafts with a capping beam. Foundations comprise 3 m thick pile caps with typically twelve 1.8 m diameter reinforced concrete bored cast in-situ piles up to 37.5 m long (Ghasemi et al. 2000, Barr et al. 2000).
