GIS Application

in Technical and Environmental Safety of Natural Gas Transmission Pipelines,

a Case Study

Tuncer OZEBİL
GEOGIS
GIS Manager

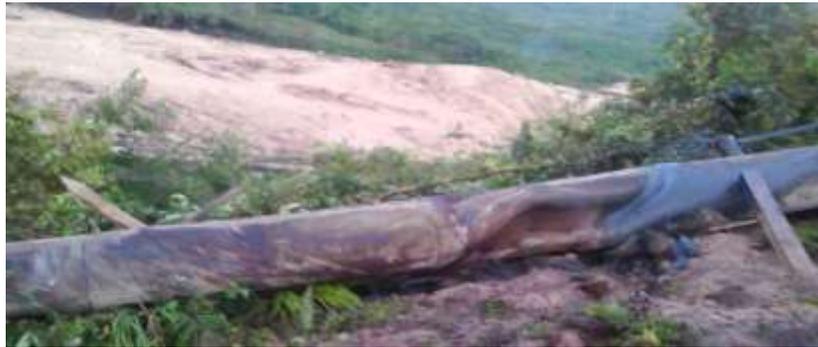
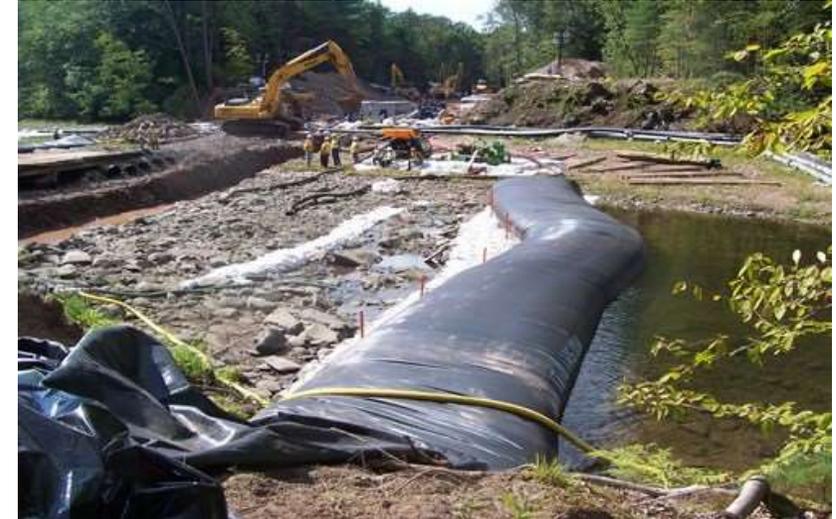
Risks related to safety in natural gas pipelines

- Fault lines
- Landslide sites
- Erosion zones

- Buildings
- Mine areas
- Sand or gravel pit
- Highway, road & railways crossing pipeline
- Power transmission lines crossing pipeline
- River & channels crossing pipeline
- Other pipelines crossing natural gas pipeline

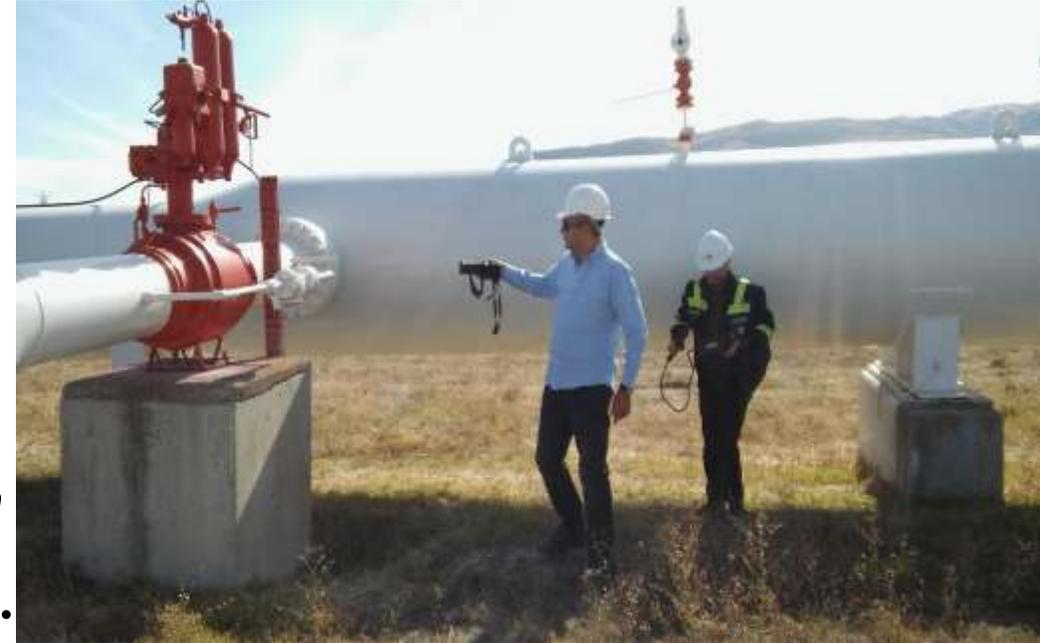
Before pilot project;

- Anomaly checks and gas leak inspection are **periodically performed** by BOTAŞ.
- The controls are made using **terrestrial methods by land vehicles or walking** along the pipeline route and in the station area.

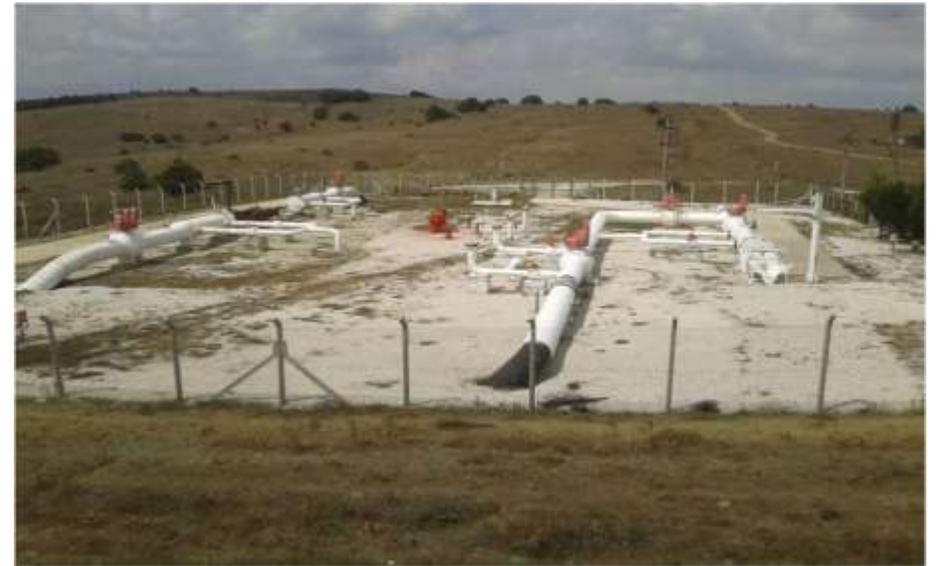
Scope of the project is

1200 km of natural gas transmission pipeline route and

Stations on route such as;

- Line Vanes Stations,
- Pig Stations,
- Regulator / Meter Stations (RMS),
- Compressor Stations,
- Take-off Vane Stations.

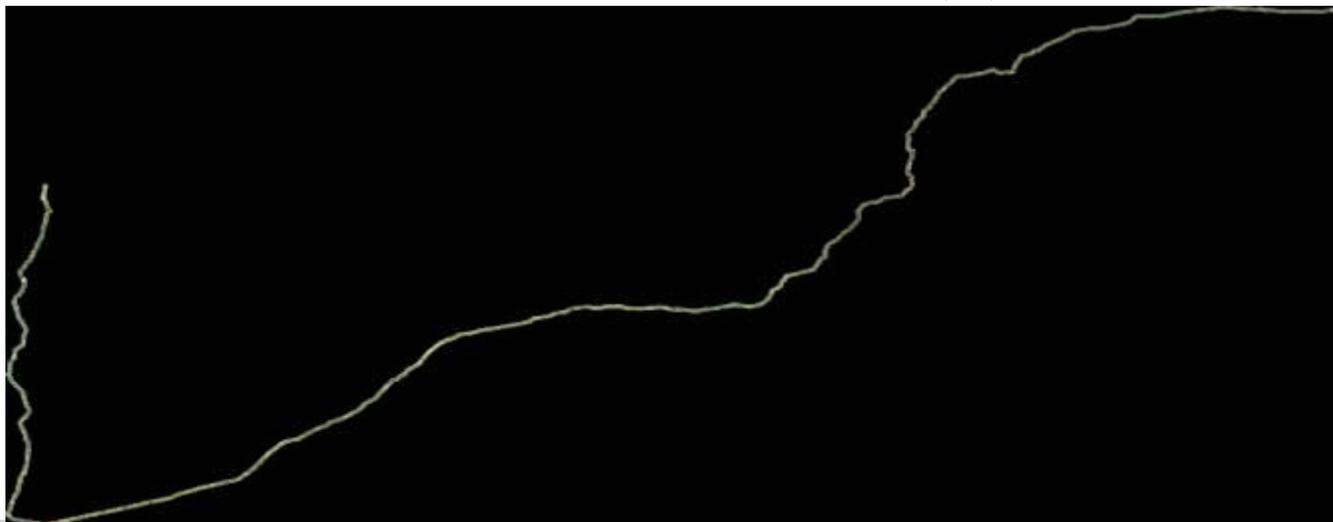
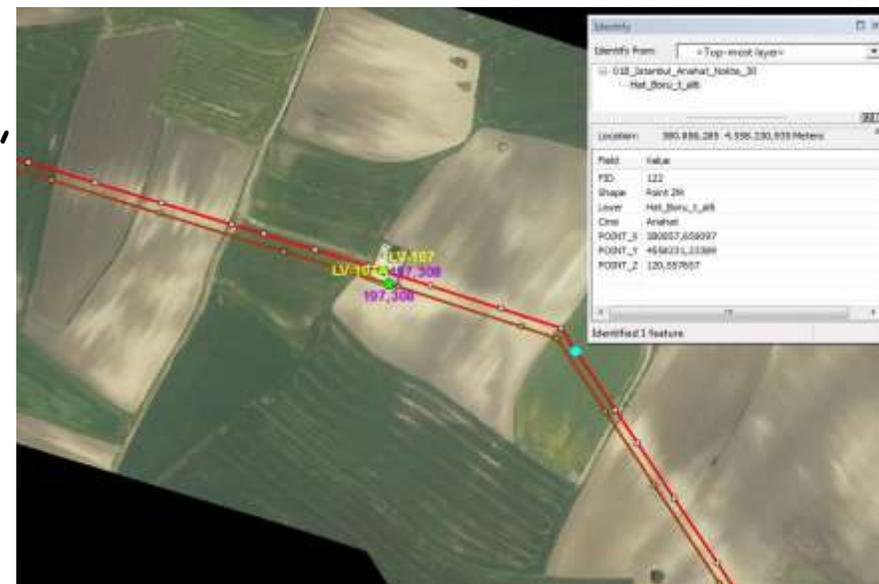
The geospatial data set for the goal contains;

- **Orthophoto** mosaic image
 - ✓ with 10 cm GSD,
 - ✓ along 1200 km long and 400 m wide,
- **DSM and DTM,**
- **Vector data and coordinate list** of pipelines and stations,

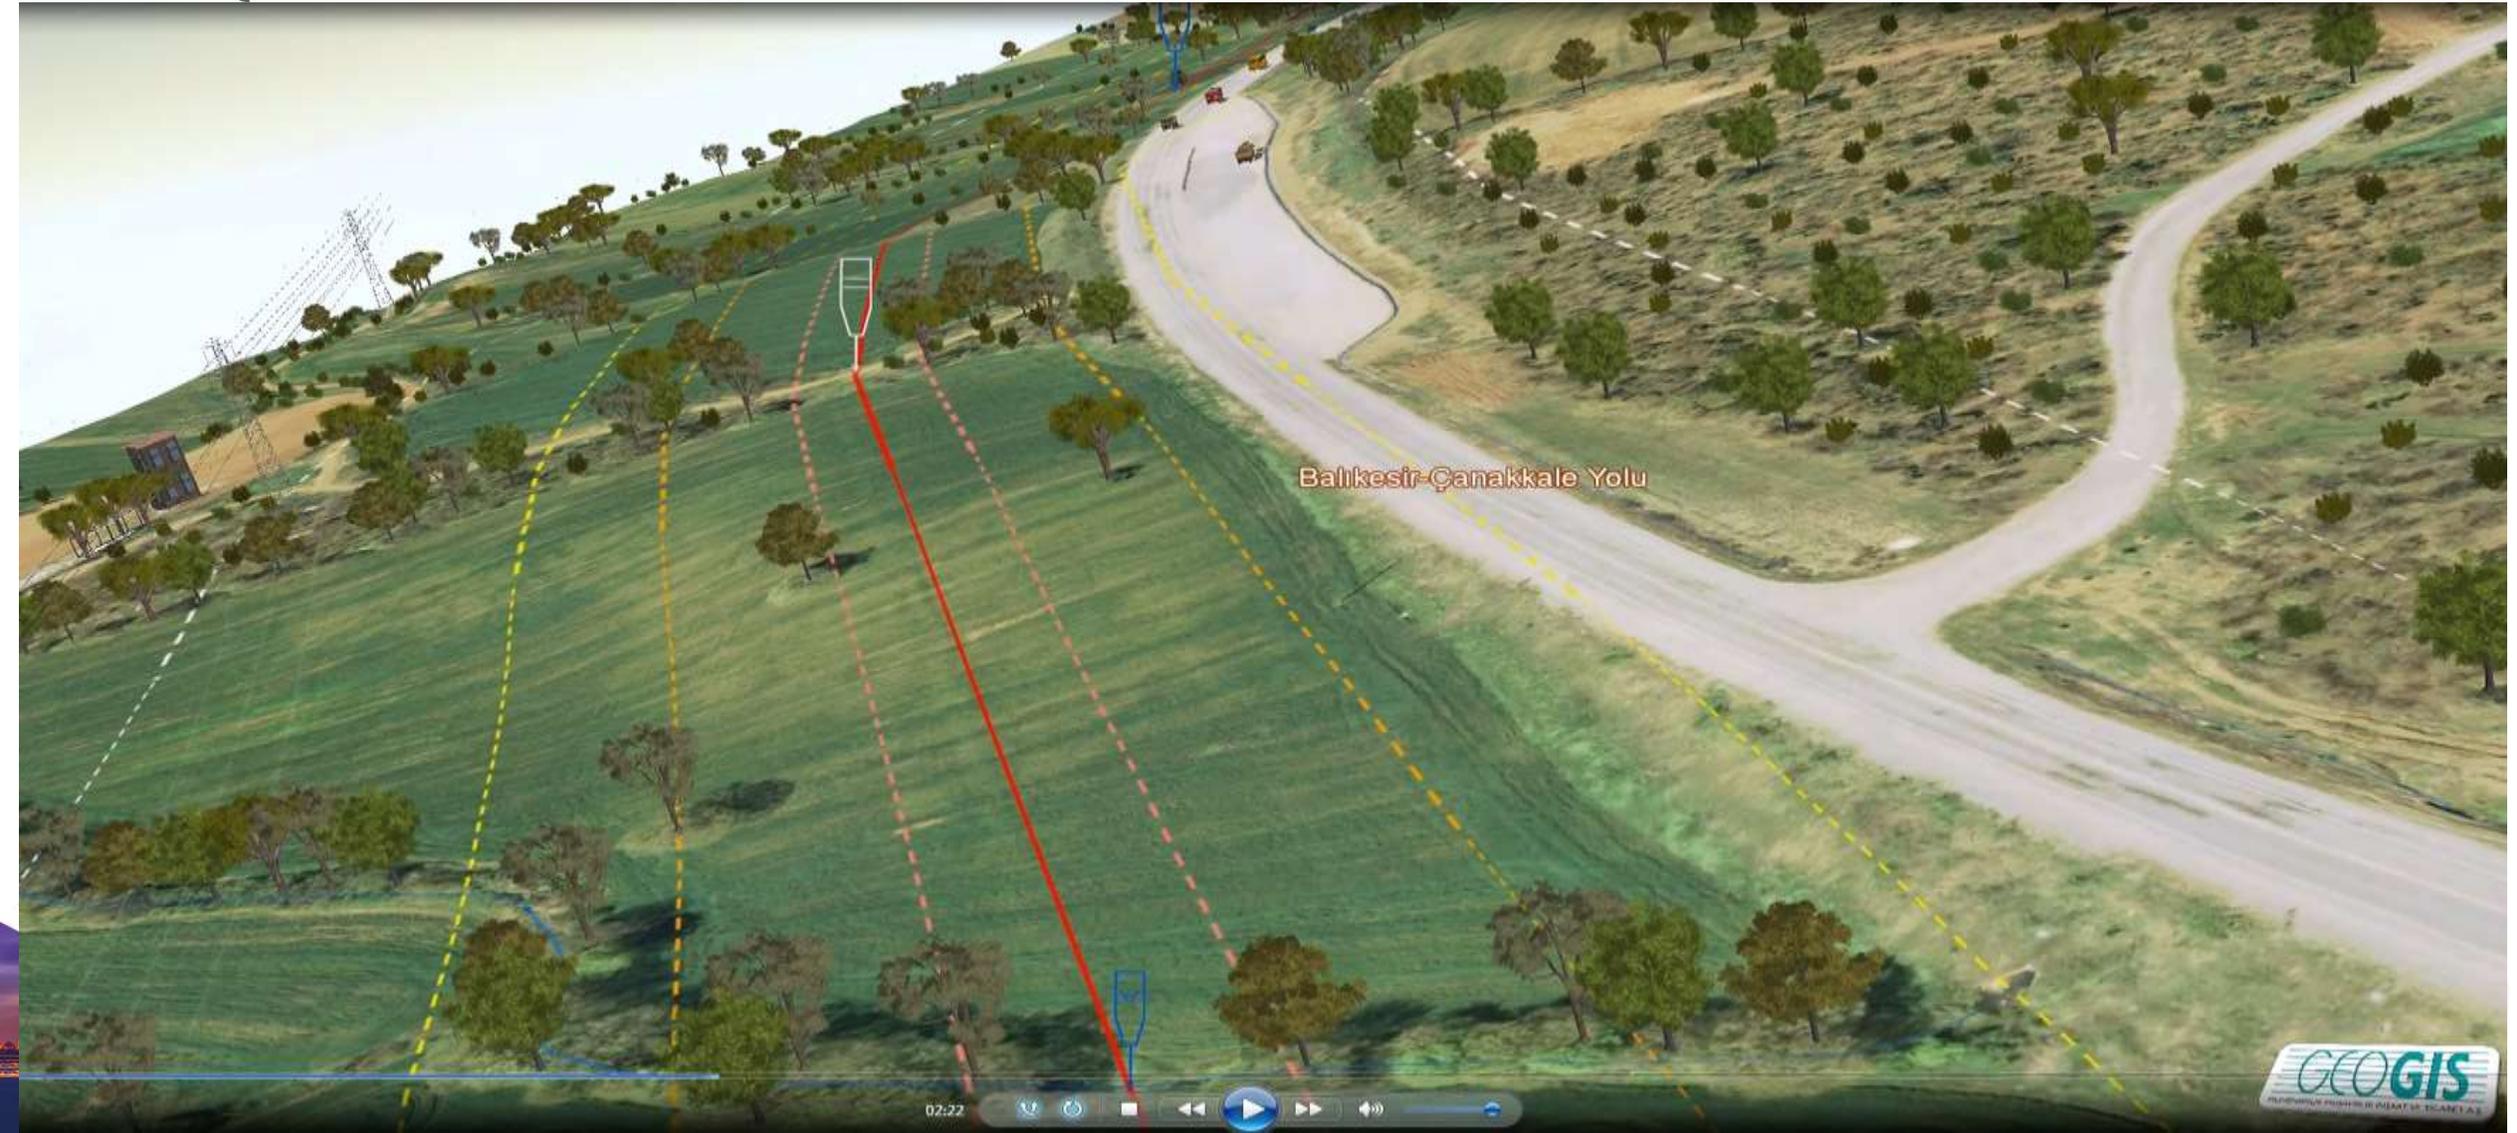
- Video recording of flight animation along pipeline route in 3D environment

In addition, video recordings prepared in 3D environment using actual aerial photographs facilitated analyzes and evaluations made by BOTAS managers and engineers within the scope of control / maintenance / repair works for pipelines.

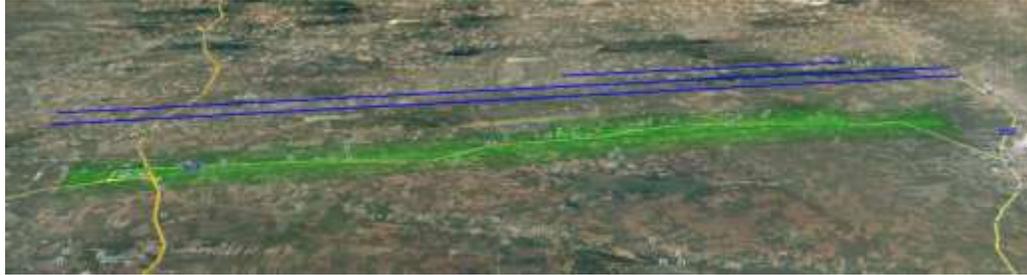
Flight planning

What we need to start the production is a KML file of pipeline route and stations provided by BOTAŞ

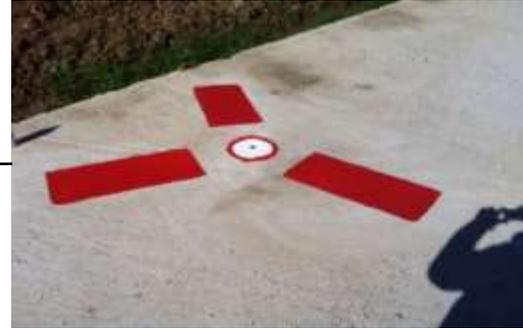
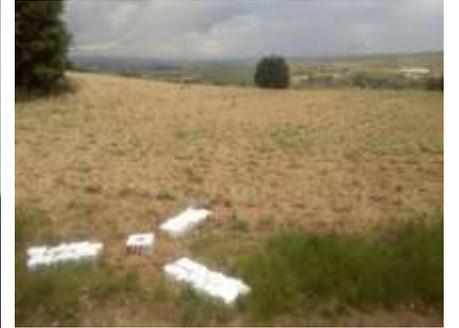
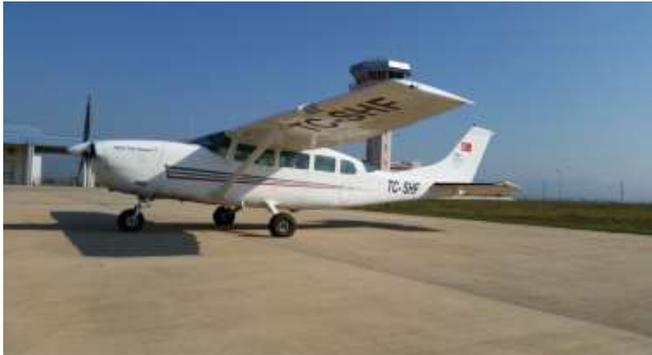
GCP planning

Flight operation

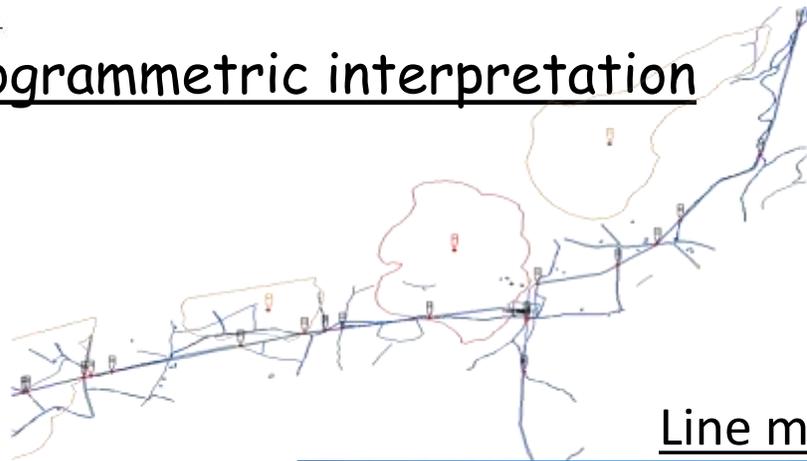
Photogrammetric interpretation

Visually controlling of pipeline route

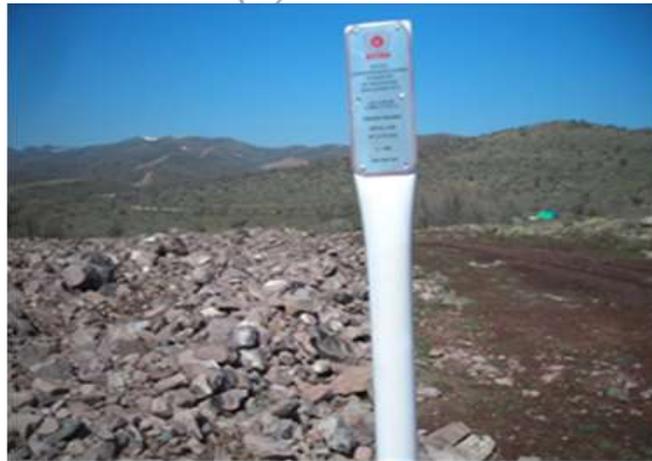
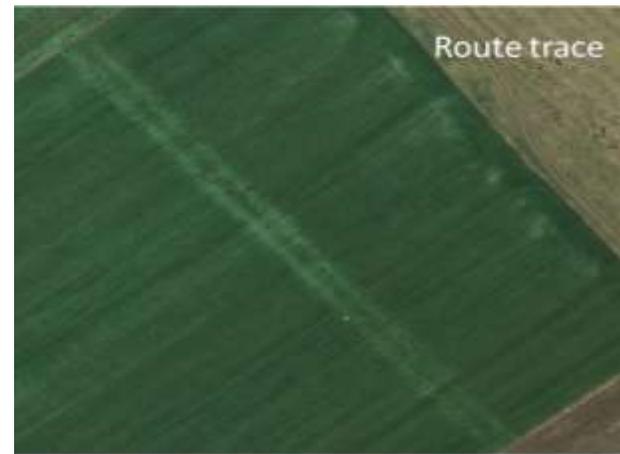
Line markers

pipeline trace on orthophoto image

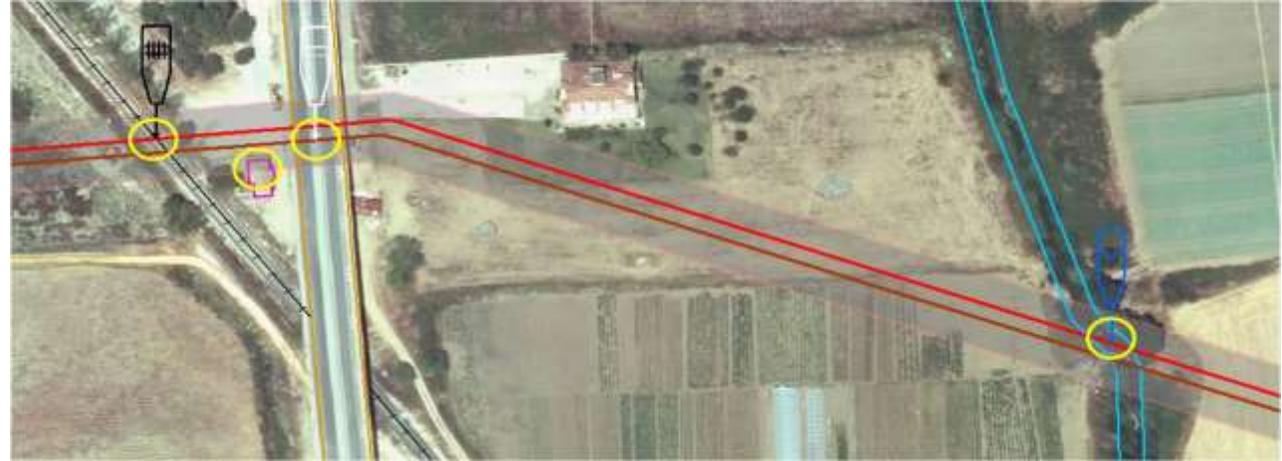
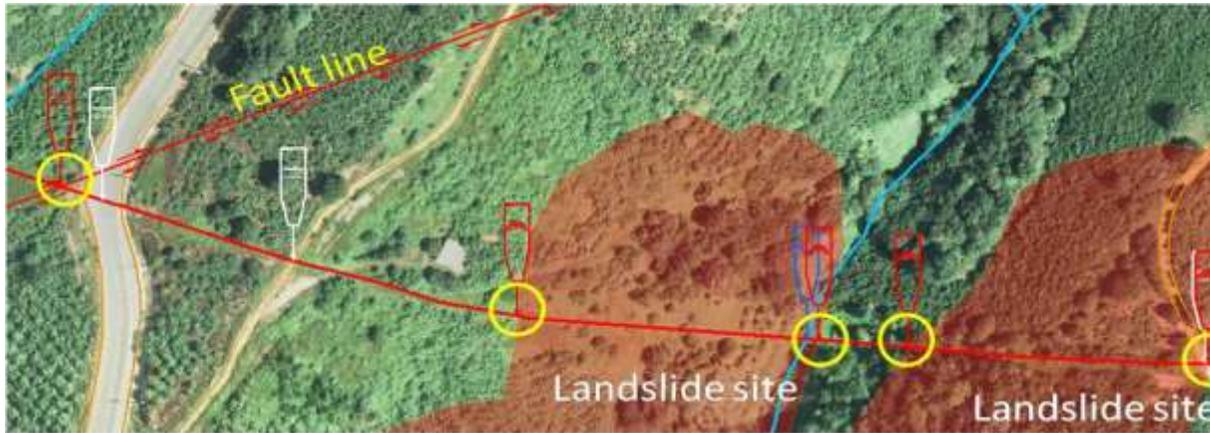
Defining cross points using GIS location analyses such as

intersect, buffer analyze, contain, point in polygon etc.

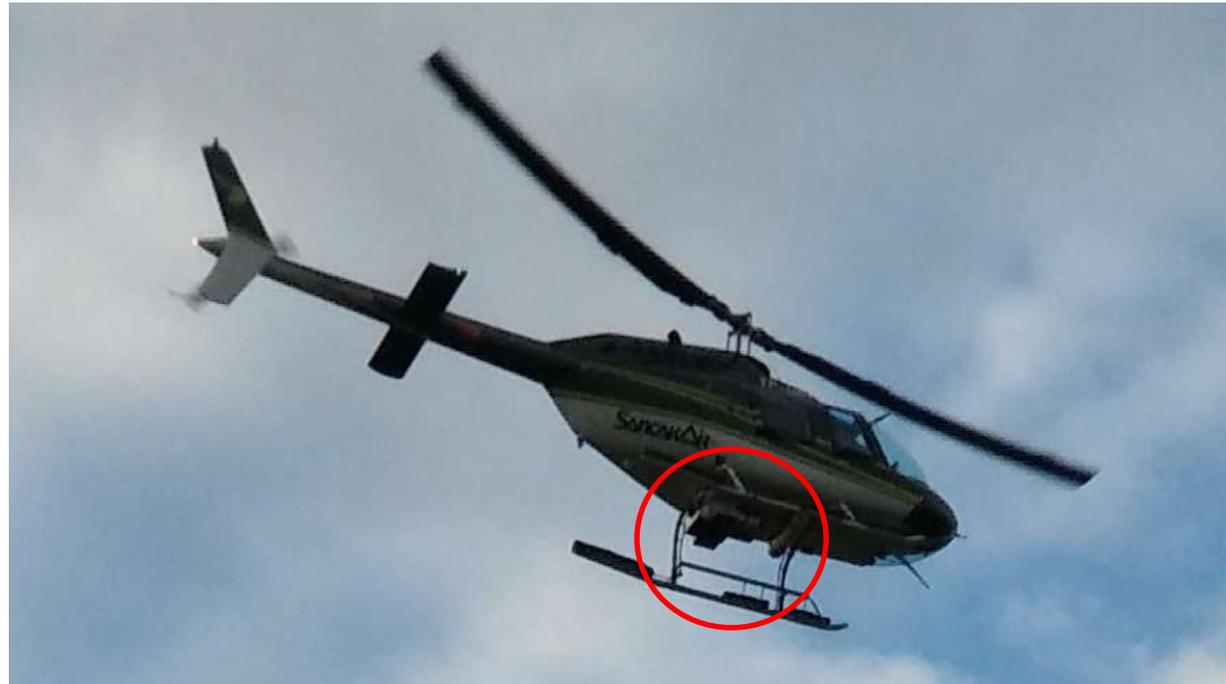
Gas leak inspection

with ALMA G2 (Airborne Laser Methane Assessment) mounted to Bell 206 Jet Ranger helicopter

Airborne inspection of gas leaks has enabled effective control, reporting and evaluation in a large area and has allowed the pipeline operating units to repair gas leaks as soon as possible.

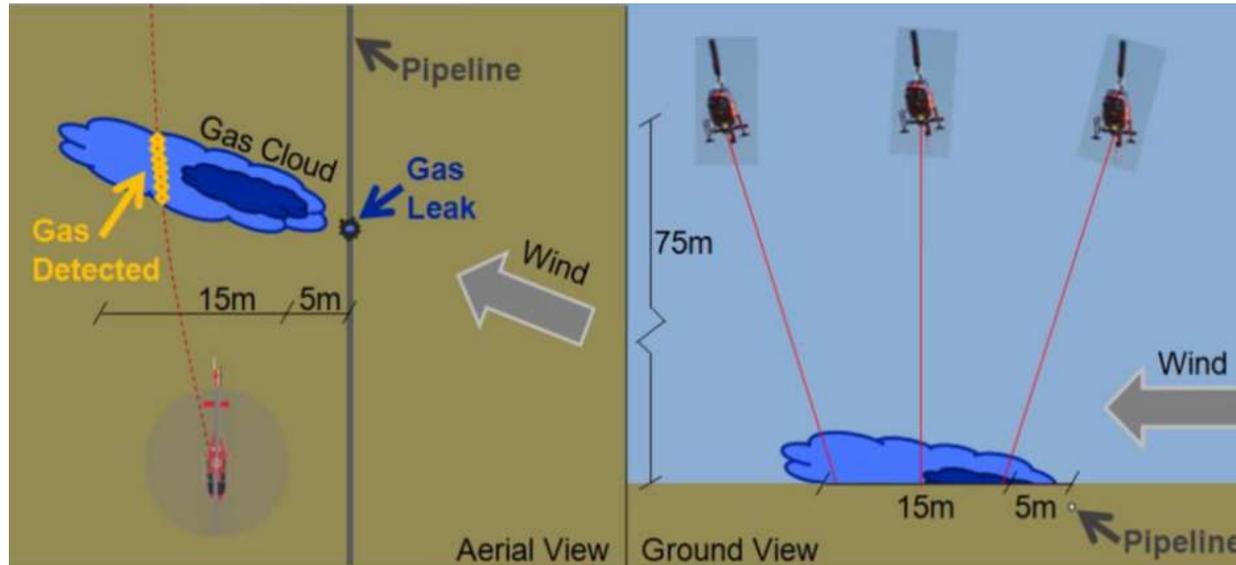
The ALMA system uses a technology based on the **measurement of the amount of infrared laser light** having a radioactive wavelength of 1650 nm **absorbed by methane gas**.

The laser beam is emitted from the Optical Unit of the system and strikes objects such as soil, grass, wood, concrete, and asphalt on the ground surface.

The **system analyzes the reflected laser beam** and calculates how much is absorbed by the **possible methane**.

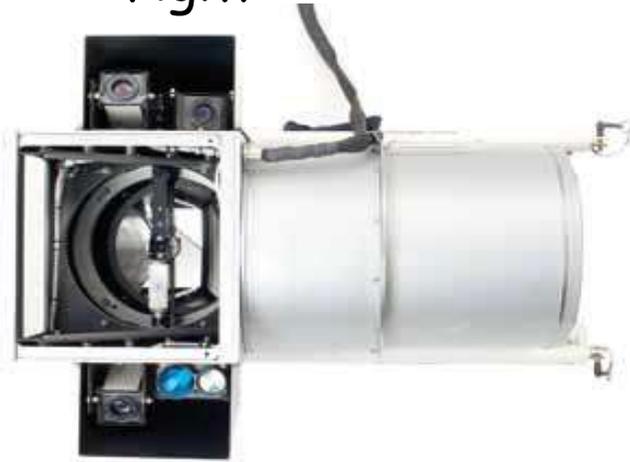
Optic unit has 3 cameras
- pilot
- left
- right

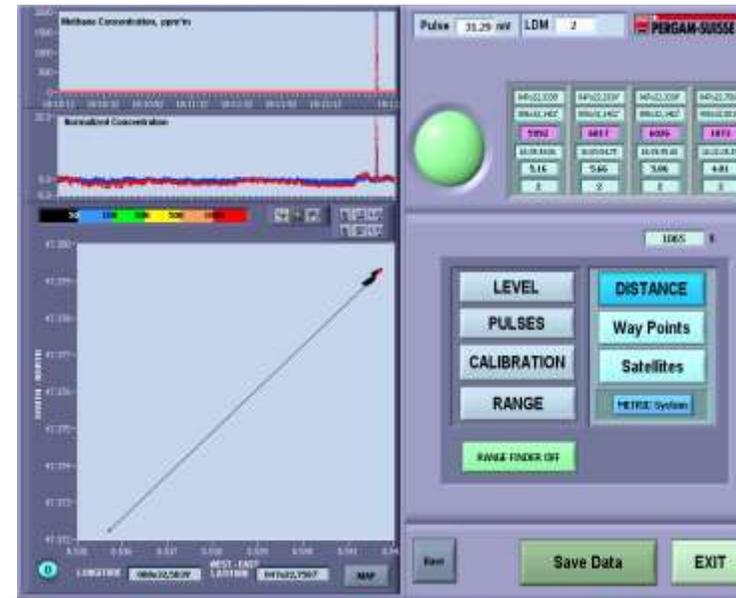
When gas leakage is detected,
the graphic will make a pig as seen.
And system records all related data as a leak point.

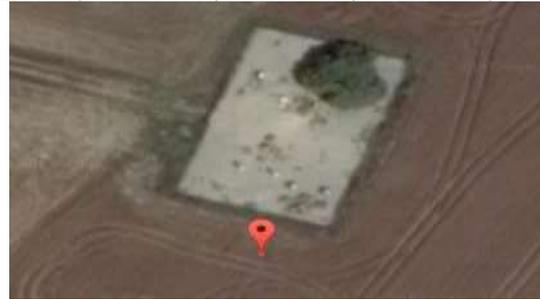
Detection #	Date	Time	Latitude	Longitude	Methane Concent. (ppm*m)	Altitude (m)
1	18.10.16	16:51:21.40	41.1506400	28.5790750	46.37	29.7

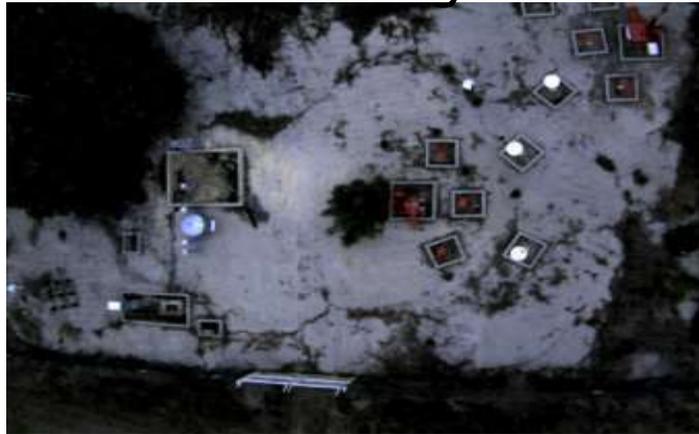
Left camera image

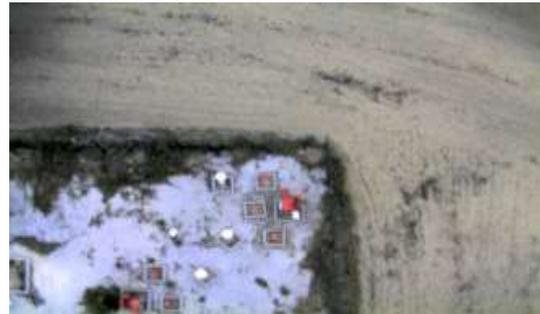
Right camera image

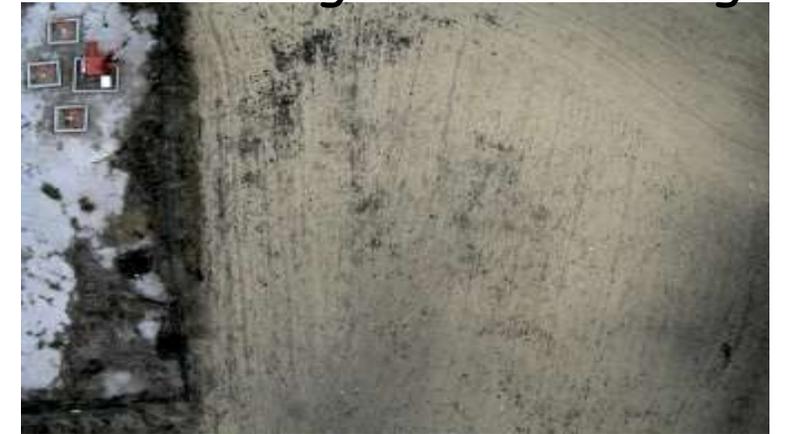
Pilot camera image
