# The use of TLS technology in the inventory of damage to building objects resulting from the impact of underground mining exploitation

### Ryszard MIELIMĄKA, Paweł SIKORA and Przemysław MAZUR, Poland

## SUMMARY

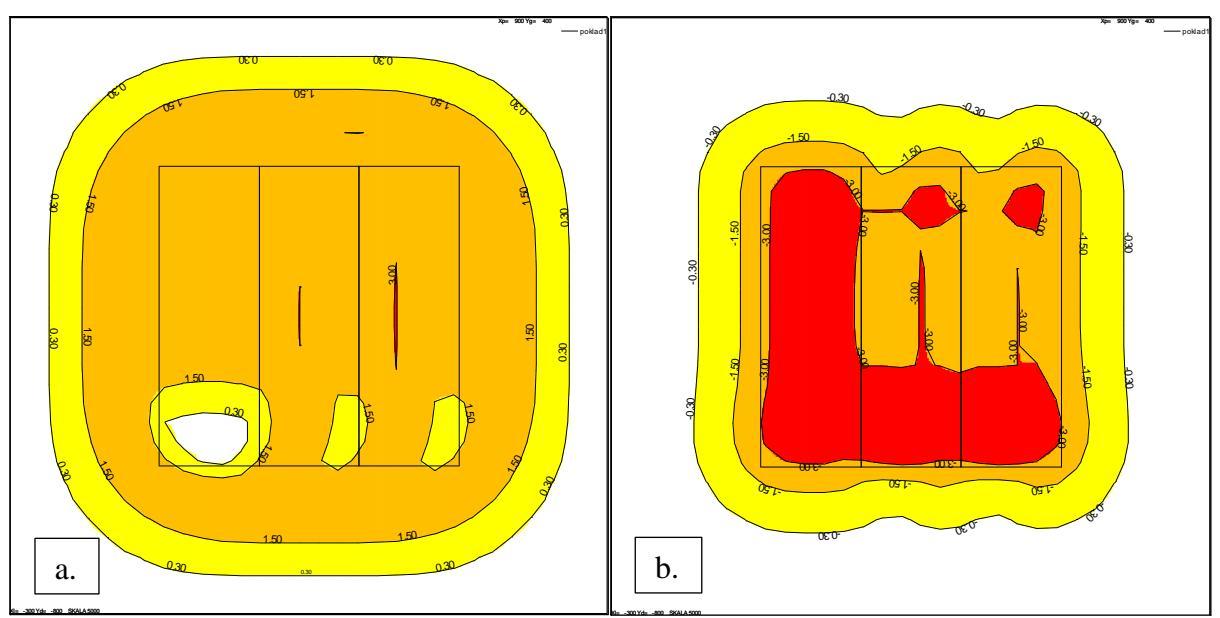
Figure 1 presents the distributions calculated with the application of the program EDBJ by prof. J. Białek (Białek J., 2003) of extreme in time principle tensile and compressive deformations which will be generated on ground surface above the exploitation of three successively

exploited horizontal longwalls with a height of 1.0 m, located at a depth of 400m. Similar distributions will have extreme in time concave and convex main curvatures.

Fig. 1. Distributions of extreme in time principle tensile (a.) and compressive (b.) deformations calculated with the EDBJ program (source: own study)

Figure 1 shows that outside the exploited field, higher values will be adopted by the extreme in time principle tensile deformations and convex curvatures, and inside this field - extreme in time principle compressive deformations and concave curvatures.

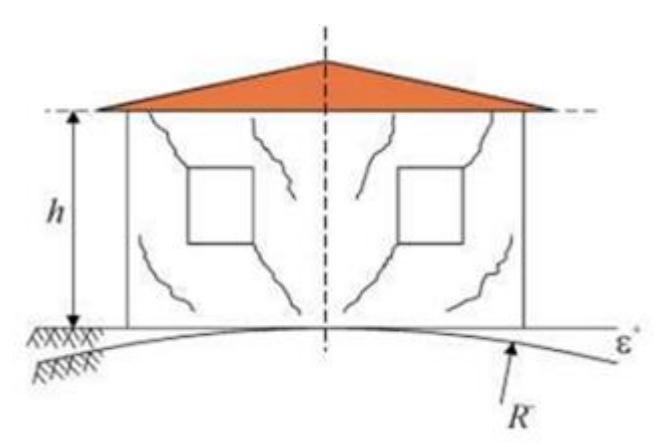
Exemplary cracks in the facade of a building located in the edge part of the subsidence trough (i.e. subjected to tensile deformation and convex curvature) are shown in Figure 2.

Fig. 2. Cracks in the facade of a building located in the edge zone of the trough (source: Misa R., 2015) (ε - tensile deformation, R - convex curvature)

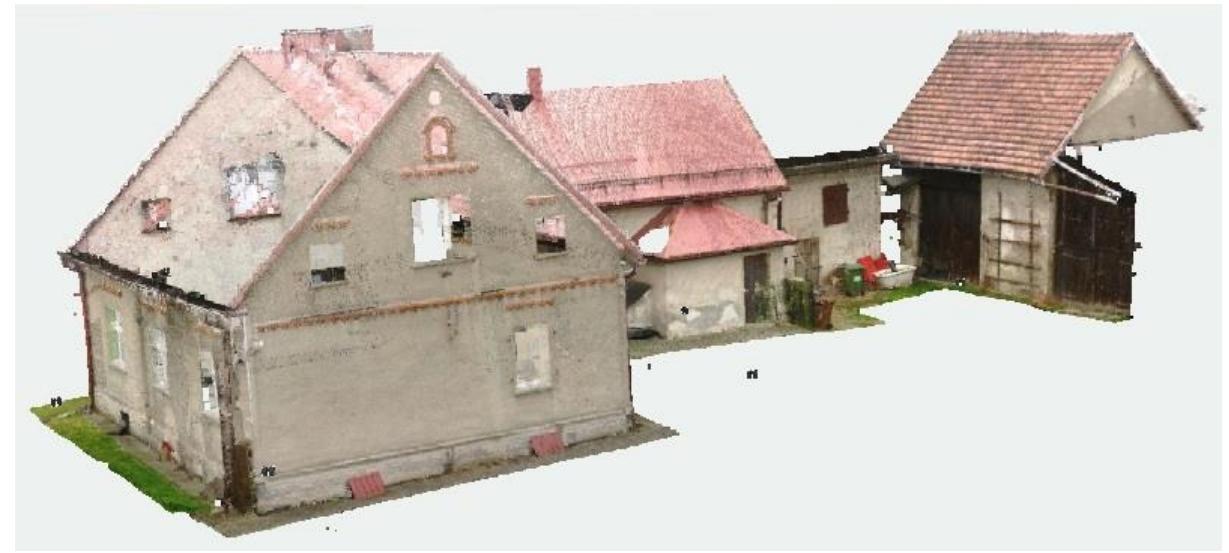
The object in question consists of a residential part, a utility room and a barn, once used for the needs of a private farm (Fig. 4). Within the area of the property there are numerous shrubs and low trees, and in close vicinity, on a high embankment, there is an express road. The facades of the buildings are covered with numerous, clearly visible cracks, and large-sized gaps were also found in many places.

Fig. 4. General view of the tested object, obtained after data processing from a stationary scanner (source: own study)

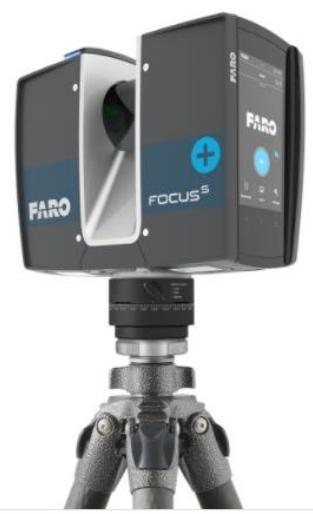
To make the model of the entire building, the scanner FARO® Focus S350 was used (Fig. 5). It enables to scan up to a million points per second, located even 350 m away from the stand of the instrument, both in the field and indoors. It also provides a distance measurement accuracy of  $\pm 1$  mm and a high precision angle measurement. It is adapted to work in temperatures from -20°C to + 55°C, and also, owing to the IP54 tightness class, in dusty conditions, high humidity or with short-term splashes of water on any side of its housing. The optical system of the device is equipped with the HDR function, which allows to accurately capture the scanned surfaces even in poor lighting conditions. Additionally, the instrument is equipped with a GNSS module, which enables spatial orientation and automatic merging of the scans. It also makes it possible

Fig. 5. Stationary scanner FARO<sup>®</sup> Focus S (source: www.faro.com)

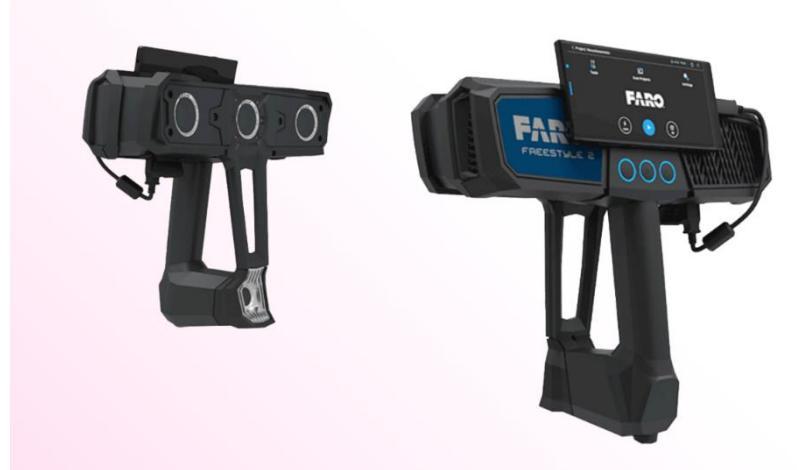
The gaps of larger size found on the facade of the building were inventoried using the FARO® Freestyle 2 handheld scanner (Fig. 6), which allowed to capture surfaces placed 0.4 - 10m away with the error of distance measuring of only 0.5 mm / 1 m. The scanner enables the registration of up to 220 thousand points per second, and like a stationary instrument, it has an HDR function that allows to work in dim light. The course of the registration of points can be followed in real time on a smartphone screen, which also allows to control the instrument. The created point cloud can be combined with data from a stationary scanner.

Fig. 6. Handheld scanner FARO<sup>®</sup> Freestyle 2 (source: www.develop3d.com)

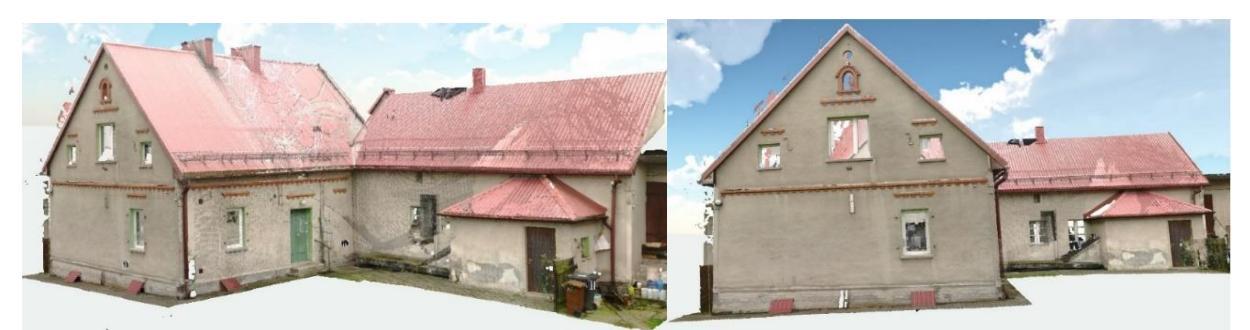
In effect, a high-quality imaging was obtained. The image was also devoid of vegetation fragments that would reduce clarity (Fig. 7).

Fig. 7. Three-dimensional model of the object after the processing of point clouds (source: own study)

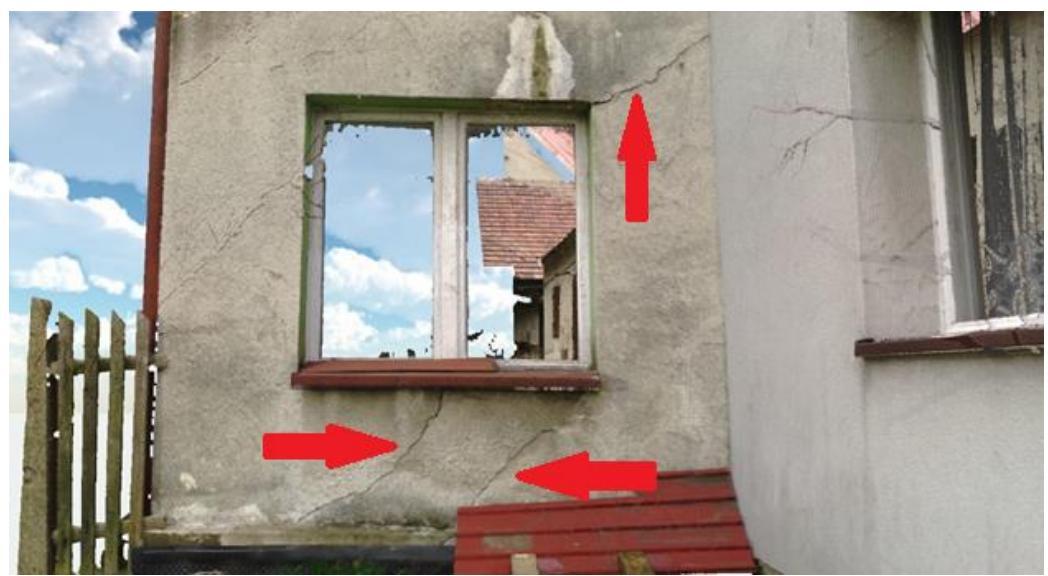
The created model very clearly shows cracks and scratches in the building's facade. Their irregular course was reconstructed ensuring the preservation of the smallest details (Fig. 8). The cyclically created studies, combined with the function of linear and angular measurements offered by the software FARO® SCENE, allow to carry out precise observation of the propagation of the shape and size of almost any damage to the object.

Fig. 8. Cracks in the building wall - model created on the basis of data from a stationary scanner (source: own study)

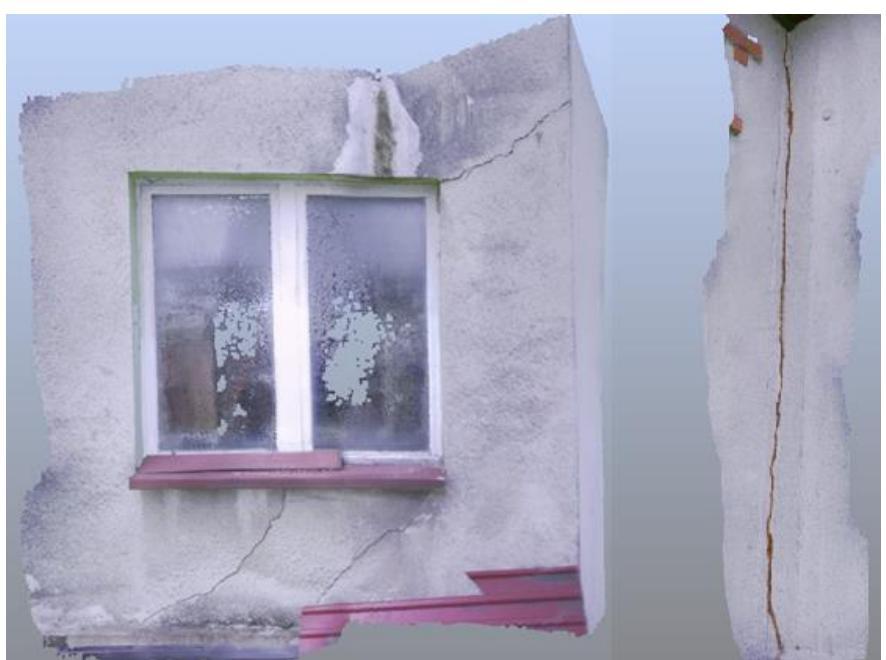
For the most extensive gaps, which pose the greatest threat to the structure of the object, models with increased accuracy were also made, using the data obtained with a handheld scanner, which were then processed in the FARO® SCENE Capture program (Fig. 9).

Fig. 9. Cracks in the walls of the building - models created on the basis of data from a handheld scanner (source: own study)

For the most extensive gaps, which pose the greatest threat to the structure of the object, models with increased accuracy were also made, using the data obtained with a handheld scanner, which were then processed in the FARO® SCENE Capture program (Fig. 9).

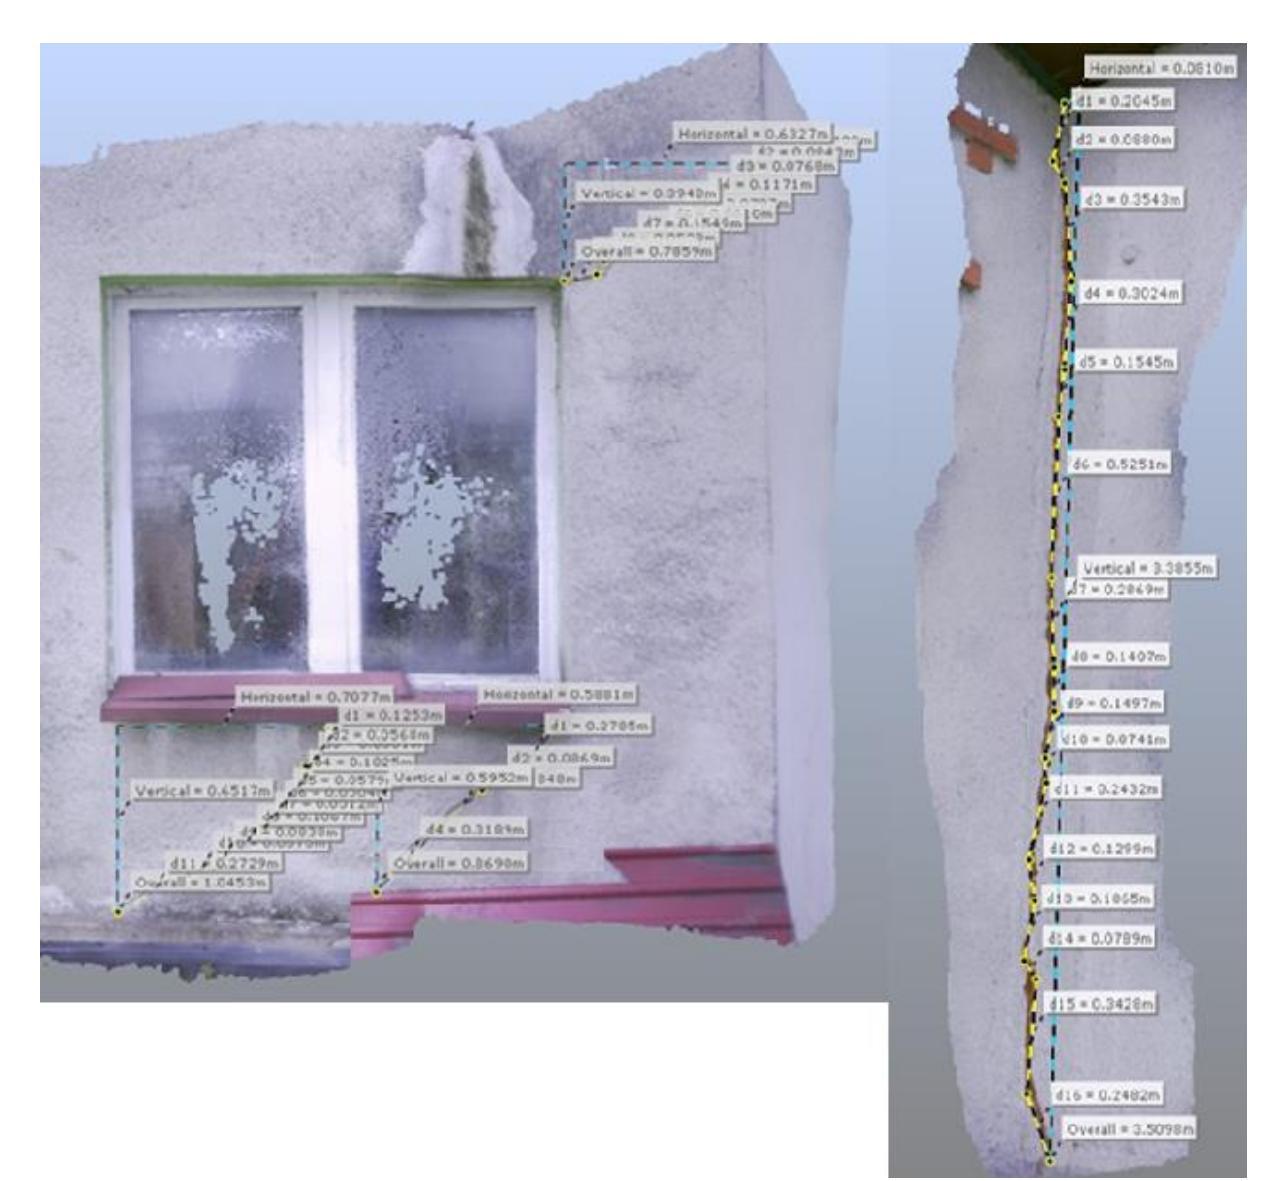
The processing of point clouds was largely the same as in the case of a stationary scanner. The created models made it possible to measure the geometrical quantities characterizing the cracks, such as: vertical dimension, horizontal dimension, total length and width. The program makes it possible to precisely outline individual sections of the crack and determine their dimensions (Fig. 10.).

Fig. 10. Determining the dimensions of the gaps in the building facade. (source: own study)
